REPORT ON THE FIRE WHICH OCCURRED AT THE RELAY BUILDING, LONDON, UK ON 7 MARCH 2022

By Frances Maria Peacock

April 2022

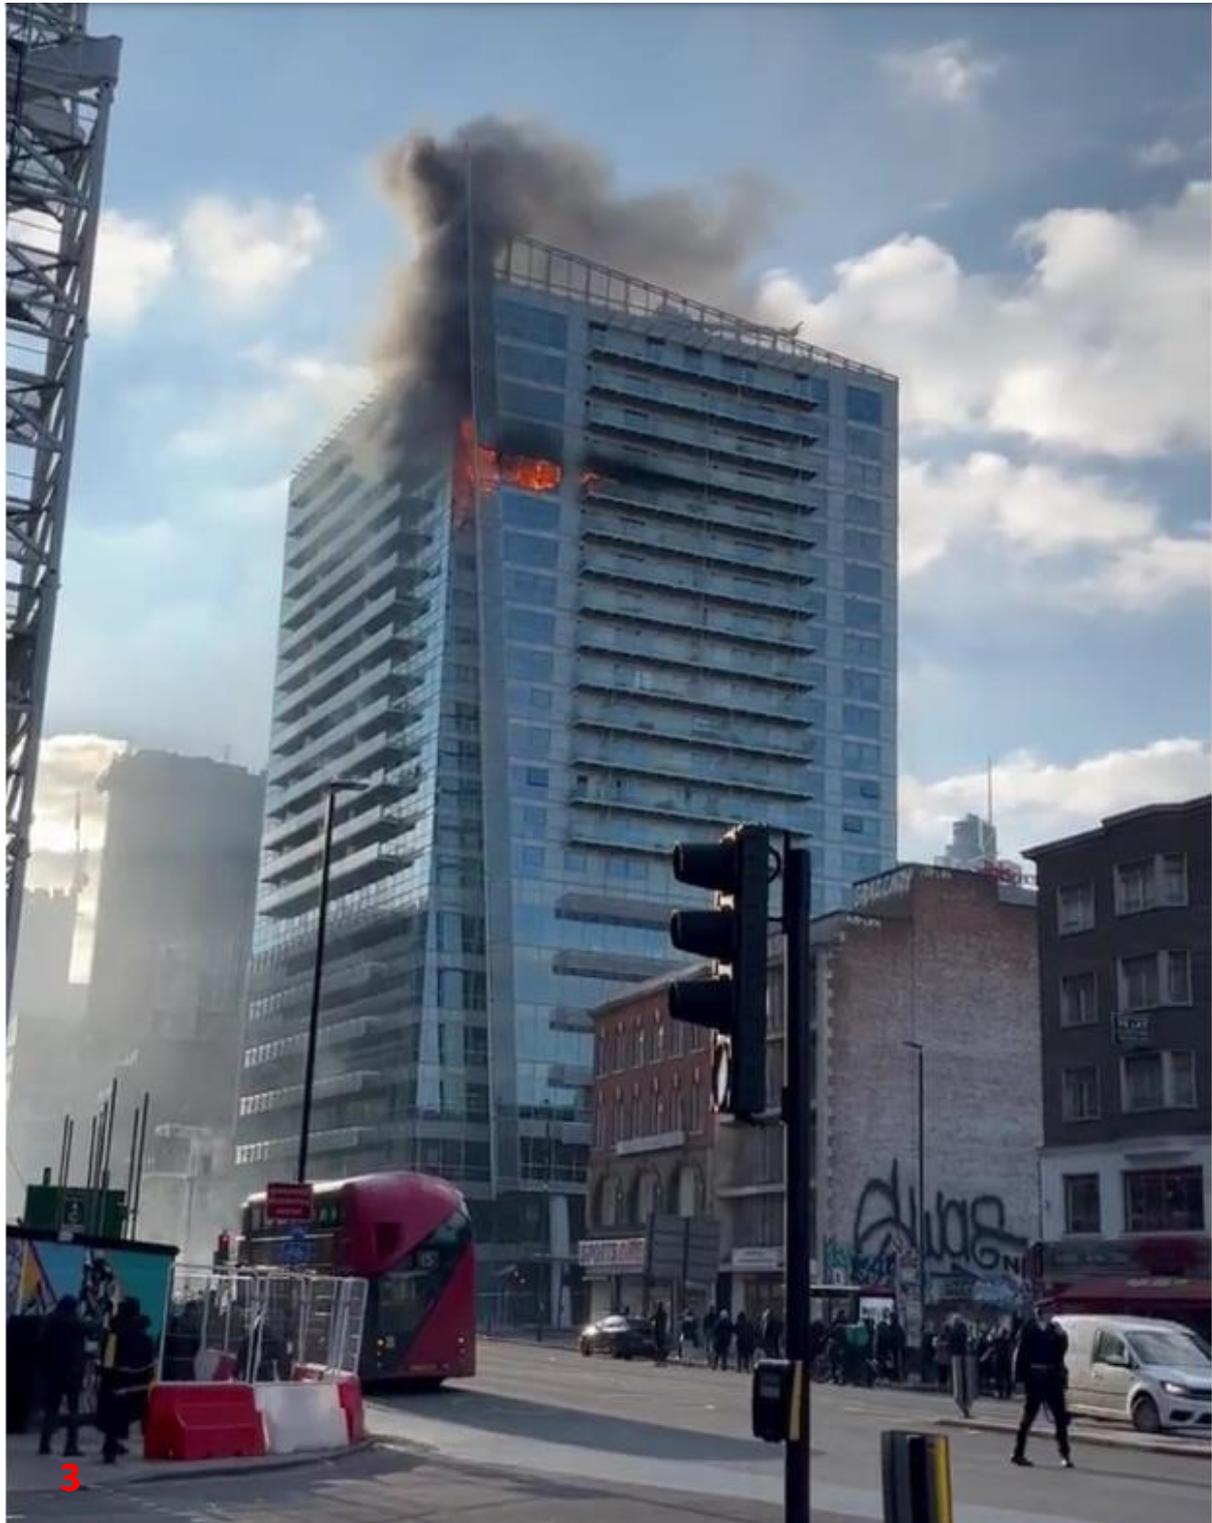
3.2 The apartment involved was not a housing association property, but one of the higher end flats created in 2014. The development of the fire is documented in the photos (Figs.3, 4 & 5) and paragraphs below. It began high up in a flat on the south-east corner of the building and developed rapidly, causing the glazing to fail on both the southern and eastern sides.

3.3 Once the glass failed, the curtain wall was opened up, allowing ventilation and a draw of air through the apartment. Being so high up, the wind speed was greater and this had an effect upon the fire; in *Figure 4* it appears that the flames are being blown around. This seems to have been noticed by observers on the ground, one of whom (Owen Wills) remarked, *“It’s very windy, so it looks like the smoke and flames are blowing all over the place.”*

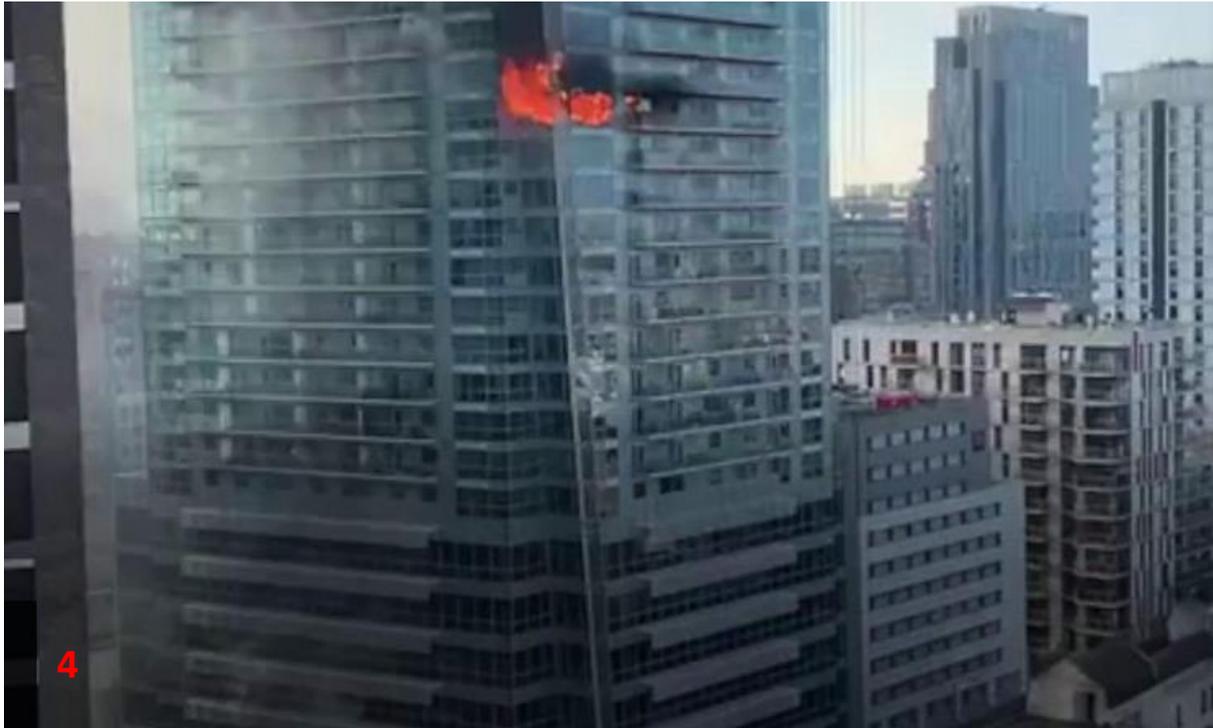
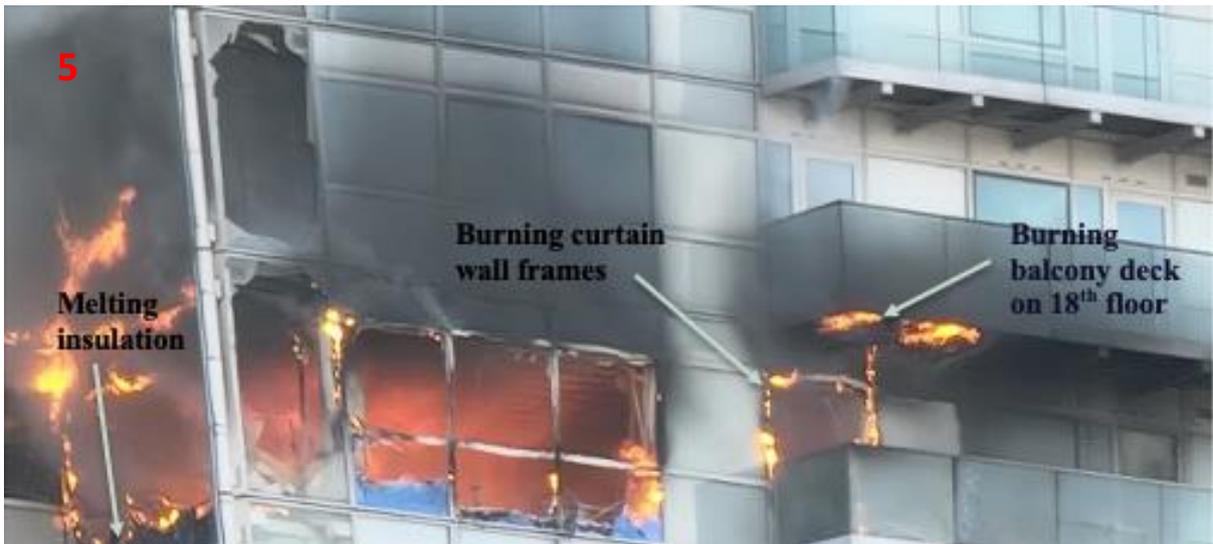
3.5 The balcony of the floor above (18th floor) is the one which actually bore the brunt of the fire, more so than the one on the 17th floor where the fire started (*Fig.5*). However, the 17th floor balcony was affected by the detachment of burning material from the building’s façade, as well as debris which fell down from the 18th floor balcony above.

4.1 From the images above, it can be seen that the framework for the curtain wall system is burning readily, which is an indication that combustible materials are present (*Fig.5*). The common assumption is that curtain walls do not burn because they are constructed from glazed panels set within a steel or aluminium framework. However, this is a dangerous assumption to make, as this case illustrates remarkably well. A curtain wall system contains numerous components, including gaskets, sealants and membranes to seal in the panels and ensure that the façade is fully weatherproof. Some systems are pre-fabricated and are brought to site as sections which are then craned into place, whereas other types are assembled on site.

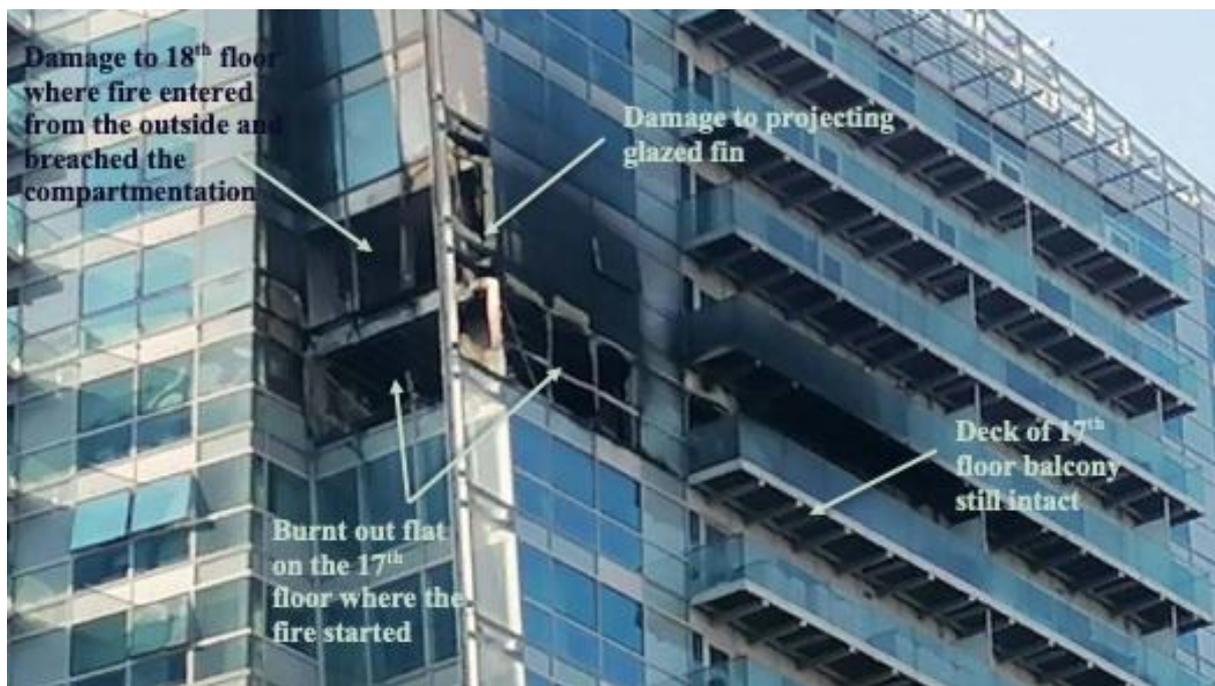
Figure 6: The Relay Building after the fire has been extinguished, where there is damage to both the 17th and 18th floors.

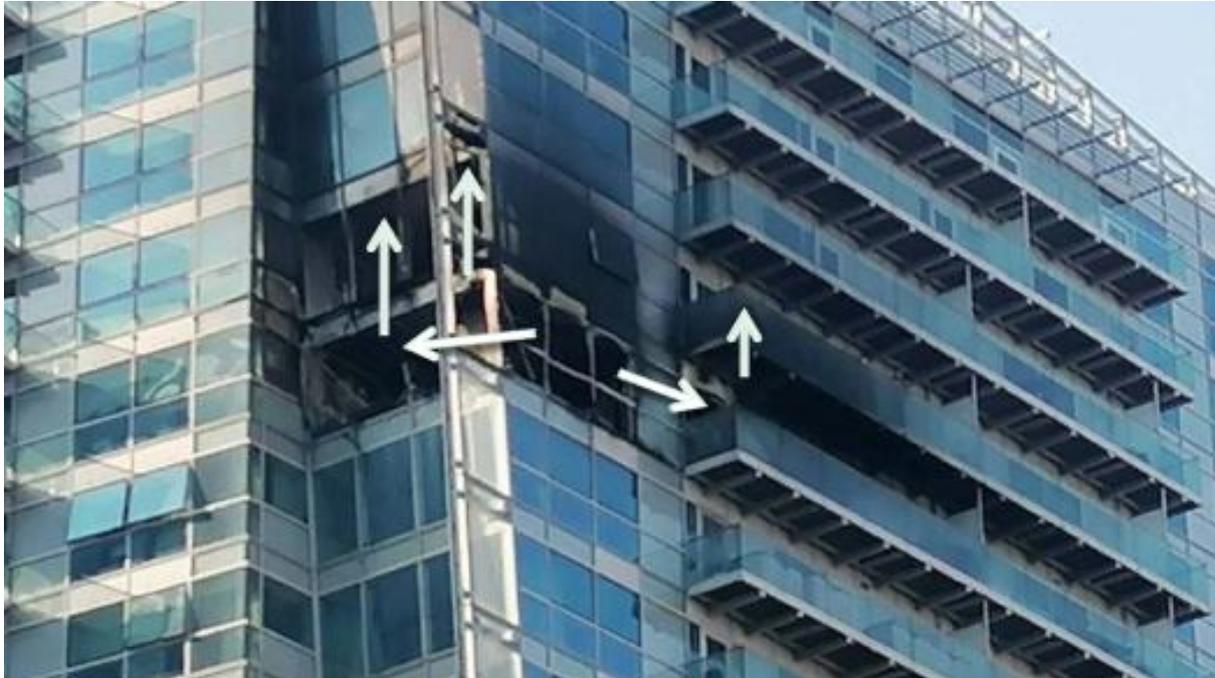
6.4 Another thing worth noting here is the tendency for the fire to target architectural features even though the building does not have a façade covered in combustible cladding panels. The fire affected the projecting fin, through which it started spreading upwards (*Figs.6 & 7*). Although some of the effects and phenomena associated with shape, form and features* cannot occur on a building with this type of façade, the geometry can still have an influence, and with this in mind, it should be considered when planning mitigation or remediation work. At the design stage, it may be wise for architects and others to avoid such features, as well as vertically stacked projecting balconies if the curtain wall system is to include combustible materials within its structure.

Figure 7: This is a repeat of *Figure 6*, but with the purpose of showing the various paths the fire took as it spread through the curtain walling system.

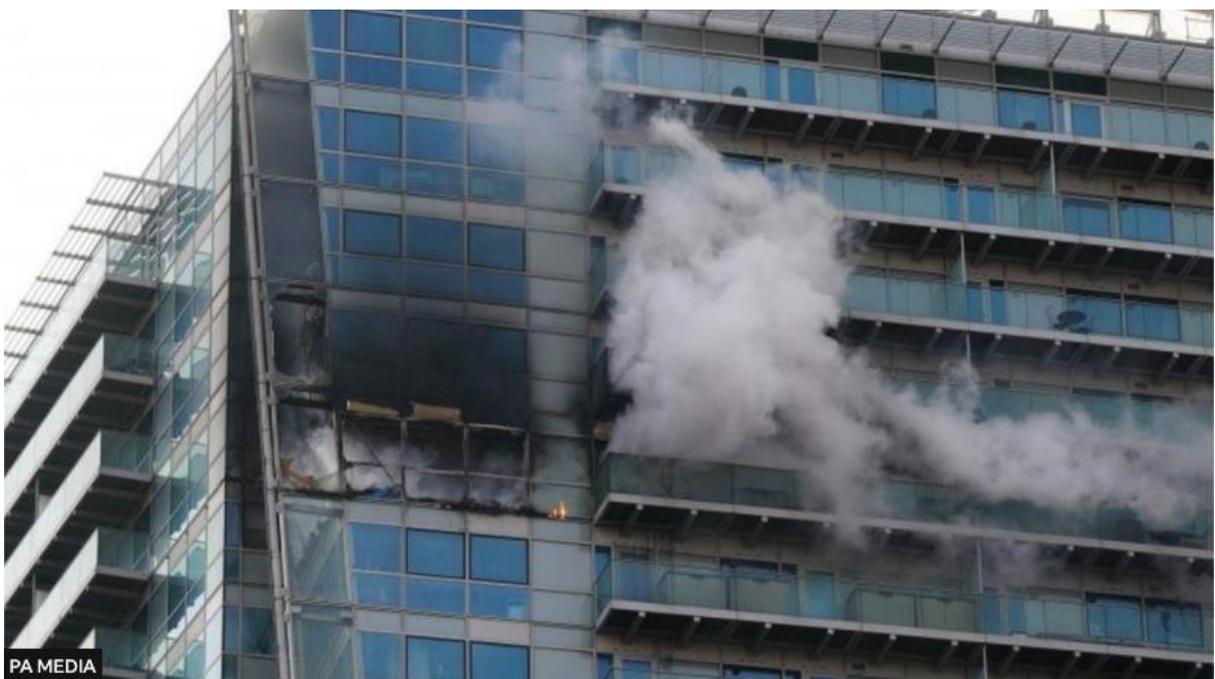
Figure 8 (p.16 above): The fire is in its dying stages, but flames can still be seen inside a glazed insulated spandrel panel. The insulation in these panels greatly contributed to the fire. A projecting glazed fin, attached to the building as a decorative feature is also badly damaged at the point where it connects with the two flats involved in the fire.
