# REPORT ON THE FIRE WHICH OCCURRED AT CHINA TELECOM TOWER, CHANGSHA, CHINA ON 16 SEPTEMBER 2022

**By Frances Maria Peacock**

*September 2022*

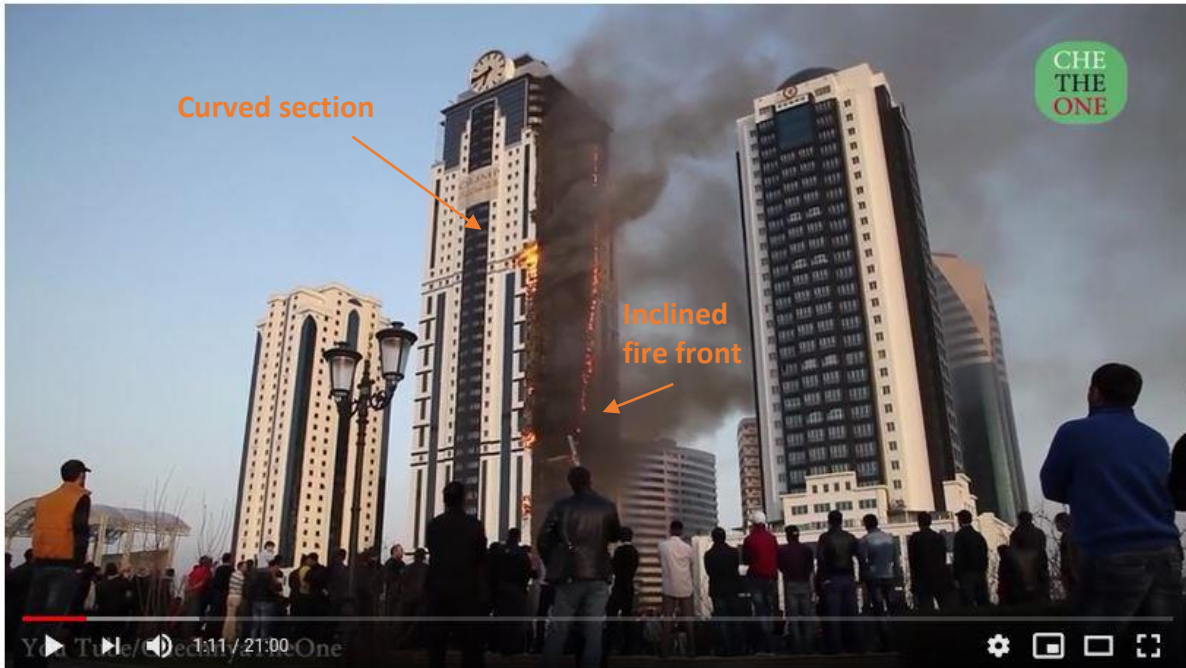
**Figure 3:** My knowledge of Cyrillic alphabet allows me to read the wording below the image, which literally says “*Požar v Groznji Citi Polnaya verciya*”. This translates as “Fire in Grozny City Public version” or simply “Fire in Grozny City,” as shown. This photo shows the fire at a relatively early stage where only one of the faces has been affected. The flames would eventually spread to all four sides of the building.

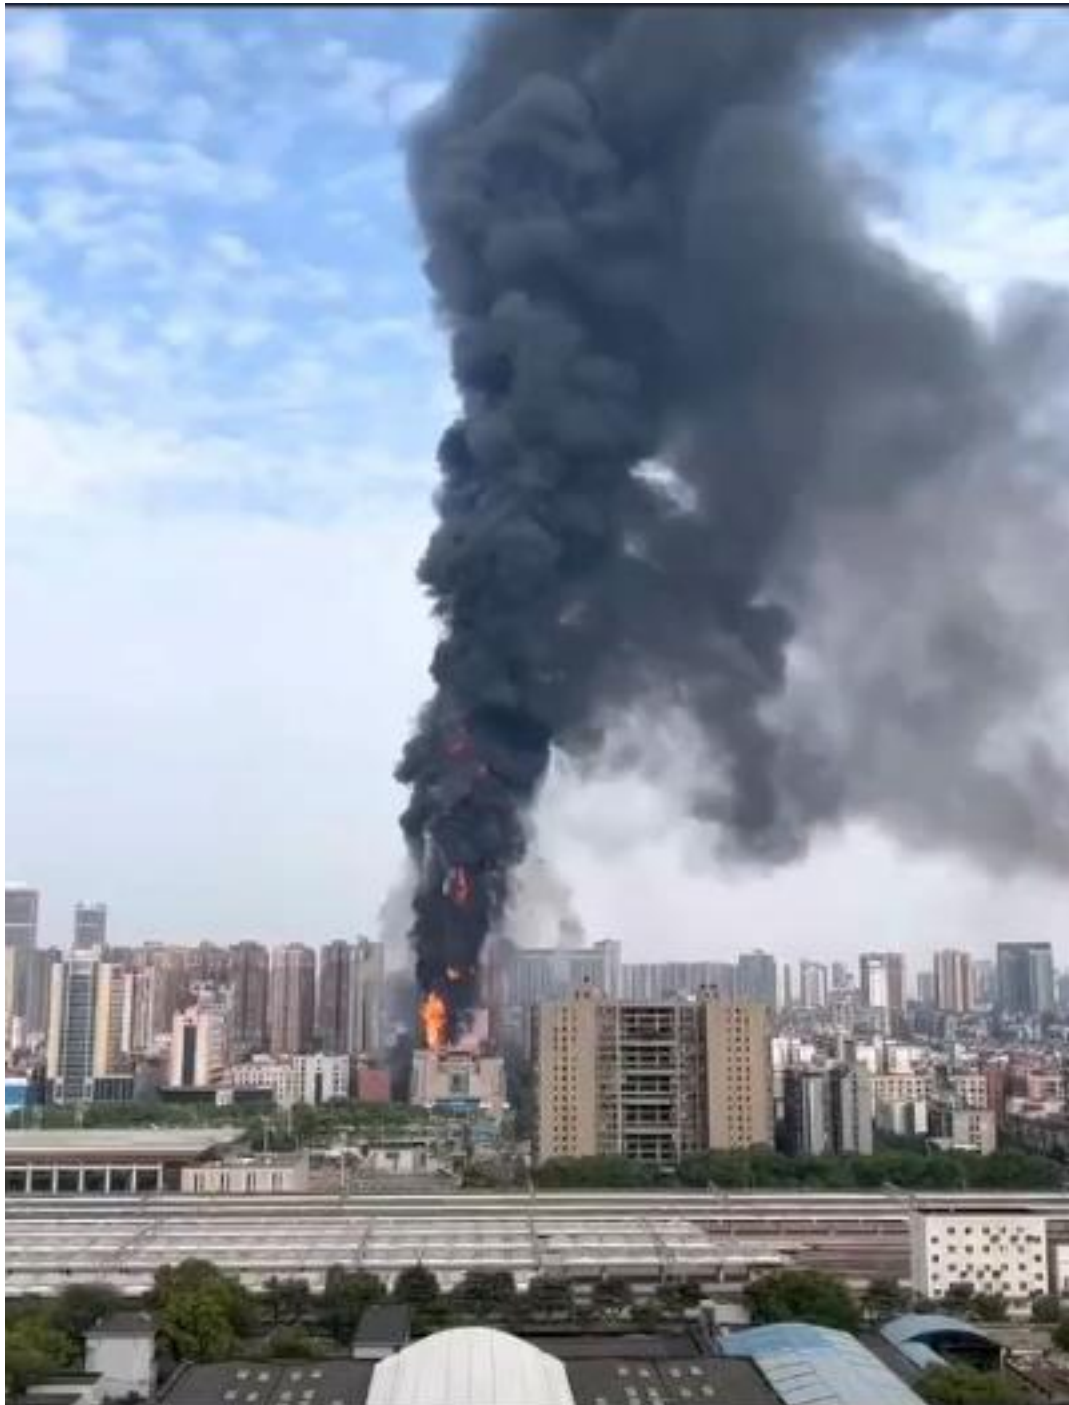
Perhaps most notable of all was the thick black smoke (*Fig.4*) which is a defining characteristic of fires involving ACM panels. This was emitted, in a quantity which was so great that it was visible right across the city in all directions and beyond, whilst obscuring much of the building

**Figure 4:** A distant view of the burning tower showing the huge cloud of dense black smoke being ejected hundreds of metres into the air above the building.

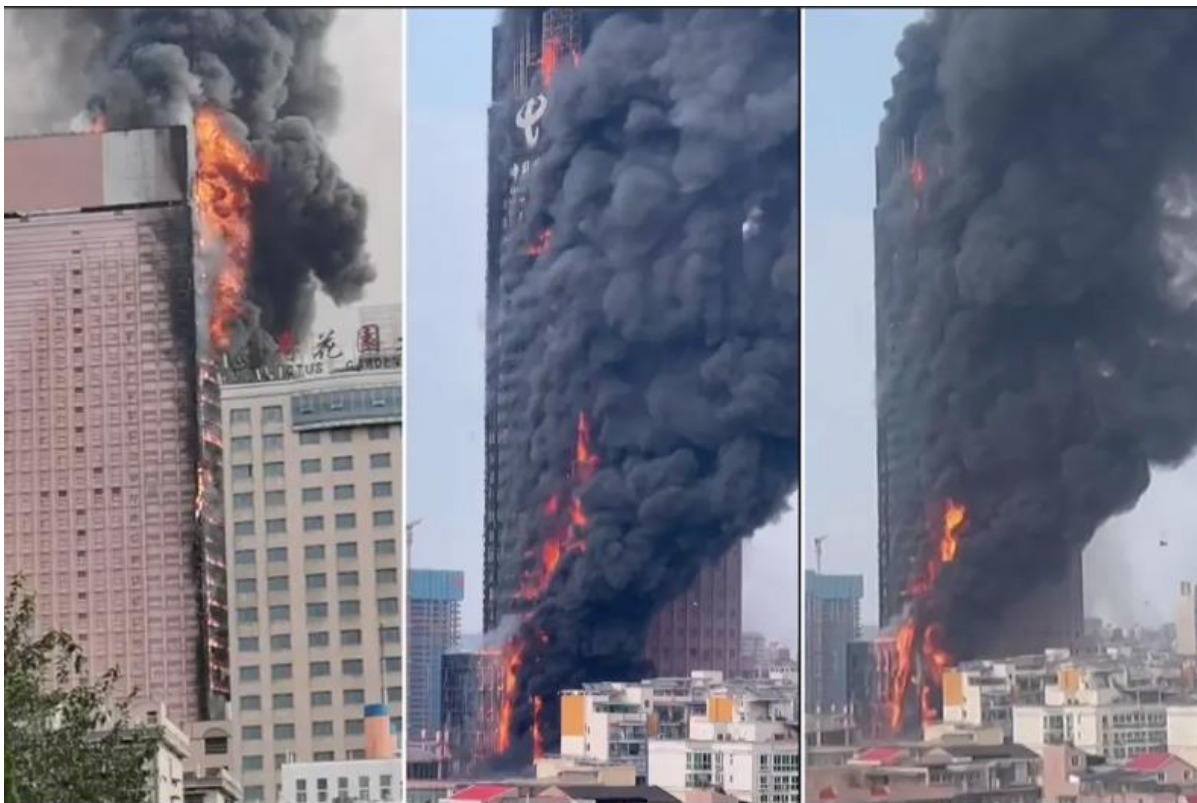
**Figure 5:** A series of three photos which show the fire at different stages of its development. The photo on the left shows a view of the building from the side, and apart from a slight blackening of the pinkish coloured cladding panels due to sooty deposits from the smoke, the fire has not been able to progress around the corner. The middle photo along with one on the right, show the podium on fire at lower levels with a column of flame spreading vertically upwards. The fire is also affecting the curved section in the middle of the tower and the front is diagonally inclined due to a differentiation in speed between the upper end of the fire front and the lower end of the fire front as the flames follow the line of curvature. The more pronounced the curve is, the greater the angle of inclination will be.

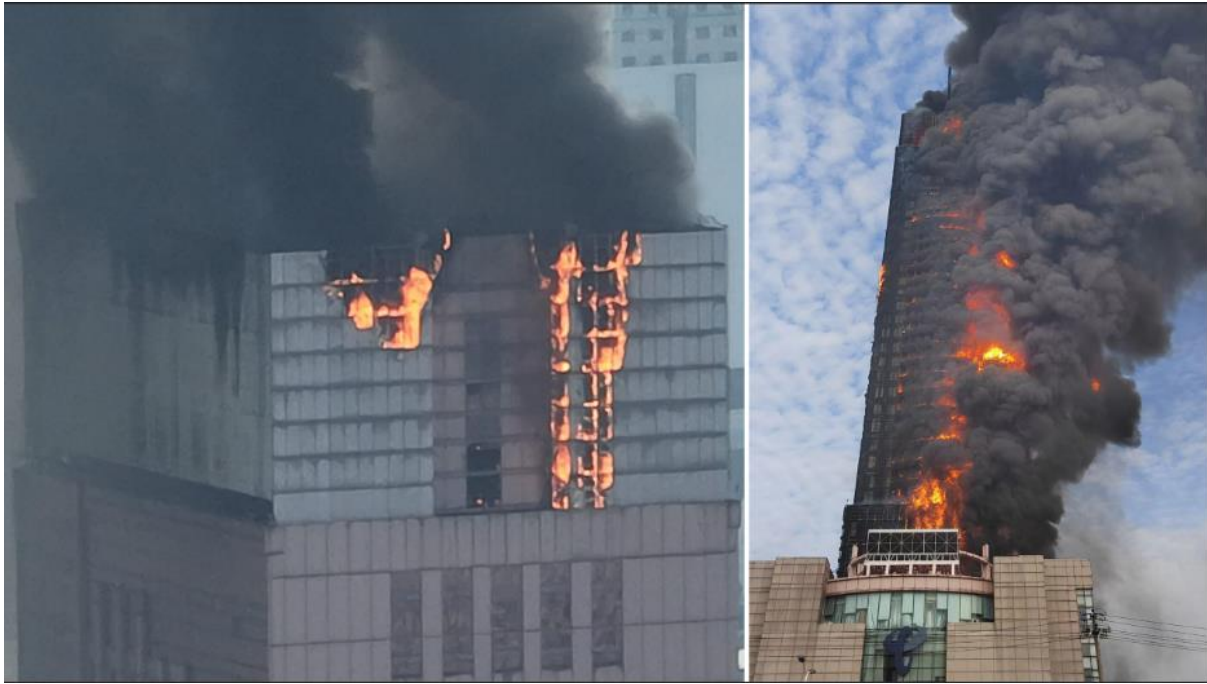
**Figure 6:** The photo on the left shows that fire has spread unseen through the inside of the cladding system and broken out through the joints near the top of the building. The joints of all the panels on the upper section – which are light grey rather than the pinkish brown on the rest of the tower – are blackened from the smoke and heat, which is also causing the skins of the panels to wrinkle. In this photo, it appears that smoke is actually emanating from the roof, to which the fire must have spread from the front side of the building where it started. The intensity of the heat at roof level is such that it has caused melting of the panels and a small amount of downward spread on other sides of the tower, although this did not spread beyond the top section. Fortunately, there is no roof top feature present which could have carried the fire from one side of the building to the next.

The photo on the right shows the combustible cladding panels erupting into flames as the fire spreads rapidly up the building. The fire began on the left side of the building and worked its way across in a similar way to Grenfell, but without the aid of a roof-top architectural crown, even assuming a distinctive diagonal pattern as it did so. As the fire front moved across the building, it caused the glazing to fail, as has been revealed in its wake, thus breaching the compartmentation on multiple floors.

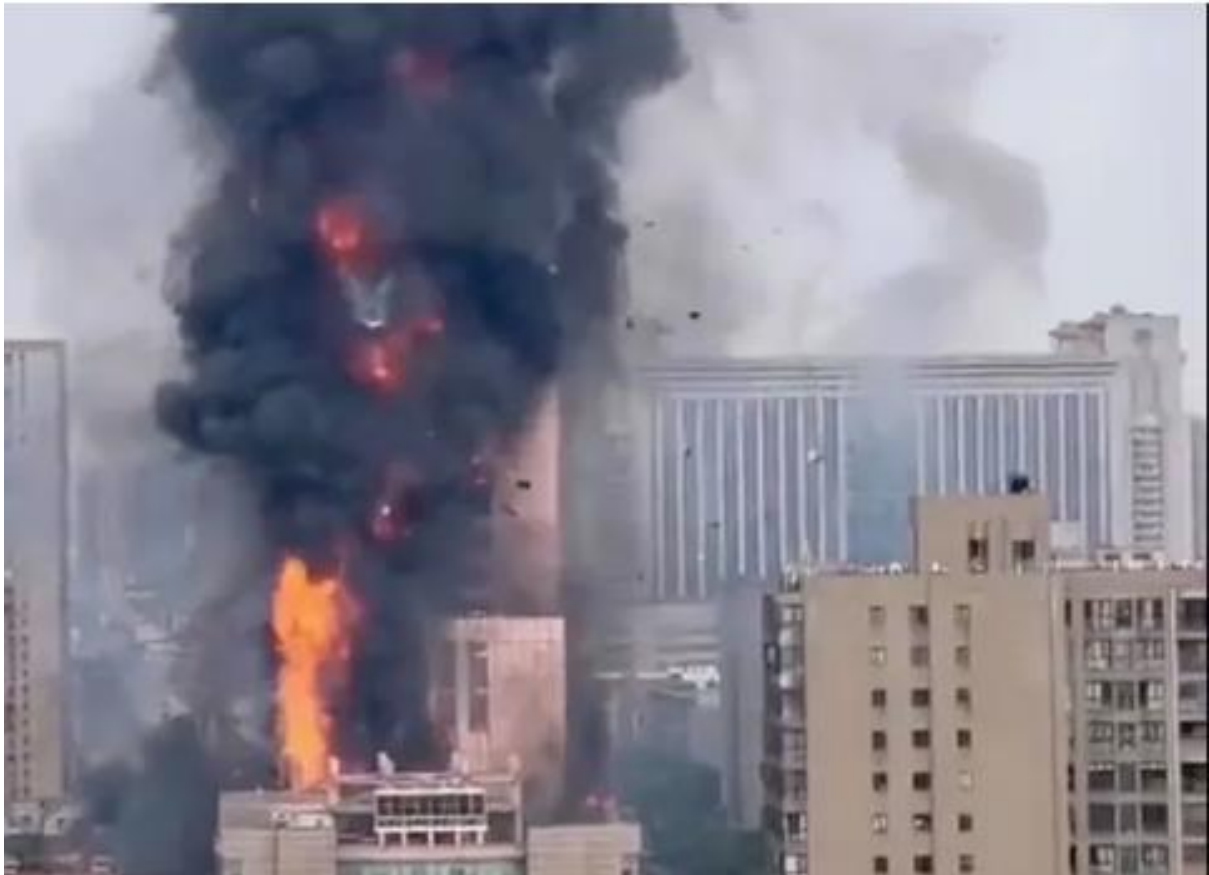
**Figure 7:** The fire began at the top of the podium on the left side of the building face as shown here. The cladding panels burned fiercely, producing a thick cloud of black smoke as the fire spread rapidly upwards and then across the building towards the other corner before it was finally extinguished. Many of the panels detached from the building as they burned and debris can be seen falling downwards.

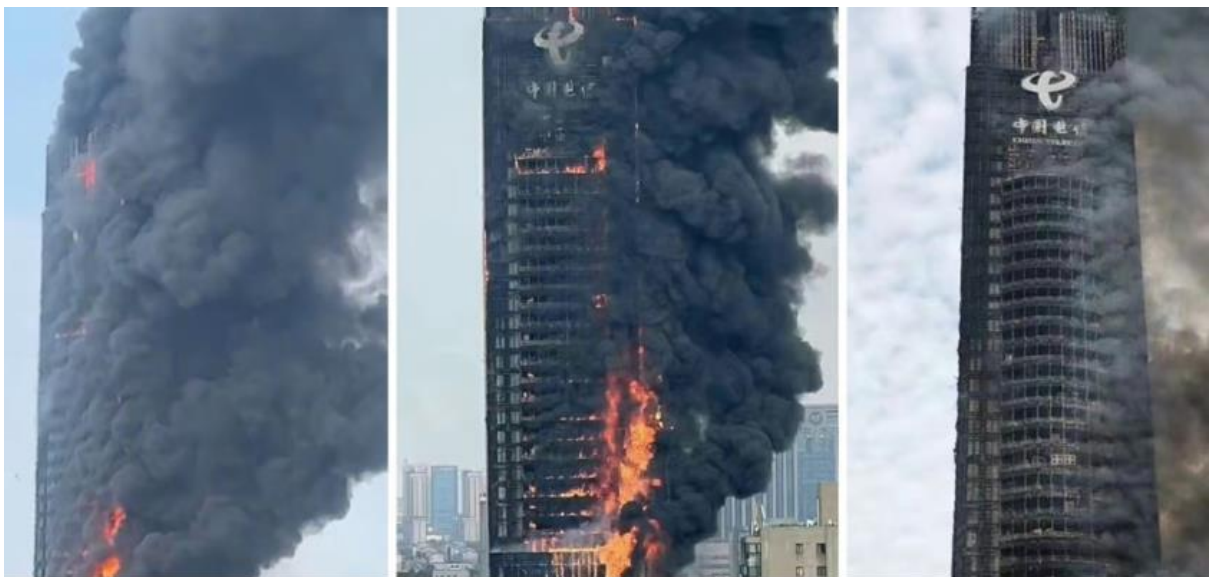
**Figure 8:** The photo on the left shows the fire at mid-stage of its development where the Coanda effect is also visible, which causes hot gases and smoke to be drawn back against the building face, as was also seen at

Grenfell Tower. It may be because of this effect and the currents generated that the smoke plume is being deflected to the right, which is also the direction in which the fire is progressing.

The middle photo shows the fire in its later stages where it has spread right across the building face leaving blackness and severe damage behind it. The flames have concentrated themselves on the window ledges which assisted the flames in their effort to spread sideways. The Coanda effect is still visible, but to a lesser extent.

The photo on the right shows the blackened frontage of the Changsha Telecom Building after the fire has been extinguished, with wisps of black smoke still rising from the charred remains of the rainscreen cladding system. As most of the windows have failed and the flames and smoke have been able to enter the interior, the internal damage must be extensive.

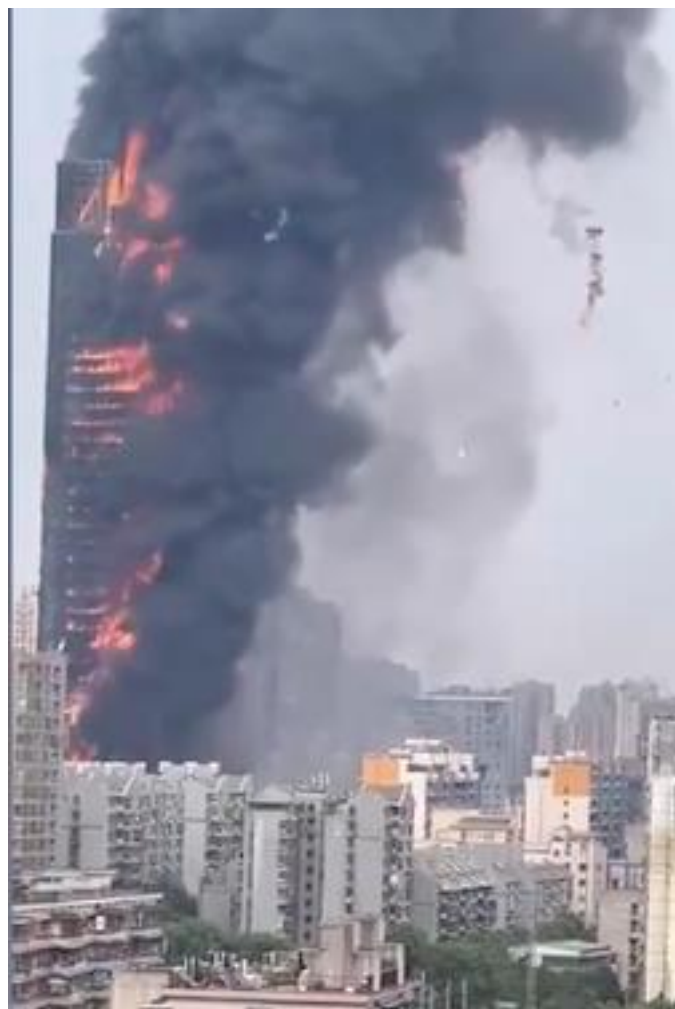
**Figure 9:** The fire can be seen here at a well-developed stage where it is affecting all levels on this side of the building. A diagonal front moves across the central curved section and flaming debris falls from the smoke cloud. The fire is following the line of the window cills and has caused the windows to fail at multiple levels.
