An Analysis of the Design, Installation & Materials of the Rainscreen Cladding System at Grenfell Tower

An Insight into what went wrong

Frances Maria Peacock

September 2020

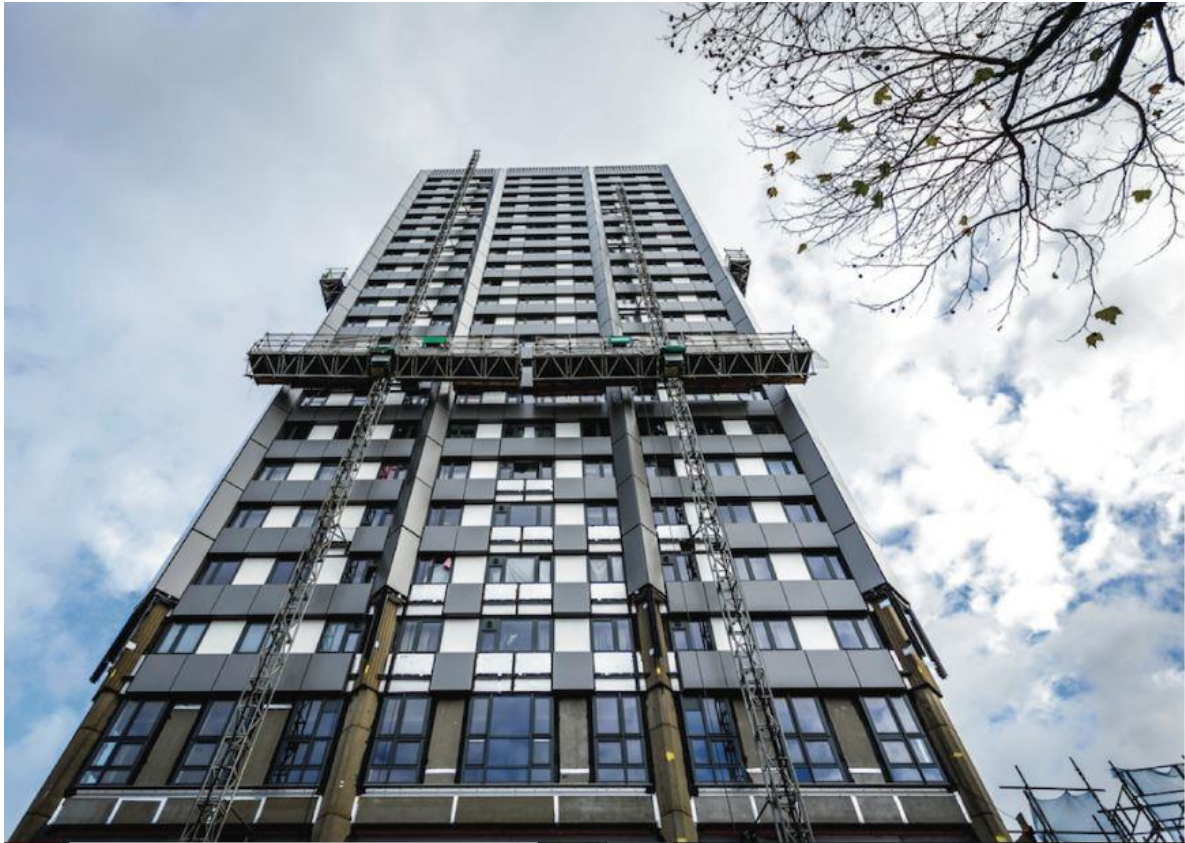
Photo 1: This view shows the east face of the tower from the third floor upwards during the installation of the cladding system. The position of the cavity barriers in relation to the windows shows that there is no proper zoning in place and that the concept is undermined to the extent that fire cannot be contained.

2.9 *Photo 1* is a good example of a departure from the safe procedure for installing a rainscreen cladding system, most obviously from the fact that support rails for the cladding panels can be seen hanging in mid-air around the columns, without any cavity barriers or insulation having been installed first. By contrast it is worth noting that the cladding system has been installed to the level of completion on some of the adjacent spandrels, which demonstrates a lack of continuity in the installation process. If the integrity of the rainscreen cladding system is to be maintained throughout the building as a whole, the spandrels and columns need to be clad systematically as part of the building in its entirety, not separately from each other as is shown to be the case here. It is therefore necessary to reiterate that the fire barriers and insulation must be continuous throughout the building, tightly abutted, accurately cut around corners and architectural features, and the joints sealed with foil tape.

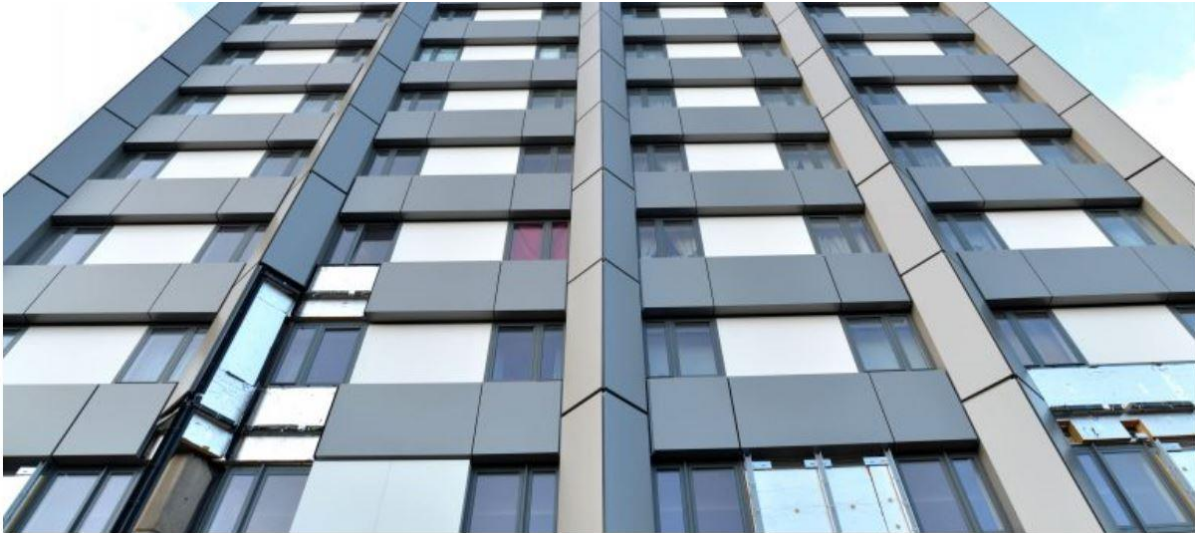
Photo 2: This is a view of the north side of the tower from the 3rd to the 9th floor, with some cladding panels removed to reveal the internal details of the rainscreen system.

2.11 It can be seen that horizontal cavity barriers are visible at an intermediate level on the fourth and fifth floor spandrels, each with a notch matching the position of the one on the next floor (*Photos 2 & 3*). The purpose of these notches is unclear as they do not seem to correspond with the observed locations of the carrier rails. Most notable perhaps is the position of the horizontal barriers which offer no direct protection at either window head or cill level, and they are not in line with the floor slab. It is also worth noting that Studio E in one of their drawings did in fact show a cavity barrier present at the window head – and also in line with the floor slab – but in many of their drawings fire protection is completely absent. Harley Facades show the fire barrier in a position further above the window head, but nevertheless still in line with the floor slab. Upon installation the position of the barriers was raised even further (*Diagram 1*).

2.13 An interesting observation can be made in *Photos 2 & 3* where it can be seen that the position of the cavity barriers on the spandrels corresponds with the panel joints on the adjacent columns. It is behind these joints that the horizontal cavity barriers on the columns are located, and the line of these seems to have been carried through across the spandrel bays. It therefore seems to have been the case that when the position of the spandrel barriers was raised, it was done so to line up with the corresponding line of cavity barriers on the columns. The system appears to have been designed so that the panel joints on the columns did not coincide with the position of the windows, and lined up with the spandrels instead. This was most likely - and rather ironically - done to reduce the fire risk and prevent any fire venting through a window from going into the joints.

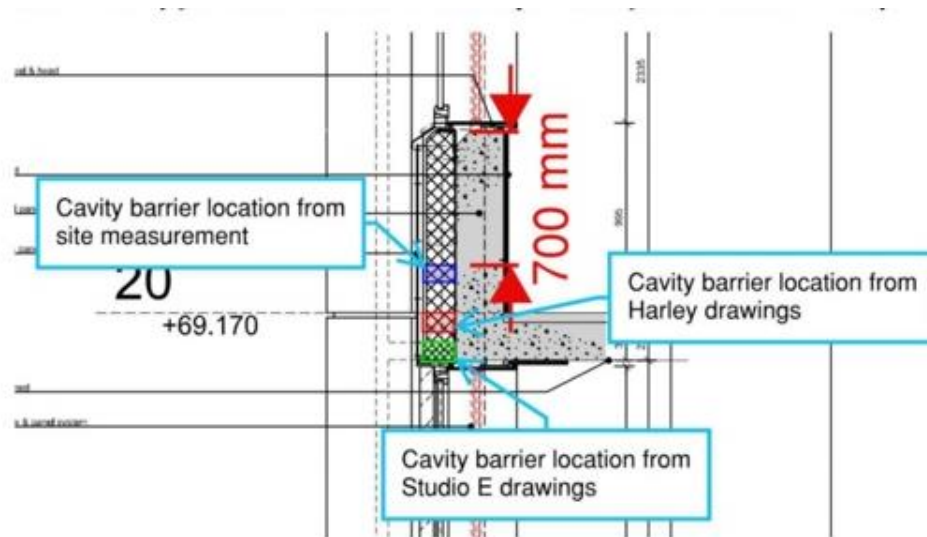
Diagram 1: This drawing taken from Chapter 8 of Dr Barbara Lane’s supplementary report shows how the proposed location of the cavity barriers at window head level was changed. The one shown in blue, which is above the level of the floor slab, is the actual location of installation. This is some 400mm above the head of the window and by moving the barrier so far up, direct protection at the window head was lost and the concept of zoning undermined.

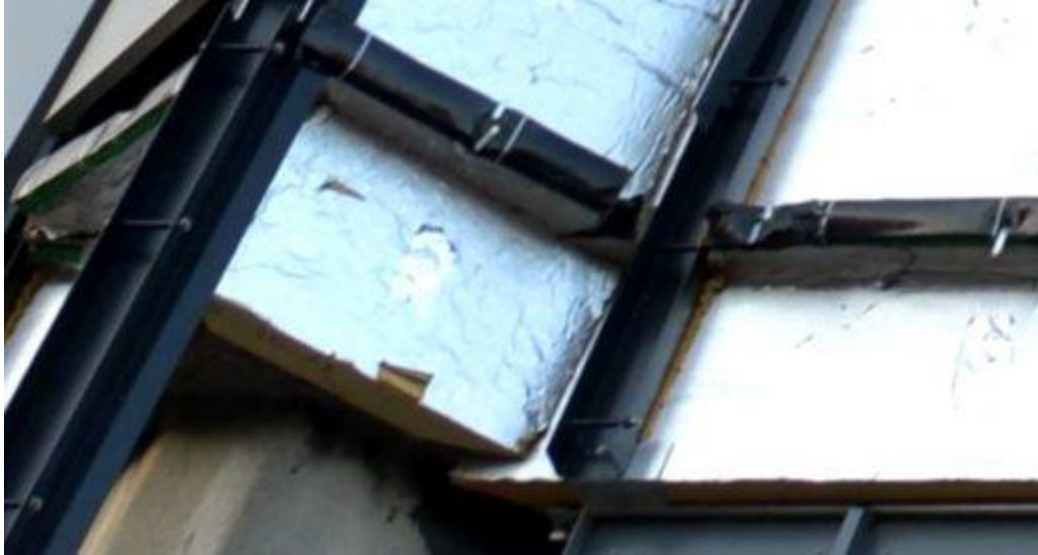
Photo 3: This is a close-up view of the column and spandrel shown in Photo 2. It can be seen that the cavity barriers correspond with the panel joints on the columns, and the line is carried through across the spandrels as a continuous band which is not in line with the floor slabs.

- The foil facing of the insulation board on the column is damaged;
- The same insulation board is also not a flush fit with its neighbour on the spandrel, and the joint between the two has not been taped;
- The horizontal cavity barrier on this column appears to have a tear in it at a point close to where it meets the support rail on the adjacent spandrel. Damage of this type would prevent it functioning properly in the event of a fire;
- The horizontal cavity barriers do not sit tightly against the “U” shaped support rails, which effectively renders them useless;
- Absence of vertical cavity barriers in locations where they would normally be required;
- Due to the absence of fire barriers around the windows, bare insulation sits against the window head;

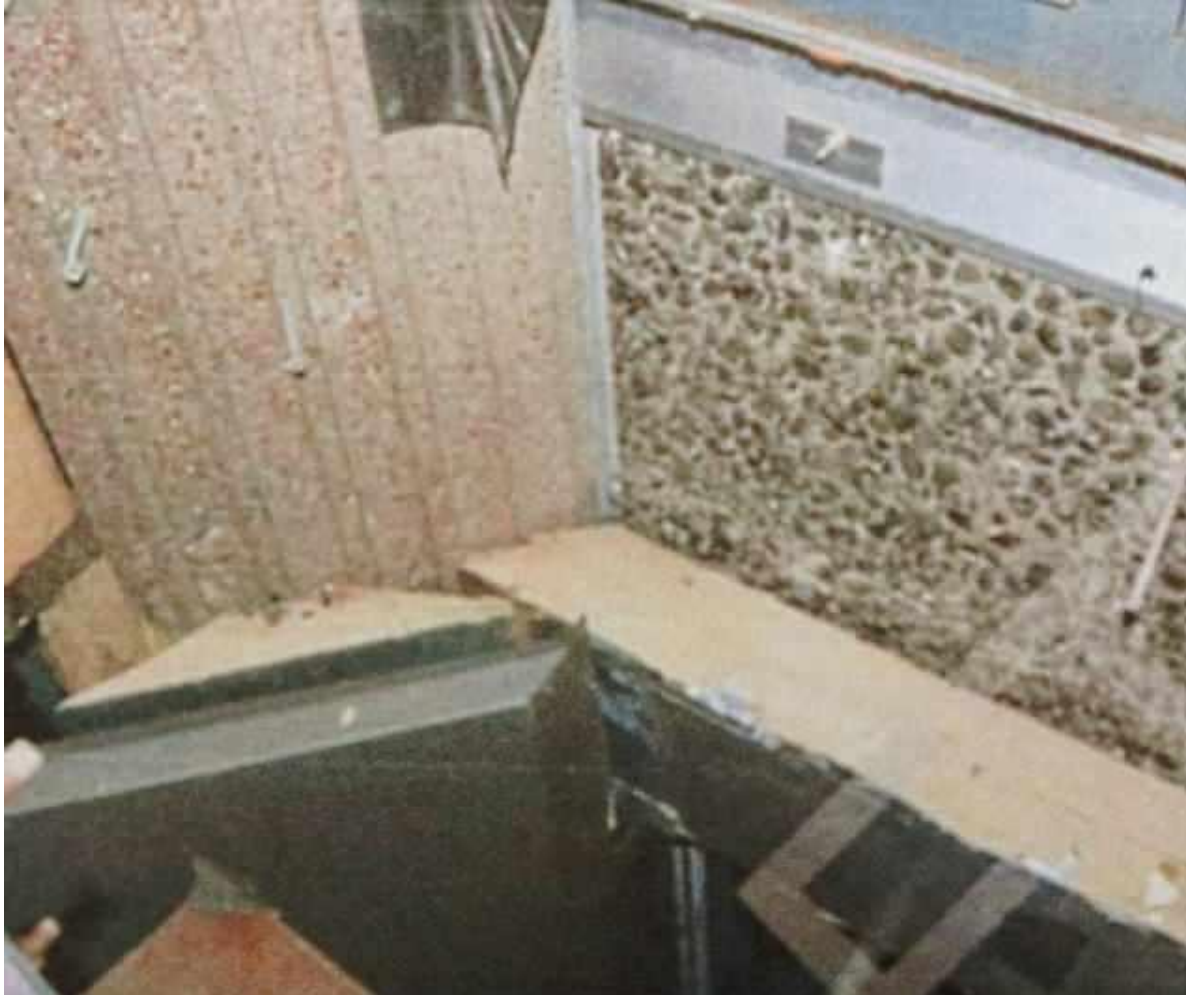
Photo 4: This photo shows the cladding system on one of the lower floors of the Tower. As in Photo 3, the insulation has been poorly cut and the piece on the column does not sit flush against that on the spandrel

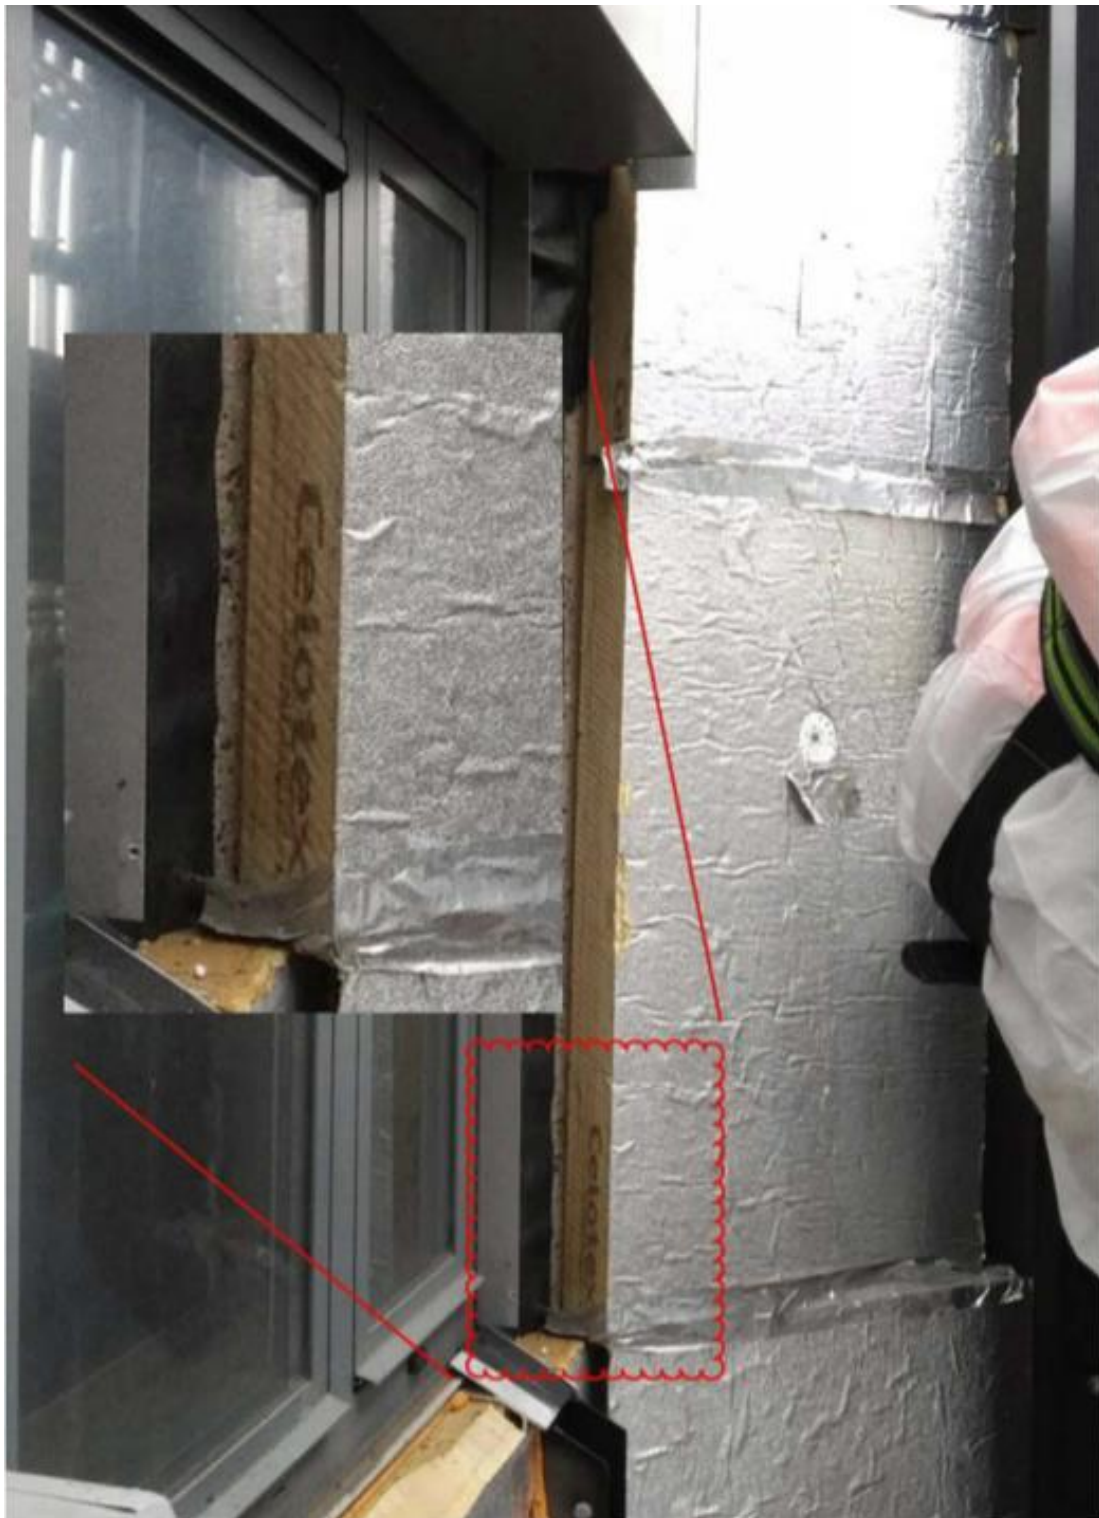
Photo 7: In this photo it can clearly be seen how awkwardly the cladding fits around the columns, and by its sheer bulk, it is difficult to keep it clear of the window opening. It can be appreciated how difficult it would have been to size up the width of the windows accurately and avoid the dangerous gap which was created at the jamb. *Photo: Dr Barbara Lane's Supplementary Report, Part 8*

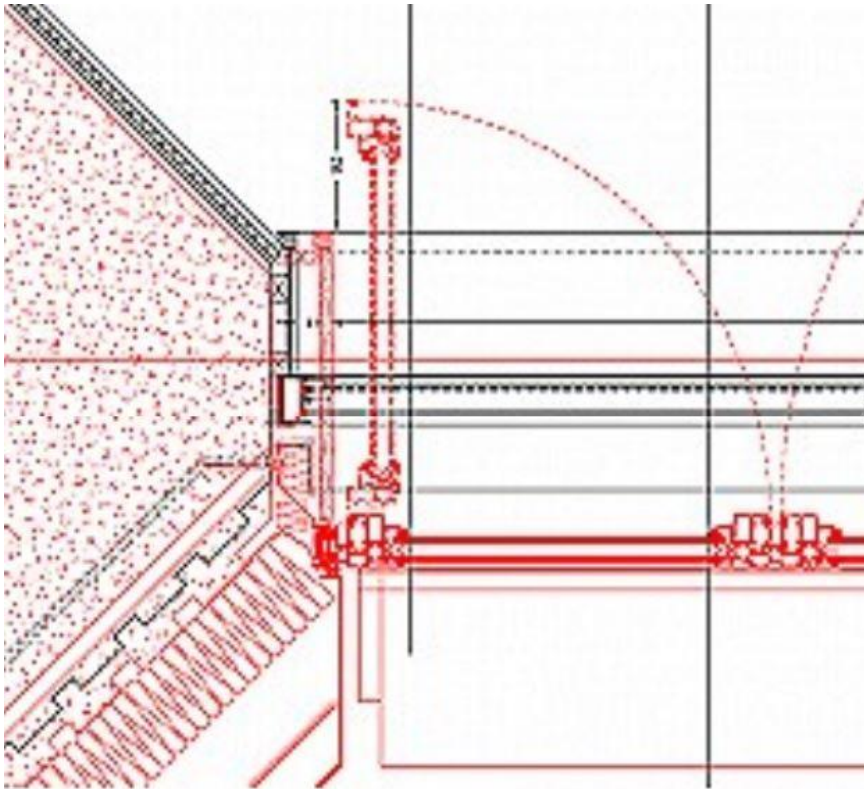
Diagram 2: An extract taken from a Studio E Architects' drawing: This is a horizontal section through a column and an adjacent window; the original window is shown in black and the new window in red. The difference in width and size of opening is apparent, and it can also be appreciated how the insulation as applied to the column overlaps the original opening, meaning that the windows have had to be reduced in width to accommodate it.

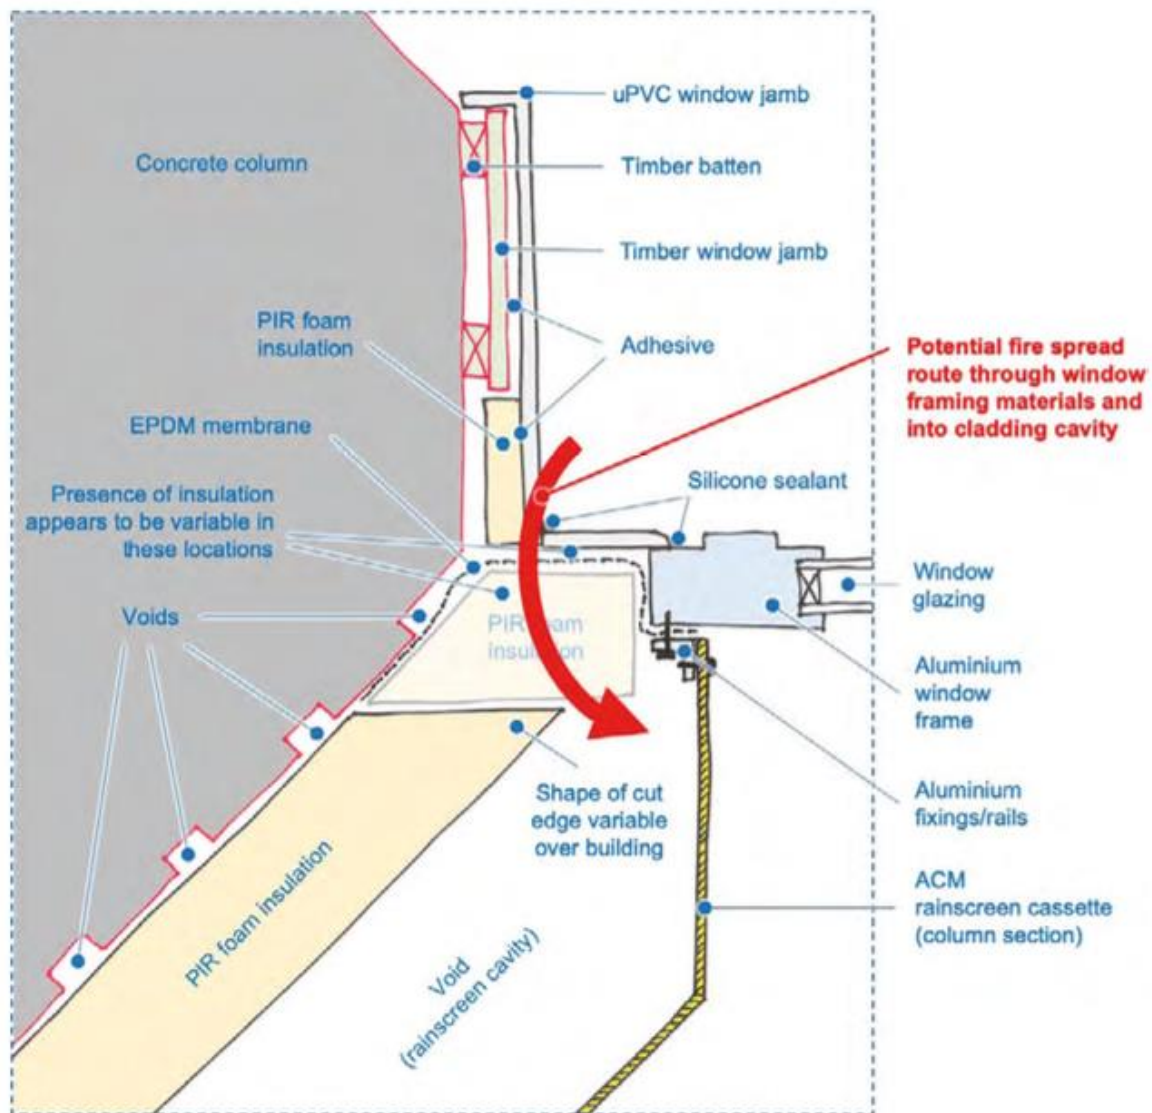
Diagram 3: This sketch by Professor Luke Bisby in his Final Expert Report for the Grenfell Tower Inquiry illustrates the difficulty in accommodating the cladding system on the columns at the interface with the windows. In this case an additional piece of PIR insulation has been used, although the fact that this was not present in all locations shows how awkward the fitting of the materials in relation to the window position was. It is worth noting here that the insulation overlaps the original window opening, despite the drawings in Diagram 3 (below) showing something different. The sketch is based on Professor Bisby's observations when he visited the Tower.

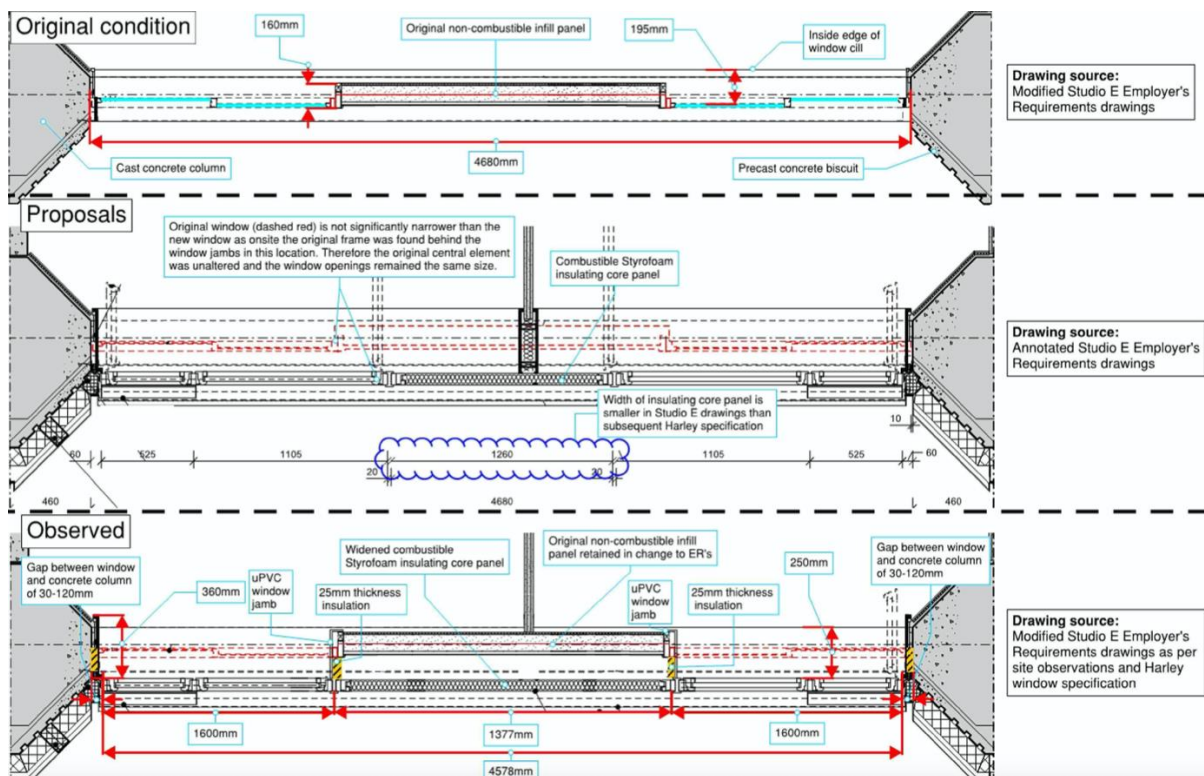
3.14 Later drawings indicate that the insulation on the columns would be cut back so as not to overlap the original window openings (*Diagram 4*), but by then the windows had already been sized, ordered and manufactured, meaning that it was too late to make such changes. This would support the witness statements in *Paragraph 3.5*. Therefore, although the reduced size of the windows was intentional, the measurements were not accurate.

Diagram 4: The three configurations show the window arrangement before the refurbishment (top), as proposed (middle) and as installed (bottom). The latter is the arrangement as observed by Dr Lane and her team, and the images – all of which are by Studio E Architects – are taken from her Expert Report of April 2019. In all three images the cladding is cut so as not to overlap the new or original window position, but observations show that this was not the case, at least in some of the locations (*Diagram 3*).

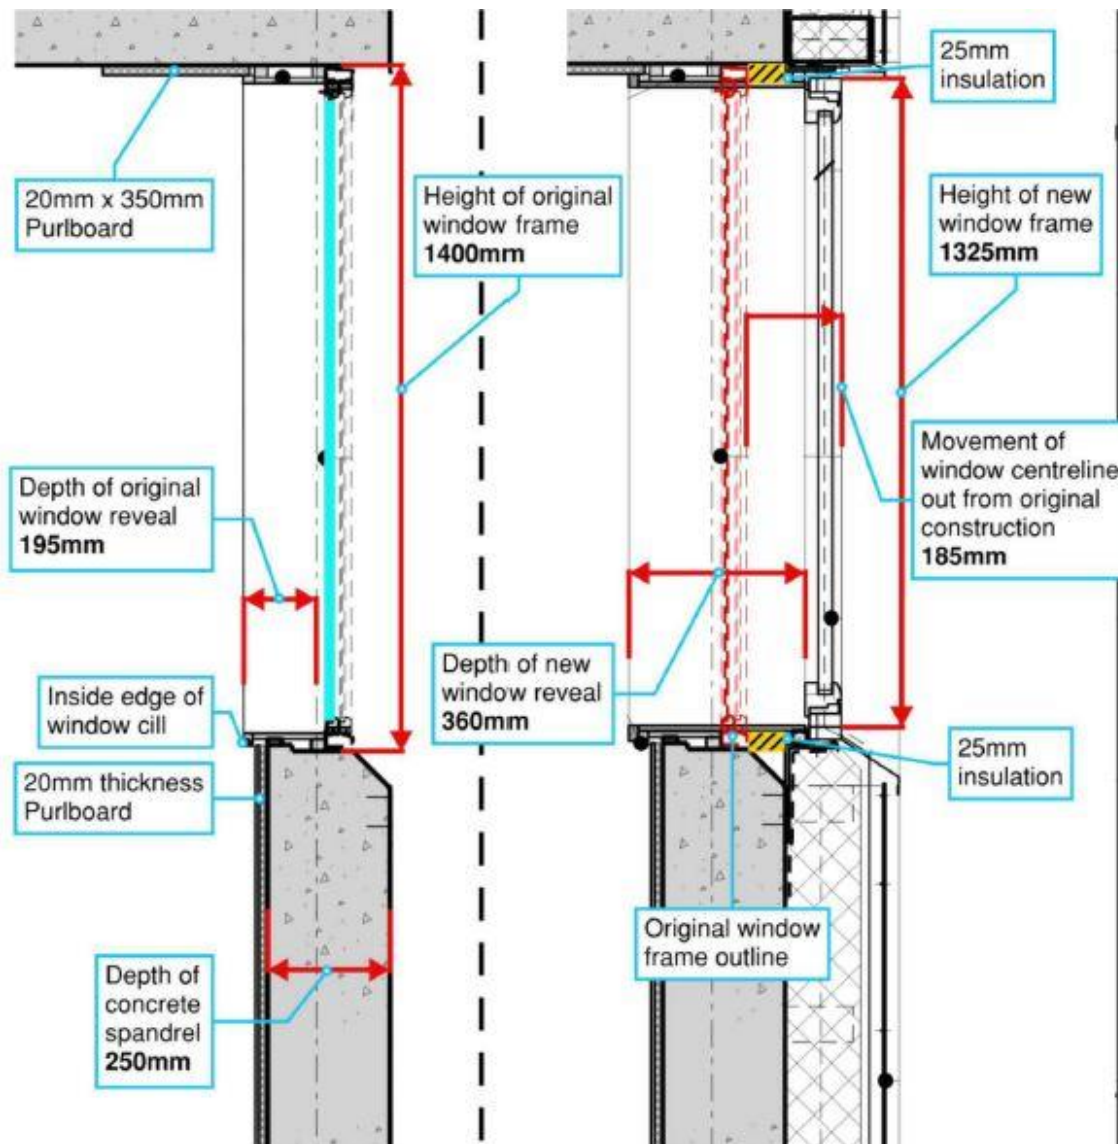
Diagram 5: Cross sections through the windows and spandrel sections at Grenfell Tower; the one on the left shows the original configuration, whereas the one on the right shows the arrangement as it was following the refurbishment. The new windows are 975mm shorter in length than the originals. *Source: Dr Barbara Lane's supplemental Report, October 2018*

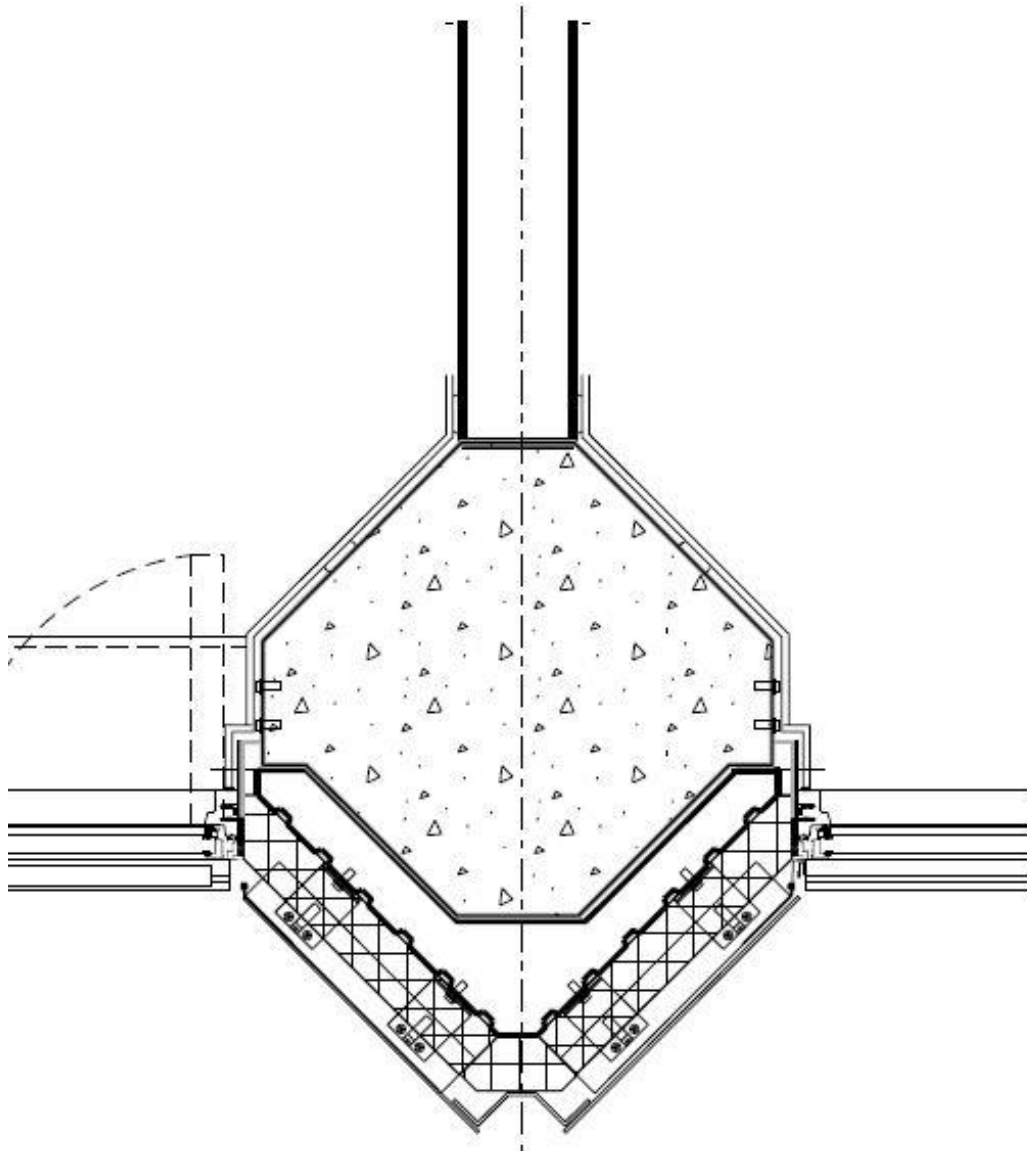
Diagram 6 : A horizontal section through a column showing the detail of the cladding system, which is attached to the ribbed piece of concrete at the front of the column. On either side there is a window. No fire protection is present and only a steel angle provides separation between the windows and the insulation on the column.

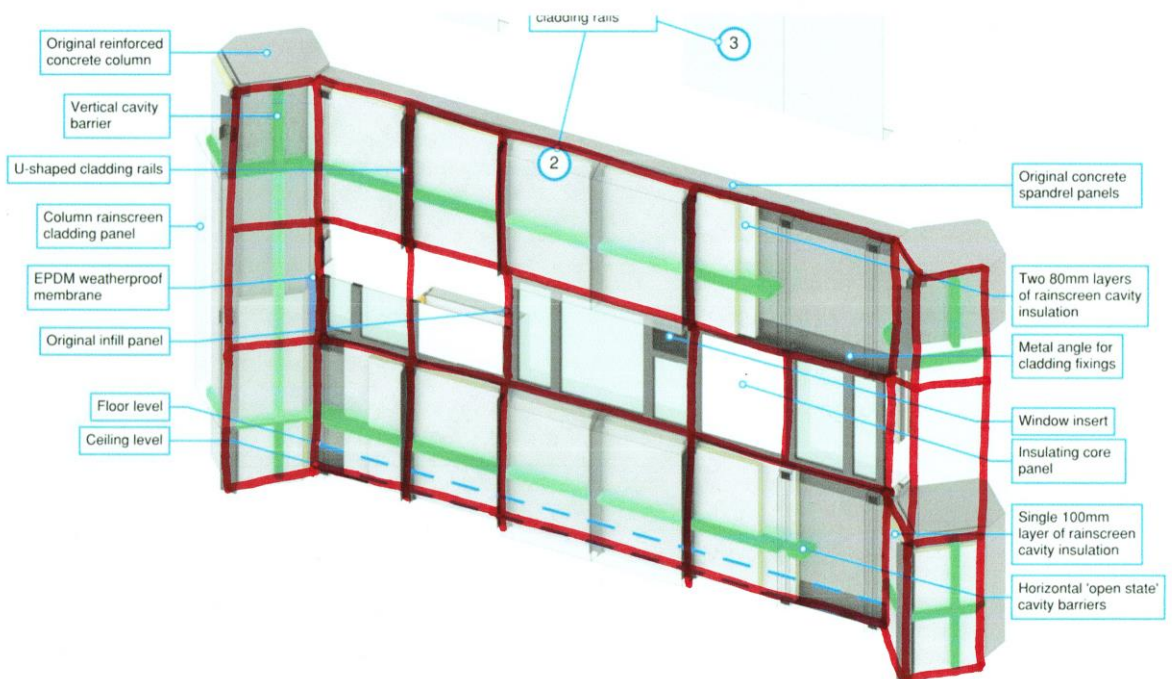
Diagram 13: I have hand-drawn in red the positions where vertical and horizontal cavity barriers should have been installed. Please compare with Diagram 10 above.

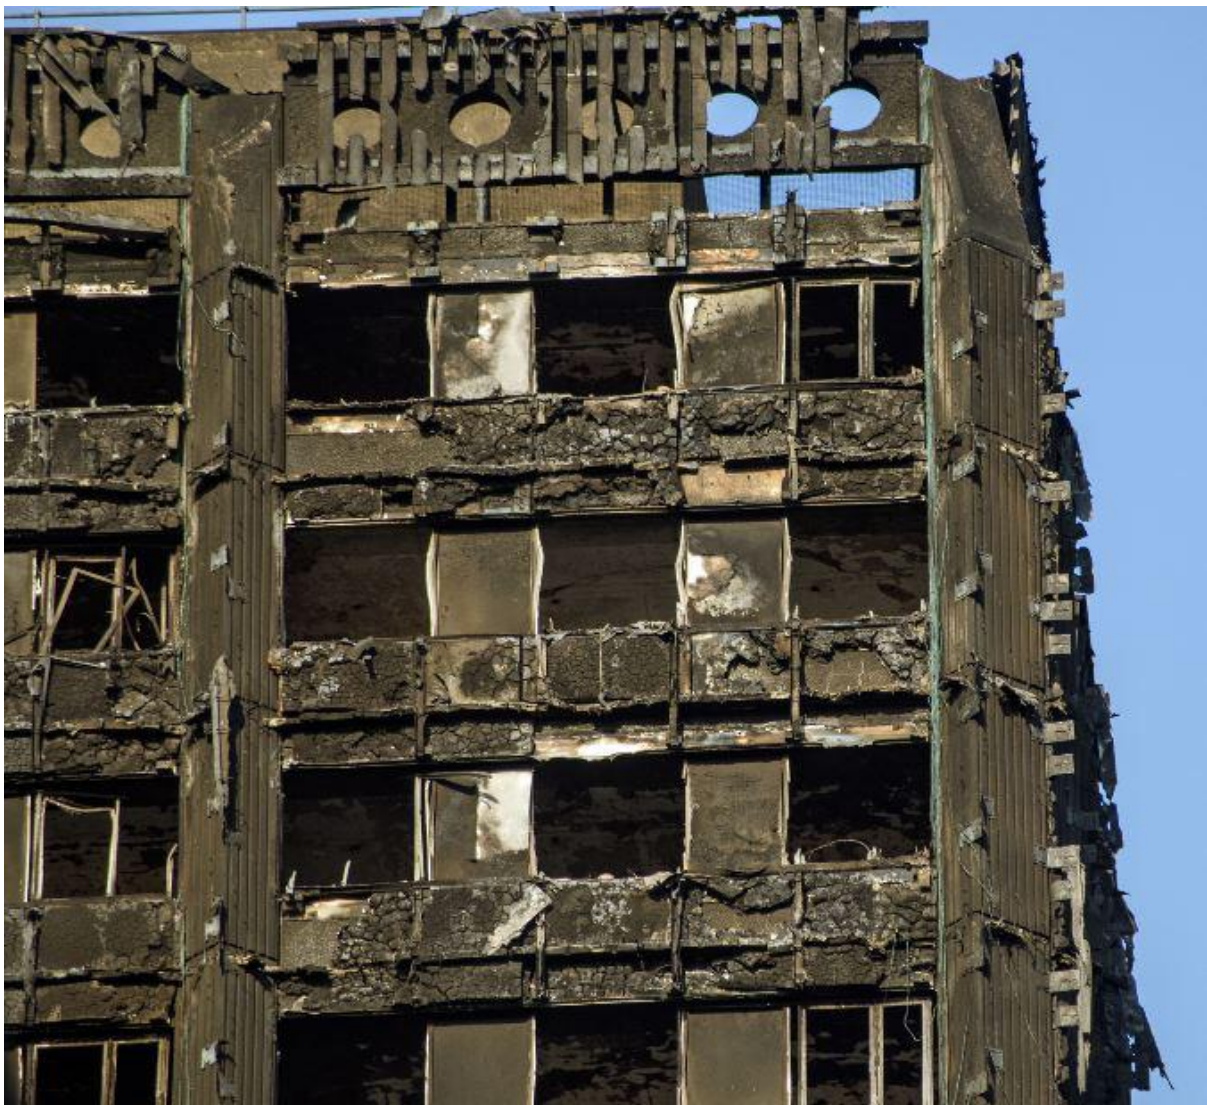
Photo 9: The upper floors of the west face of Grenfell Tower showing complete consumption of the PIR insulation despite the charring. It can be seen that the pieces of insulation which have survived at this level are charred all the way through, indicating that successive protective layers which formed as the material burnt were progressively destroyed as the fire continued.

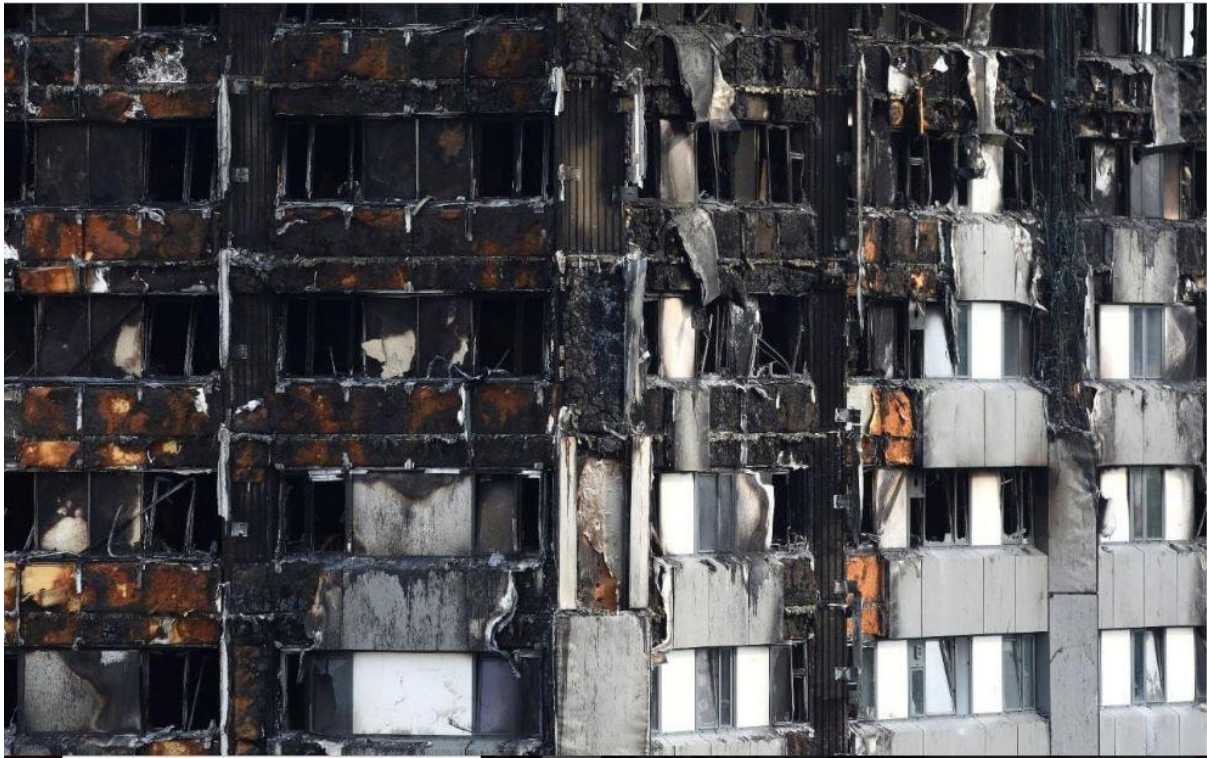
Photo 10: A close-up of the north-west corner of Grenfell Tower showing damaged PIR insulation where the charred layer has detached to expose the material underneath. At these lower levels, the heat was less intense so the insulation has not completely burned through as it has on the upper levels.

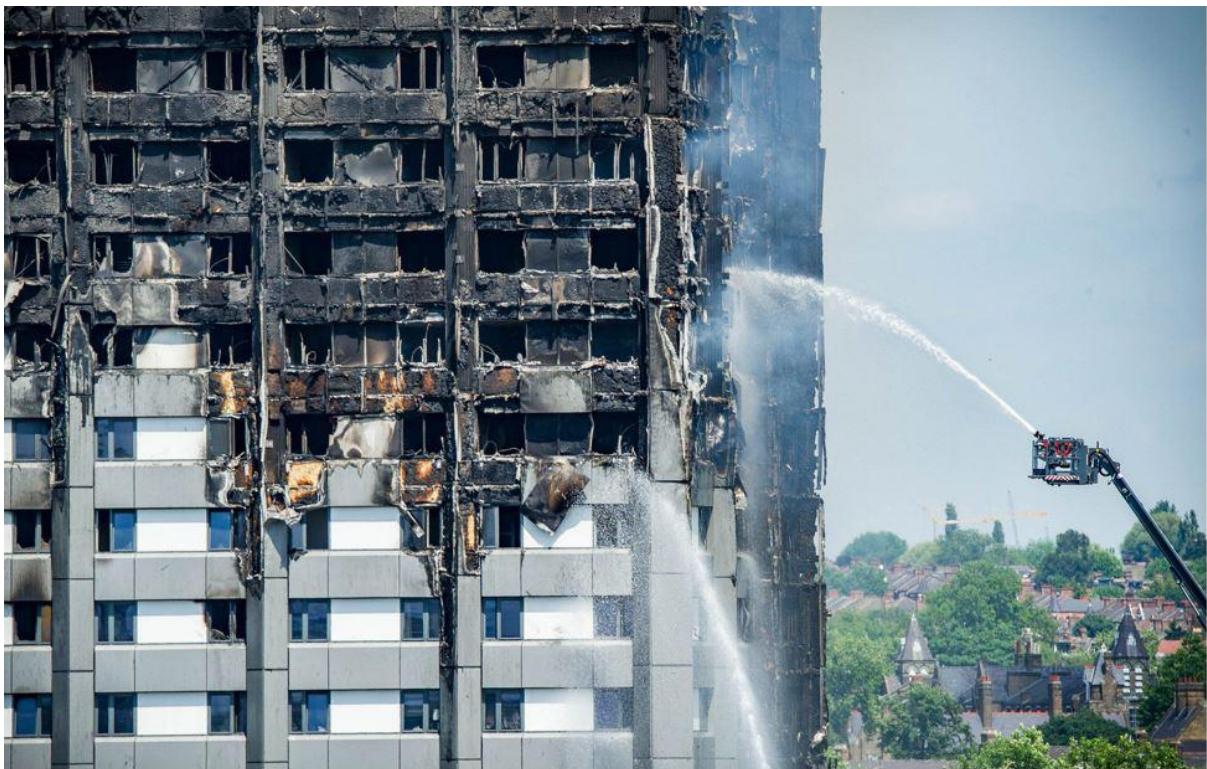
Photo 11: The south face of Grenfell Tower showing the progressive change in the severity of damage to the PIR insulation with ascension up the façade

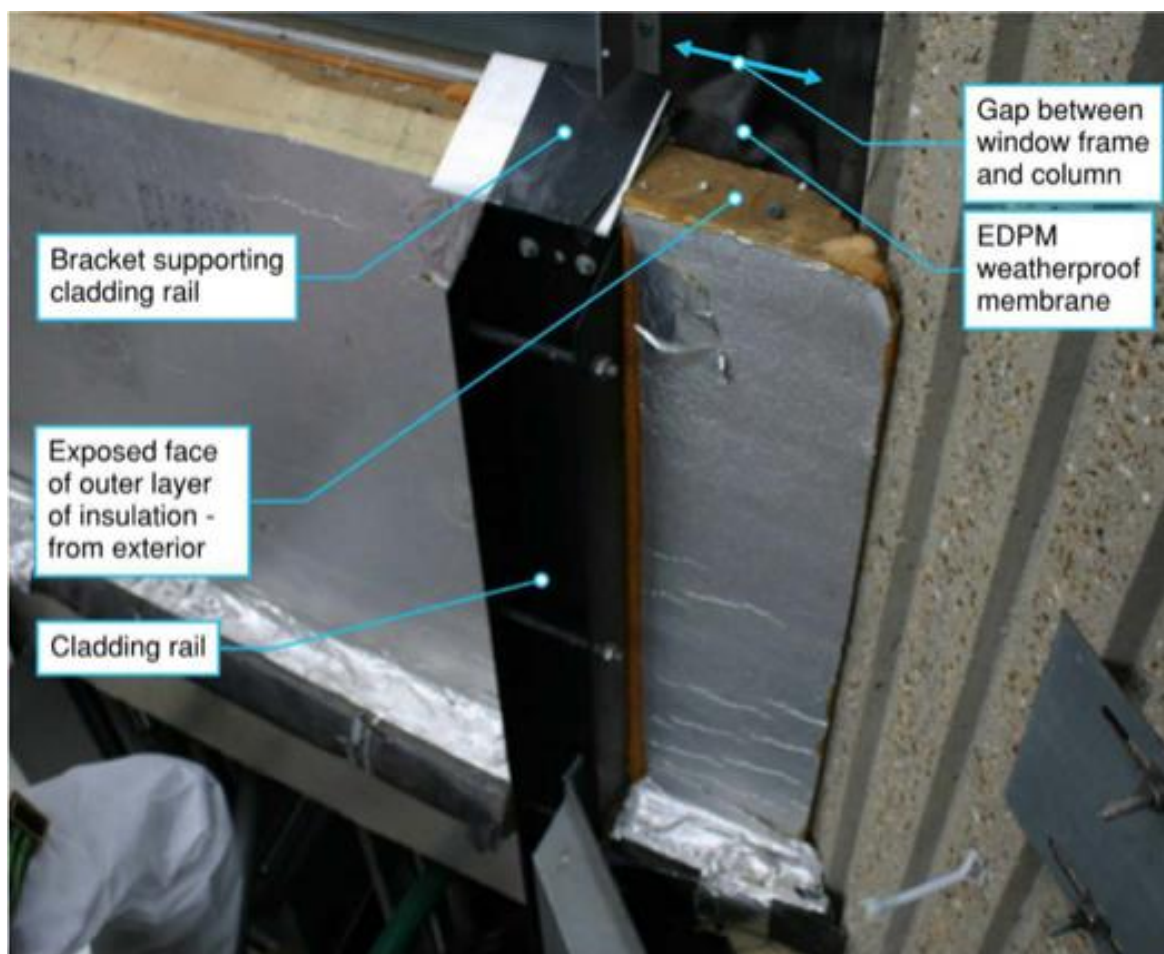
5.11 At Grenfell, the PIR insulation was not sufficiently well sealed within the construction for there to be a guarantee that flames could not come into contact with it if there was a fire. The edges were not taped, leaving the combustible material fully exposed to any flames which may enter the cladding system via the insulation gaps at window head and cill levels (*Photo 12 and Diagram 15*).

Photo 12: Insulation on a spandrel at Grenfell showing exposed PIR insulation along the edge at cill level. Such exposed insulation was also present at the window head and was accessible to flames through the ventilation gaps (see *Diagram 15*). *Source: Dr Barbara Lane's Expert Report*

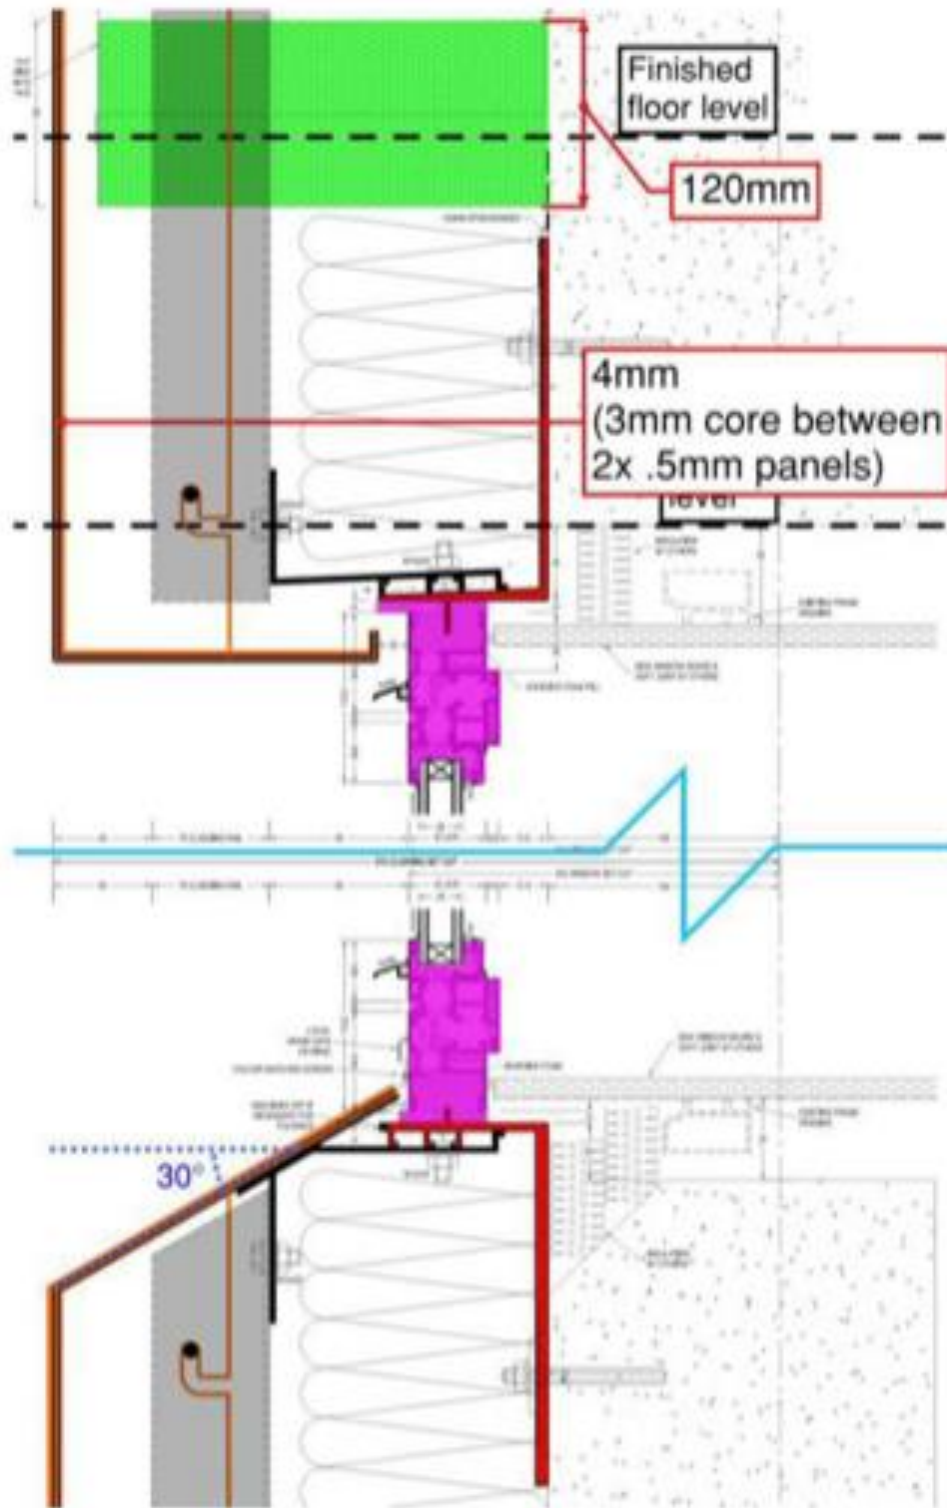
Diagram 15: In this diagram from Dr Barbara Lane’s Supplementary report, the details of the cladding system at the window head (top of the diagram) and window cill (bottom of the diagram) are shown. Fire can easily enter the system through the ventilation gaps which are present at each of these locations. The ACM panels also had exposed edges, meaning that their Polyethylene cores were accessible to fire.
