REPORT ON THE FIRE WHICH OCCURRED AT MARINA DIAMOND 2, DUBAI, UAE ON 23 OCTOBER 2021

By Frances Maria Peacock

November 2021

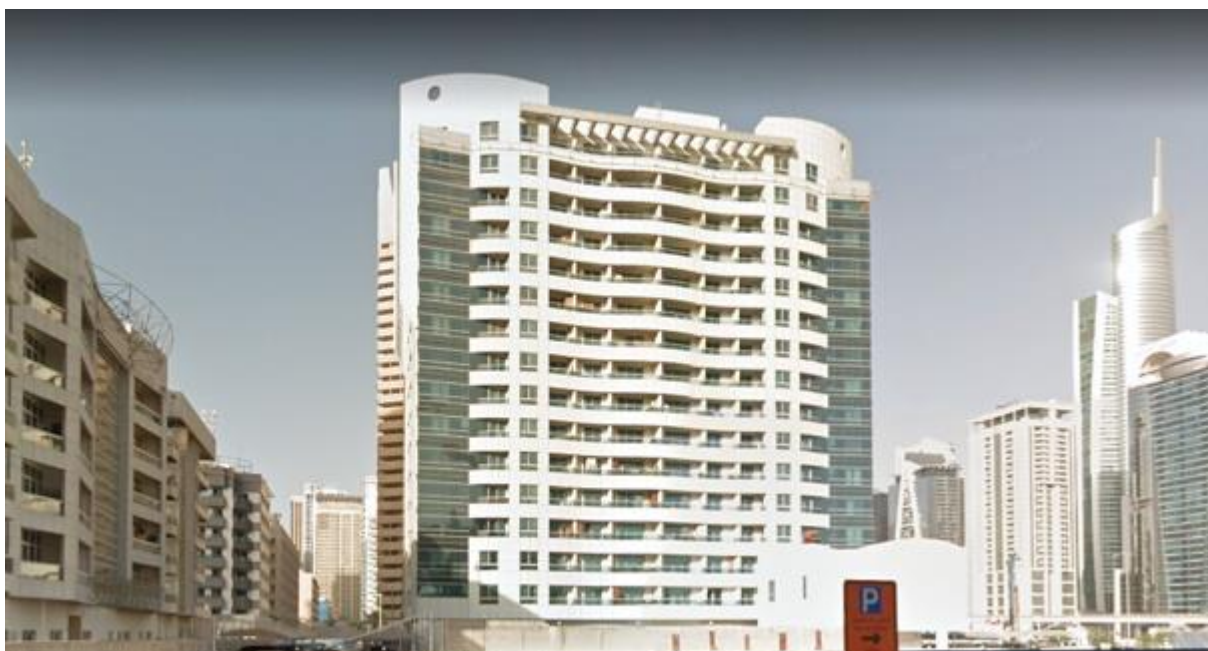
Figure 3: The south-west side of Marina Diamond 2 showing the curved corners which are covered in combustibile cladding. Glazed living areas protrude from these corners at right angles. The rest of the façade has a rippled effect, like waves in the sea. *Photo: The Author*

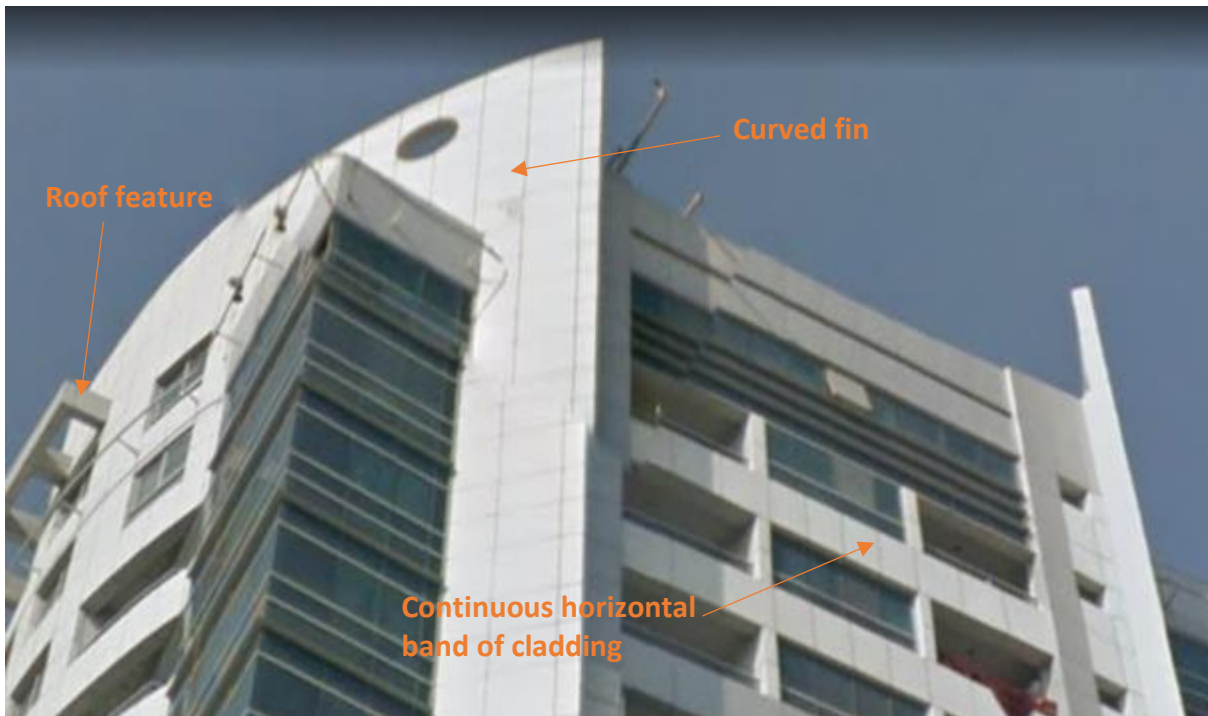
Figure 6: A view of the top of the building showing the curvature of the building face with the projecting fins which curve around the ends of the building at this level. These present a significant fire hazard.

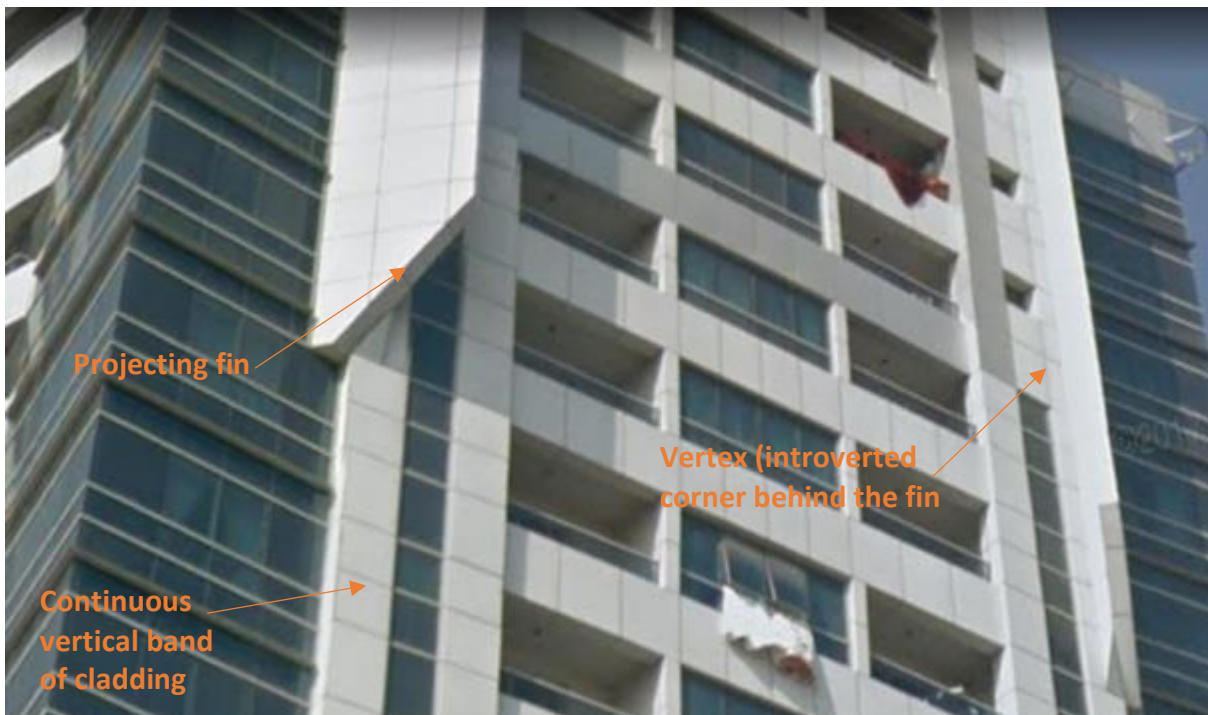
Figure 7: The fins extend from the tenth floor upwards and this photo shows where they connect with the building at their lower ends. A continuous vertical band of cladding extends into the vertex of each fin, thereby creating an opportunity for intense fire spread. *Photos (Figs.6 & 7): The Author*

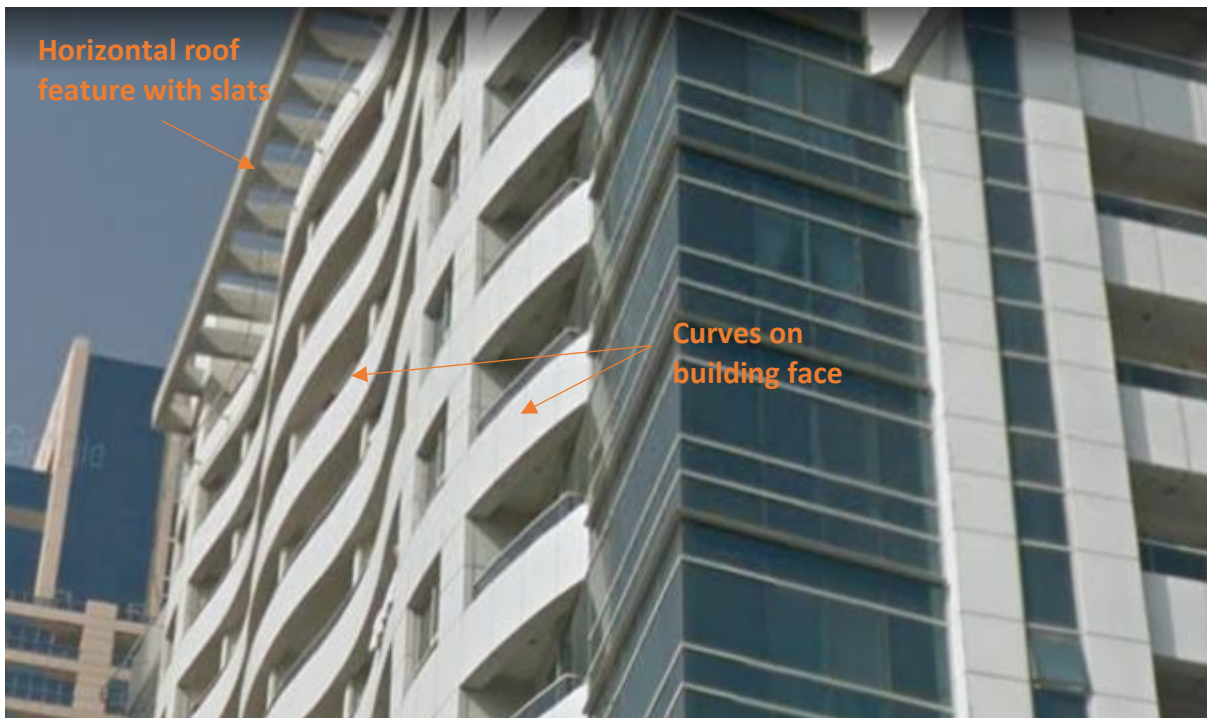
Figure 8: This view is taken midway up the building and is taken from a corner so that an end elevation and a side elevation can be seen simultaneously. The vertical bands of cladding which form balcony walls with multiple ledges would be a means of fire spread, as would the projecting roof-top feature. *Photo: The Author*

3.4 As the roof-top feature in *Figure 8* is not a parapet or an architectural crown, and as it is not present on all sides of the building, it would not give rise to **Perimeter (roof-top) Fire Spread** which is defined as, “*essentially Feature Enhanced horizontal fire spread which occurs at roof level, involving a parapet, crown or rim around the perimeter of a building. It may also affect features which sit on top of the roof and is influenced by exposure of the architectural feature.*” However, this does *not* mean that it would be incapable of causing fire to spread at roof level.

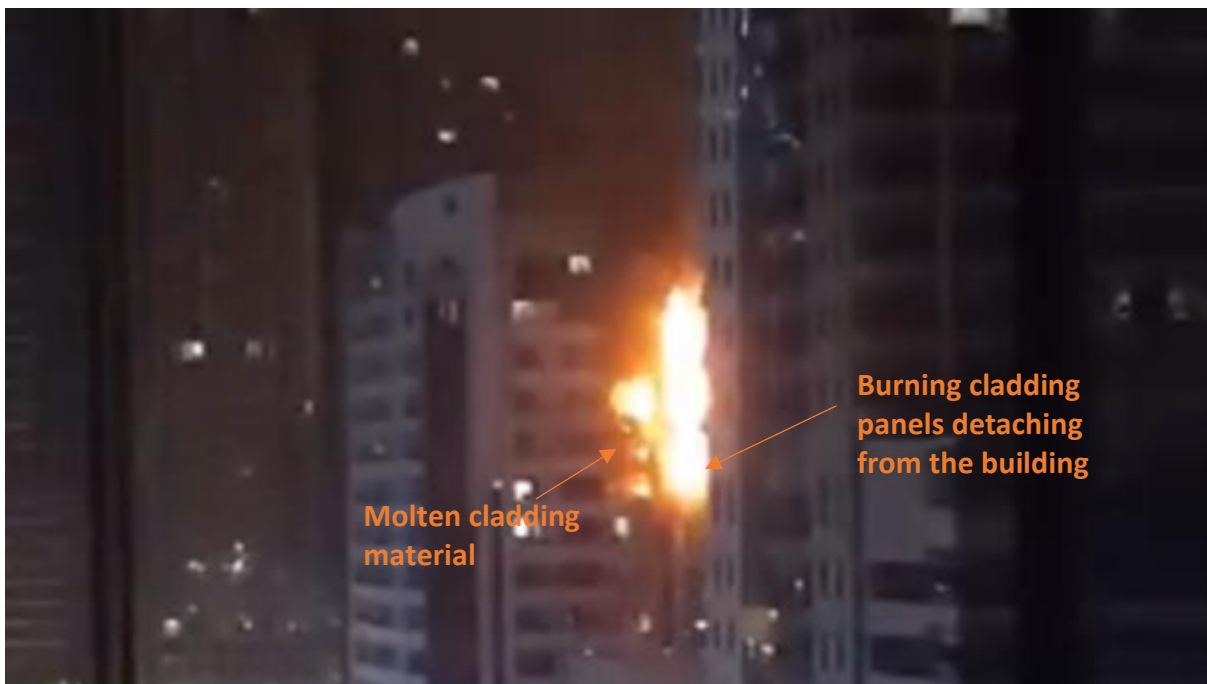
Figure 9: The upper floors on one side of the north-west of the Marina Diamond 2 are engulfed in flames, which can be seen spreading downwards as the cores of the cladding panels melt, flow and drip.

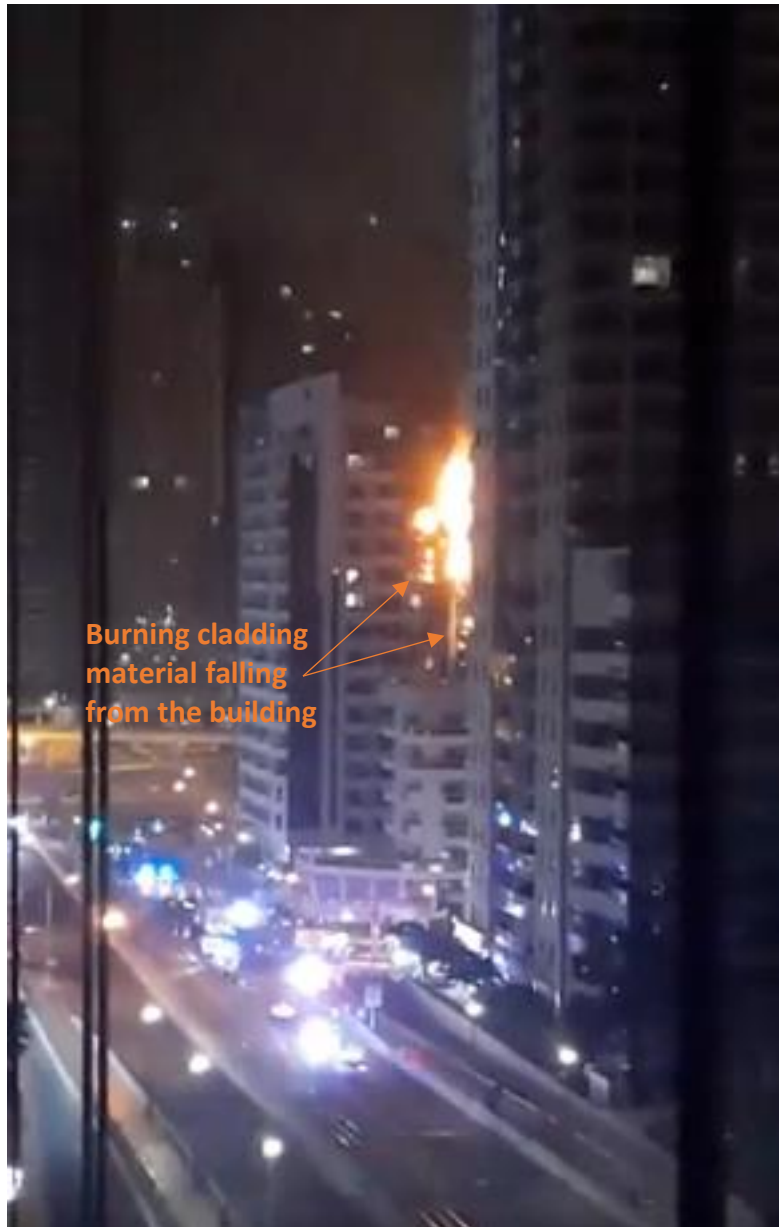
Figure 10: Another view of the fire showing the downward progression and pieces of burning cladding material falling from the building.

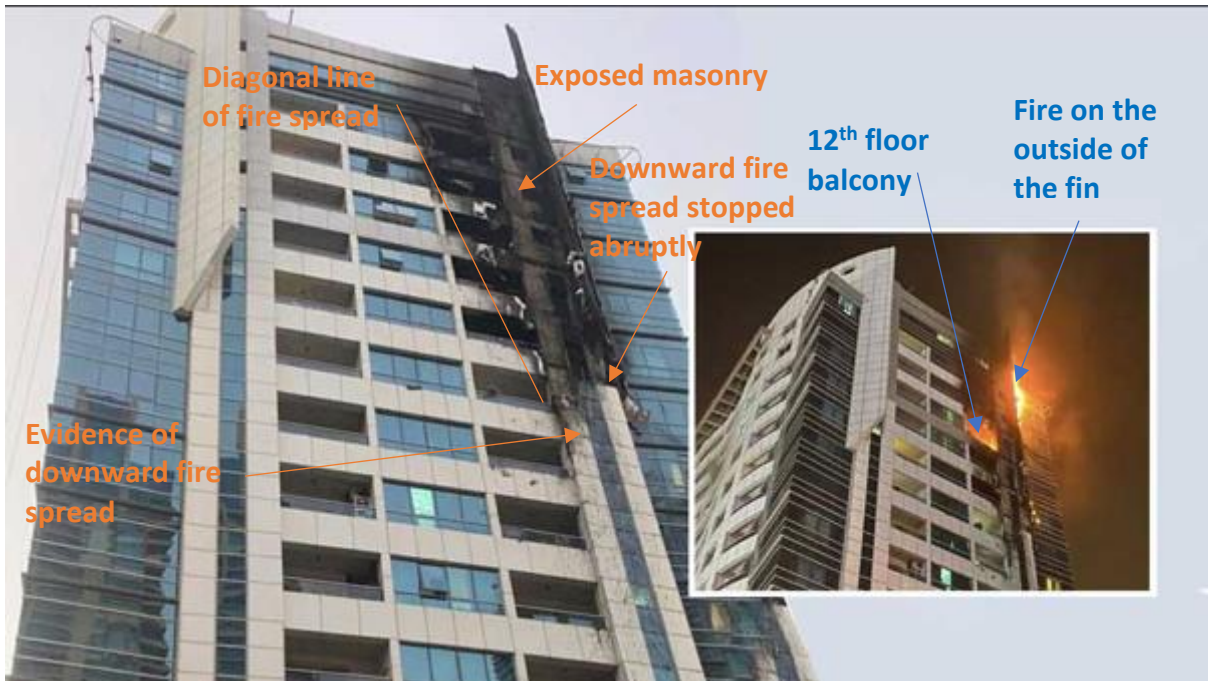
5.4 There is evidence to suggest that the fire began on the 9th floor balcony and entered the cladding system on the immediate right of the opening, as you stand facing the building from the outside. The fire then developed and spread to other floors, following the sequence as detailed below. Please also refer to *Figures 11* and *12*.

Figure 11 (above, p.15 and below): Two comparable photos showing the building during the fire and the damage which was visible once the fire had been extinguished. Such was the intensity of the fire, especially behind the fin, that the cladding has been completely consumed to expose the masonry behind. Some of the cladding also detached and fell from the building as it burned. *Photos: Dubai Civil Defence*

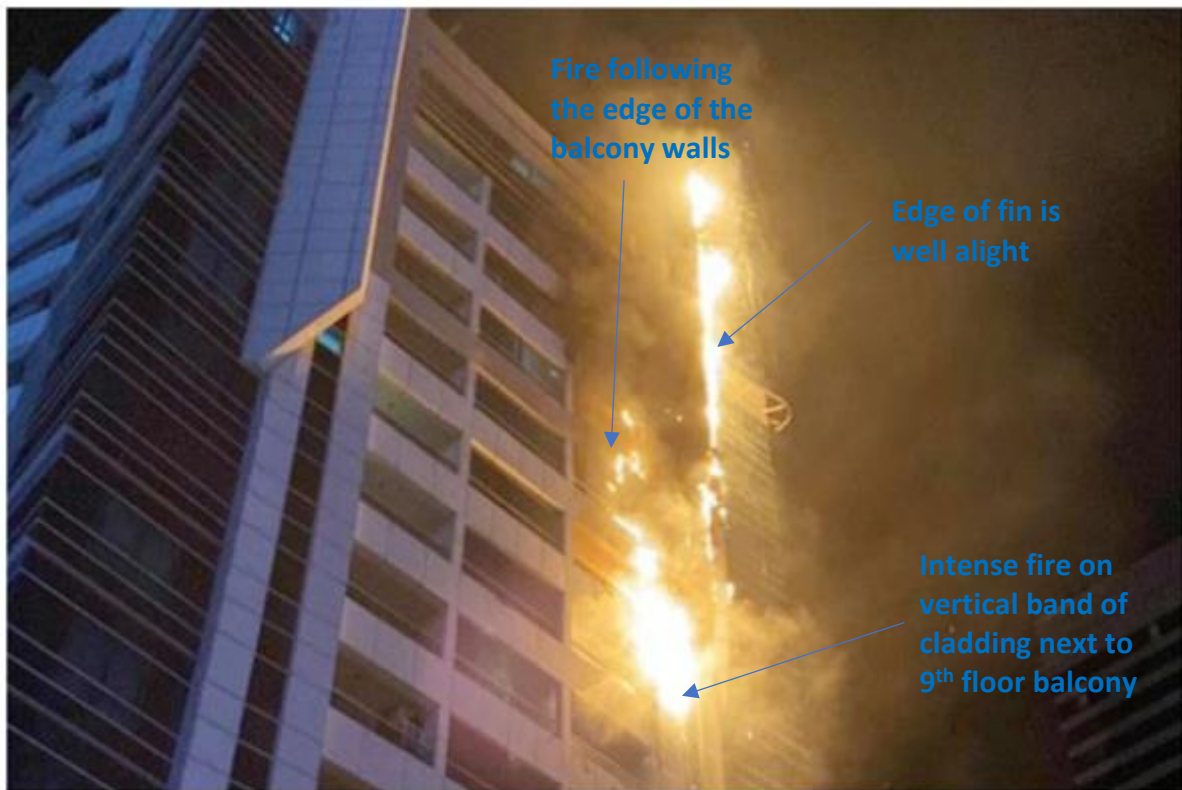
Figure 12: The fire is at its most intense on the band of cladding next to the 9th floor balcony and is spreading upwards to affect other floors. The fin is also well alight.

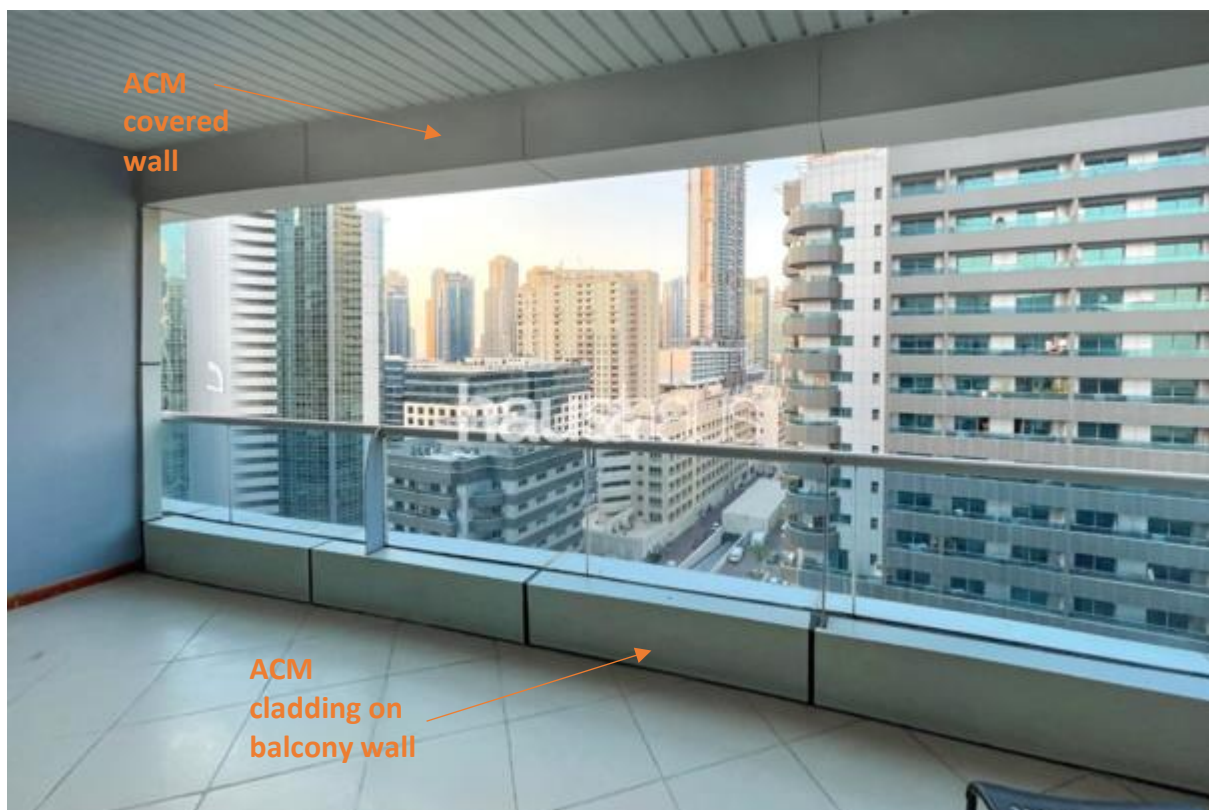
Figure 13: A balcony at the Marina Diamond 2 showing combustible materials around the opening and on the ceiling. The example shown in this photograph is for a one-bedroomed flat on the north-east side of the building. Photo: www.bayut.com

5.9 The balconies have ceramic tiled floors which are not combustible and the side walls appear to be plastered (*Figs.13 & 14*). However, the balcony wall consists of combustible cladding with glass balustrading above. The framework for the glazing is metal, and therefore is not combustible (*Fig.14*). At ceiling level, there is an abundance of combustible material, mainly in the form of synthetic boarding, but also on the short section of wall which extends down into the opening. Like the wall below the balustrading, this too is covered in combustible cladding.

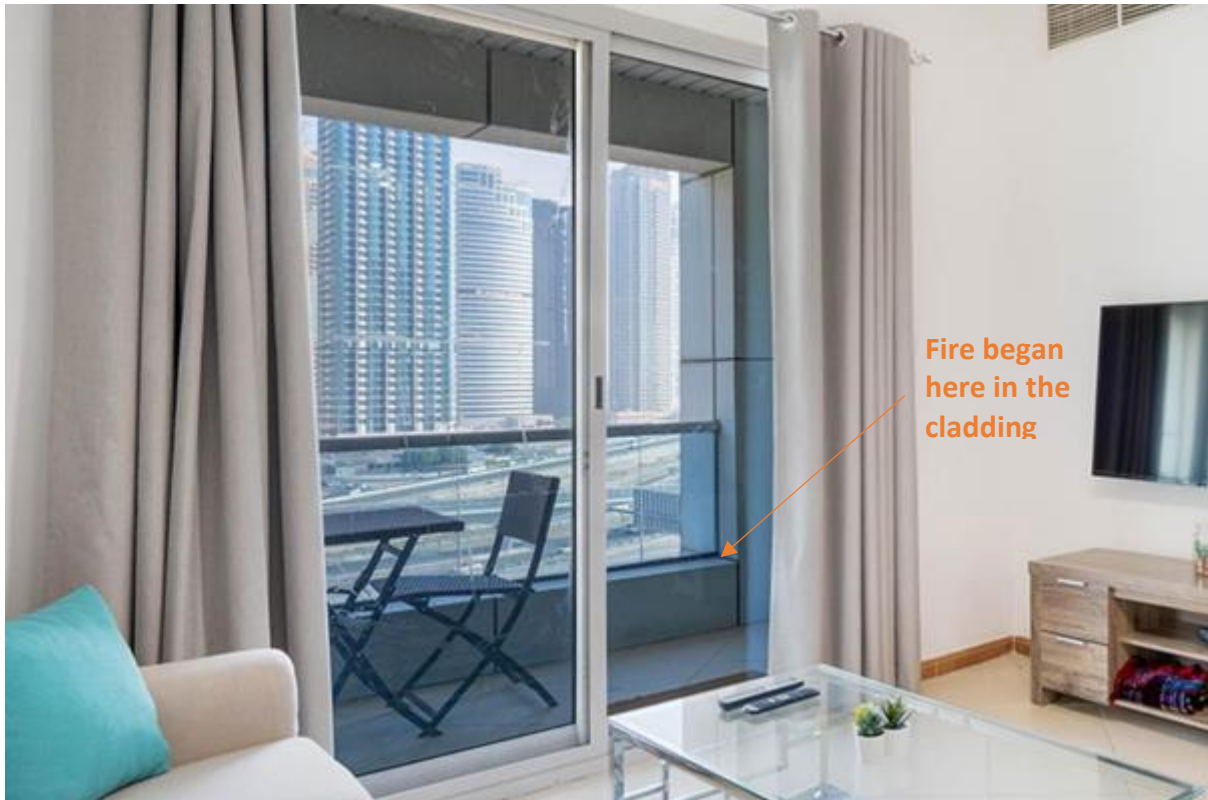
Figure 15: The living area of a two-bedroomed flat which is a mirror image of the one where the fire began at the opposite end of the building. An area of cladding equivalent to that where the fire started can be seen through the balcony doors. Photos (Figs.14 & 15): Kennedy Towers www.kennedytowers.com

5.10 The fire started in the location shown in Figure 15, where there are multiple locations for it enter the interior of the cladding system. These include panel joints, as well as the point at which the balustrade rail penetrates the cladding system (Fig.14). The location as seen from outside the balcony, is shown in *Figure 16*.

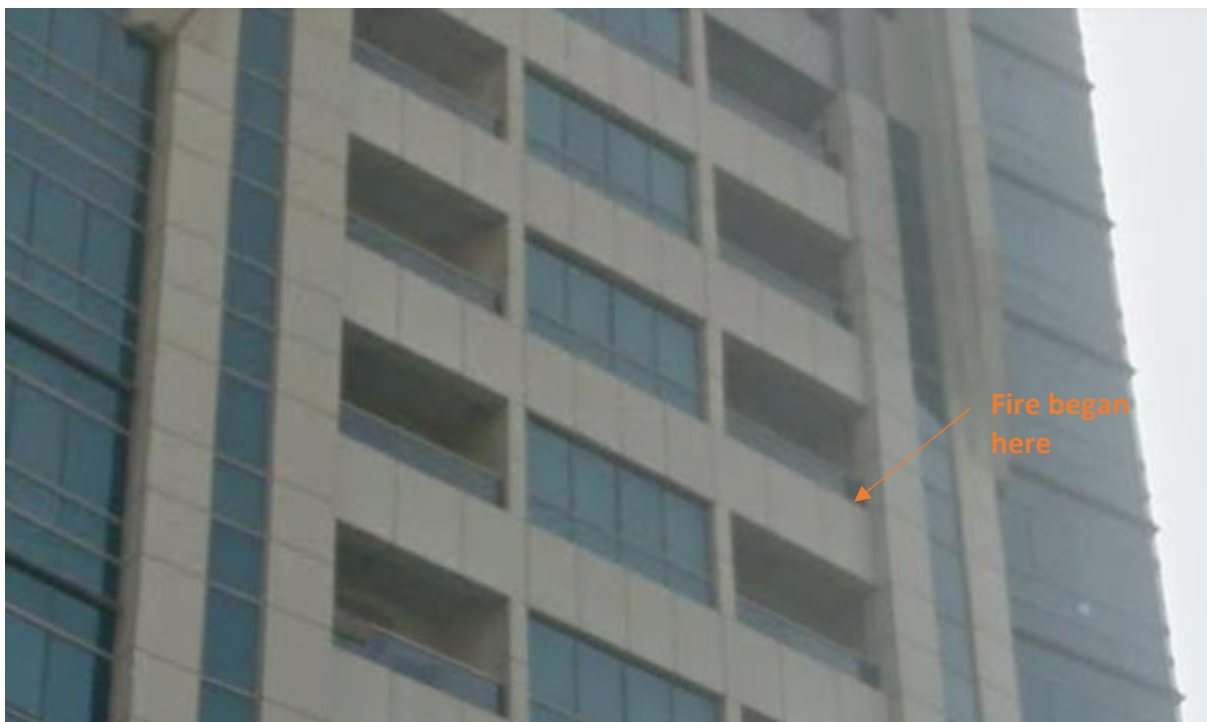
Figure 16: The flat of origin in December 2016, in its undamaged state. An arrow points to the area of the cladding where the fire is thought to have started. *Photo: The Author*

5.12 The exact cause of the fire has not yet been announced, but the point of origin suggests:

- A carelessly discarded cigarette which either directly ignited the cladding or items placed adjacent to it
- A candle placed on the ledge next to the balustrade
- A faulty lamp which was placed on the ledge next to the balustrade
- A portable air conditioning unit which malfunctioned

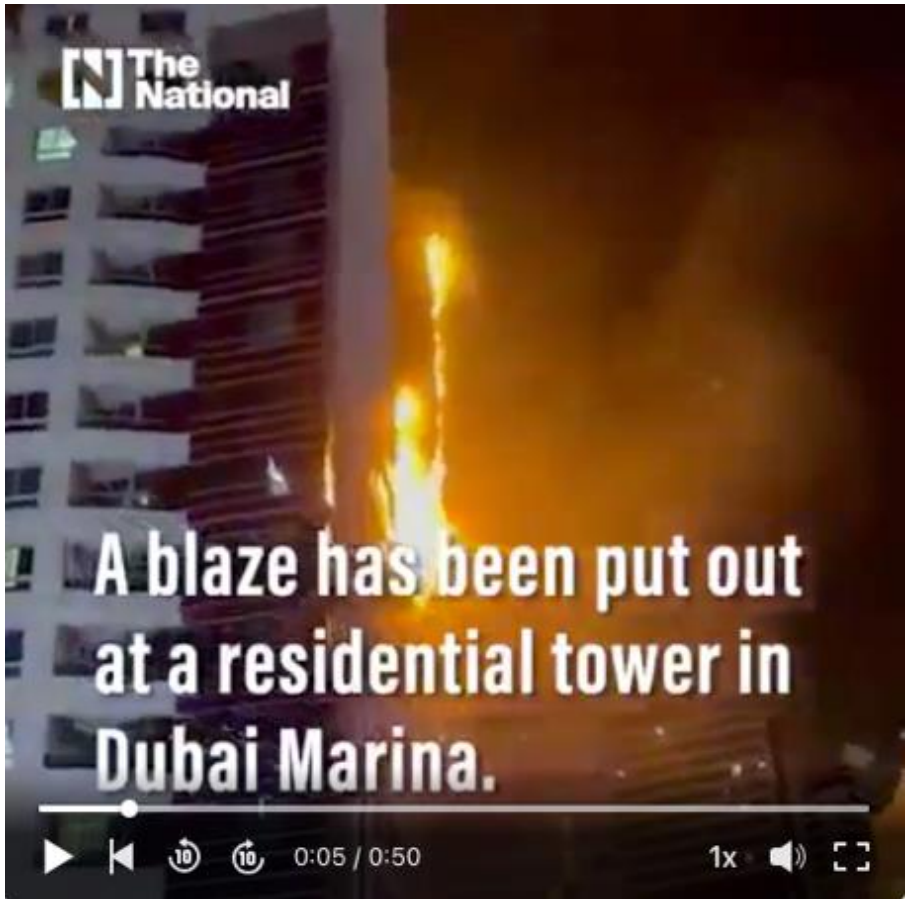
Figure 17 (top photo, p.21): An extract from a video made by a witness to the fire which shows the fin well alight with the flames concentrated along its edge. The flames are also in the vertex behind the fin and are affecting the adjacent balconies.

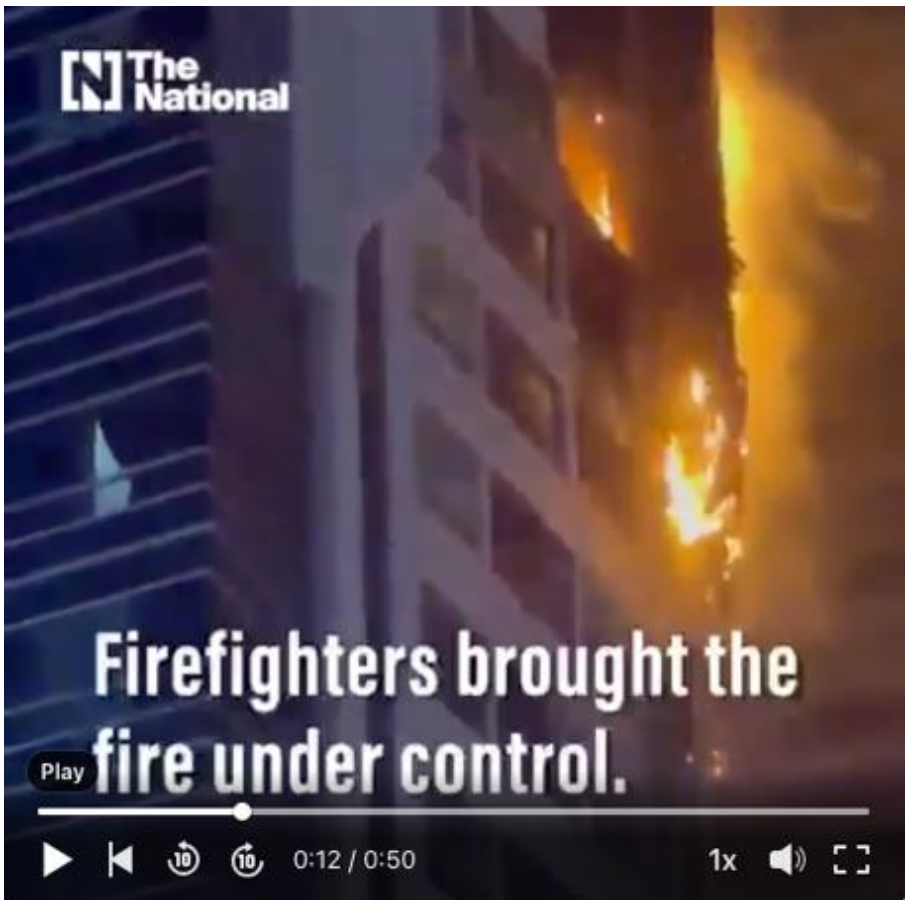
Figure 18 (bottom photo, p.21): Another extract from the same video, but taken seven seconds after the one in Figure 17. The cladding on the fin is being consumed by the fire and the balcony of the 12th floor flat is glowing orange due to the extent of its involvement in the fire.

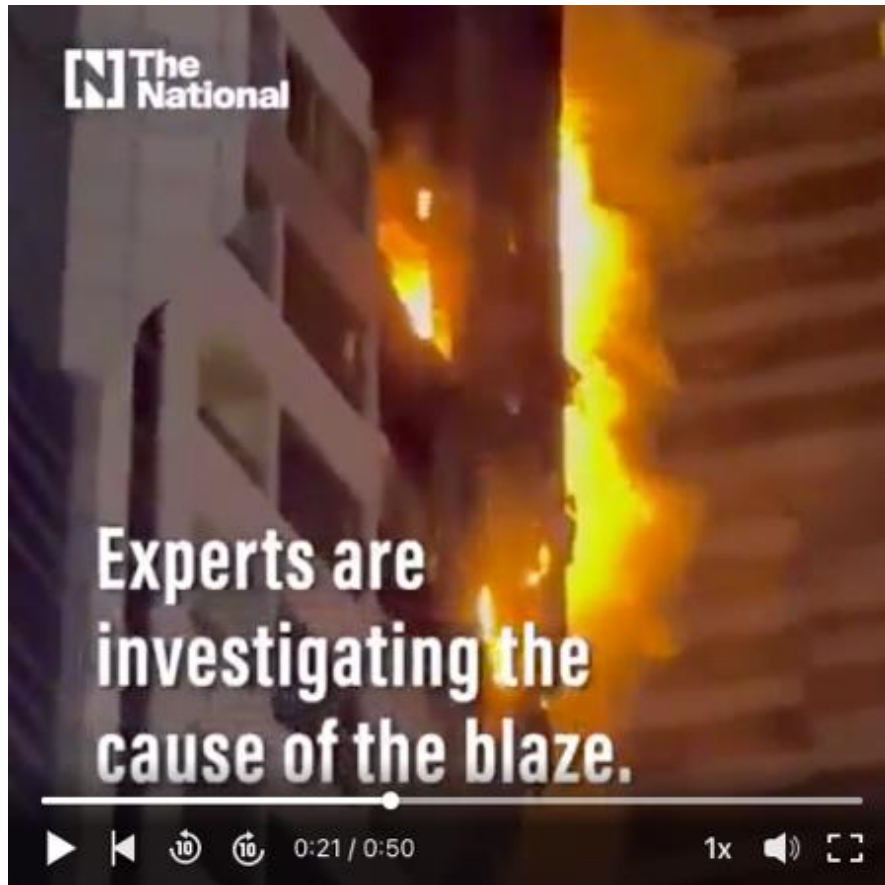
Figure 19: A third extract from the same video, taken at 21 seconds (9 seconds after the second extract in Figure 18 and 16 seconds after the first extract in Figure 17). The fire has intensified, especially on the fin and the balcony on the 12th floor is approaching flashover conditions.

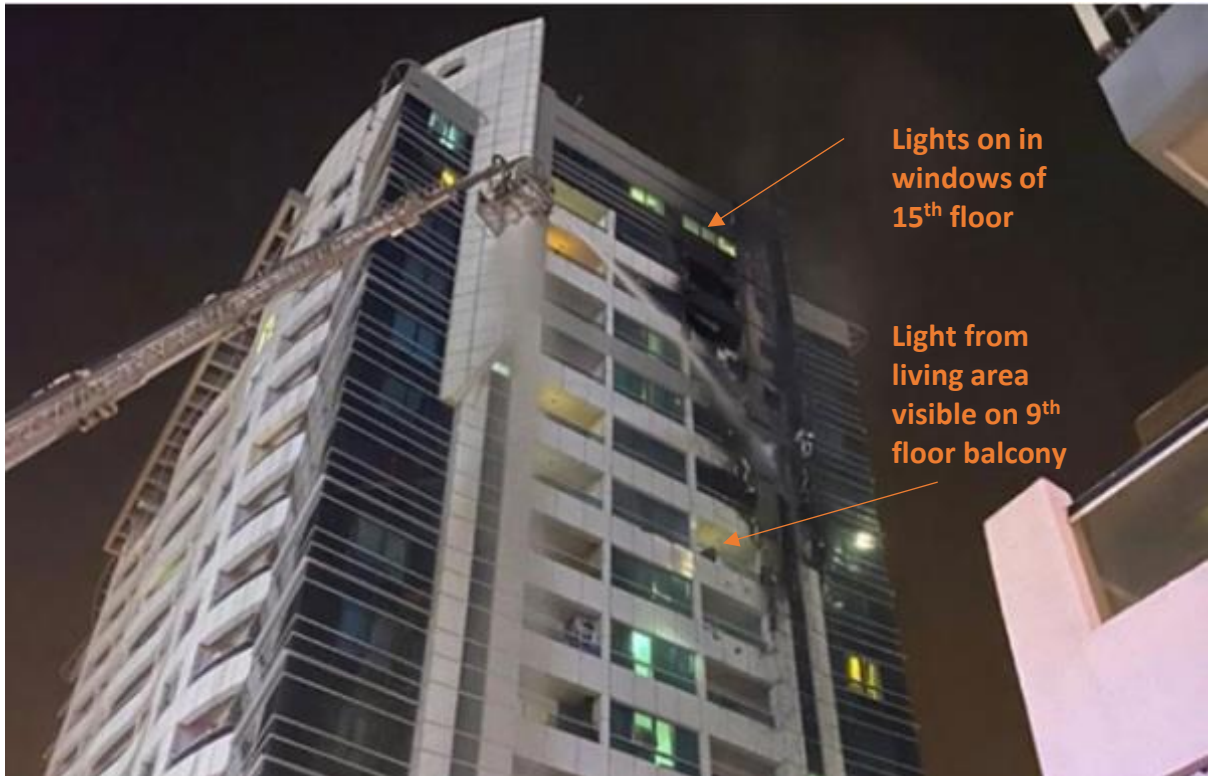
Figure 20: Most of the fire has now been extinguished and the firefighters are damping down. A light can be seen in the 9th floor balcony, which is coming from the living area and projecting through the glazing of the balcony doors. It has illuminated the ceiling of the balcony which appears to be undamaged. The lights are also on in the 15th floor flat where the damage is confined only to the external cladding. *Photo:* www.gulftoday.ae

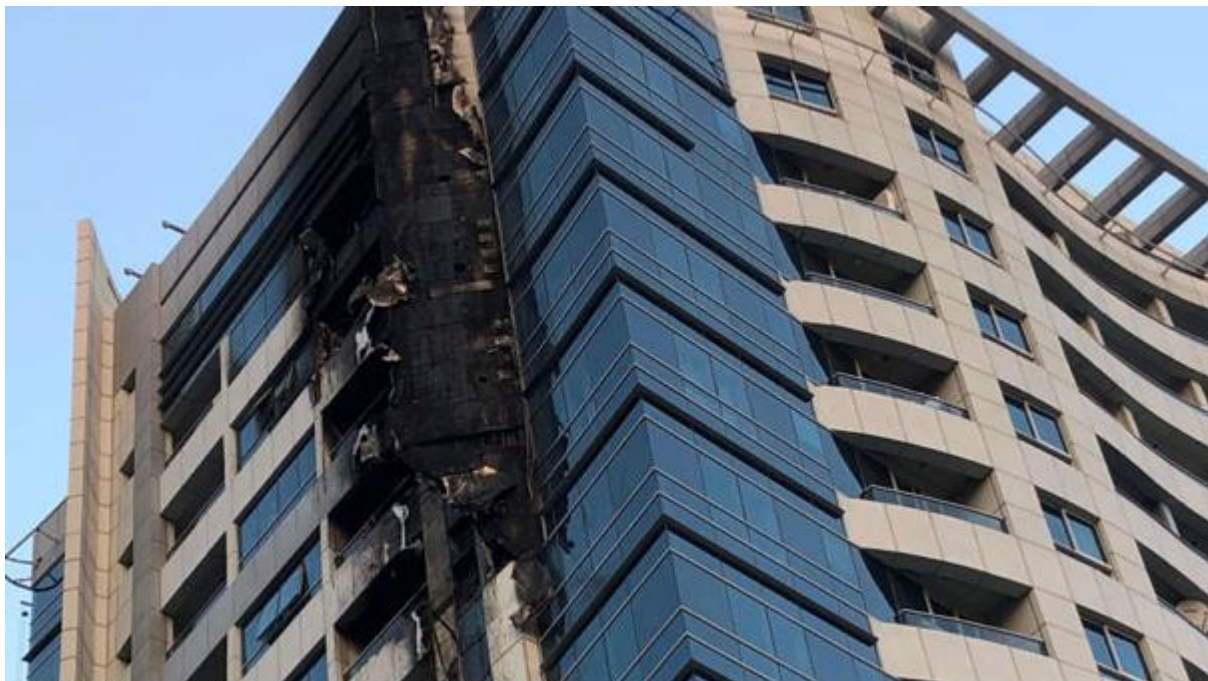
Figure 21: The fire has now been extinguished. Most of the cladding on the fin has been destroyed and the balconies from the 10th to the 14th floor are blackened and damaged.
