**REPORT ON THE FIRE WHICH OCCURRED AT TORRE DEL MORO,
MILAN, ITALY ON 29 AUGUST 2021**

By Frances Maria Peacock

Updated Version - October 2021

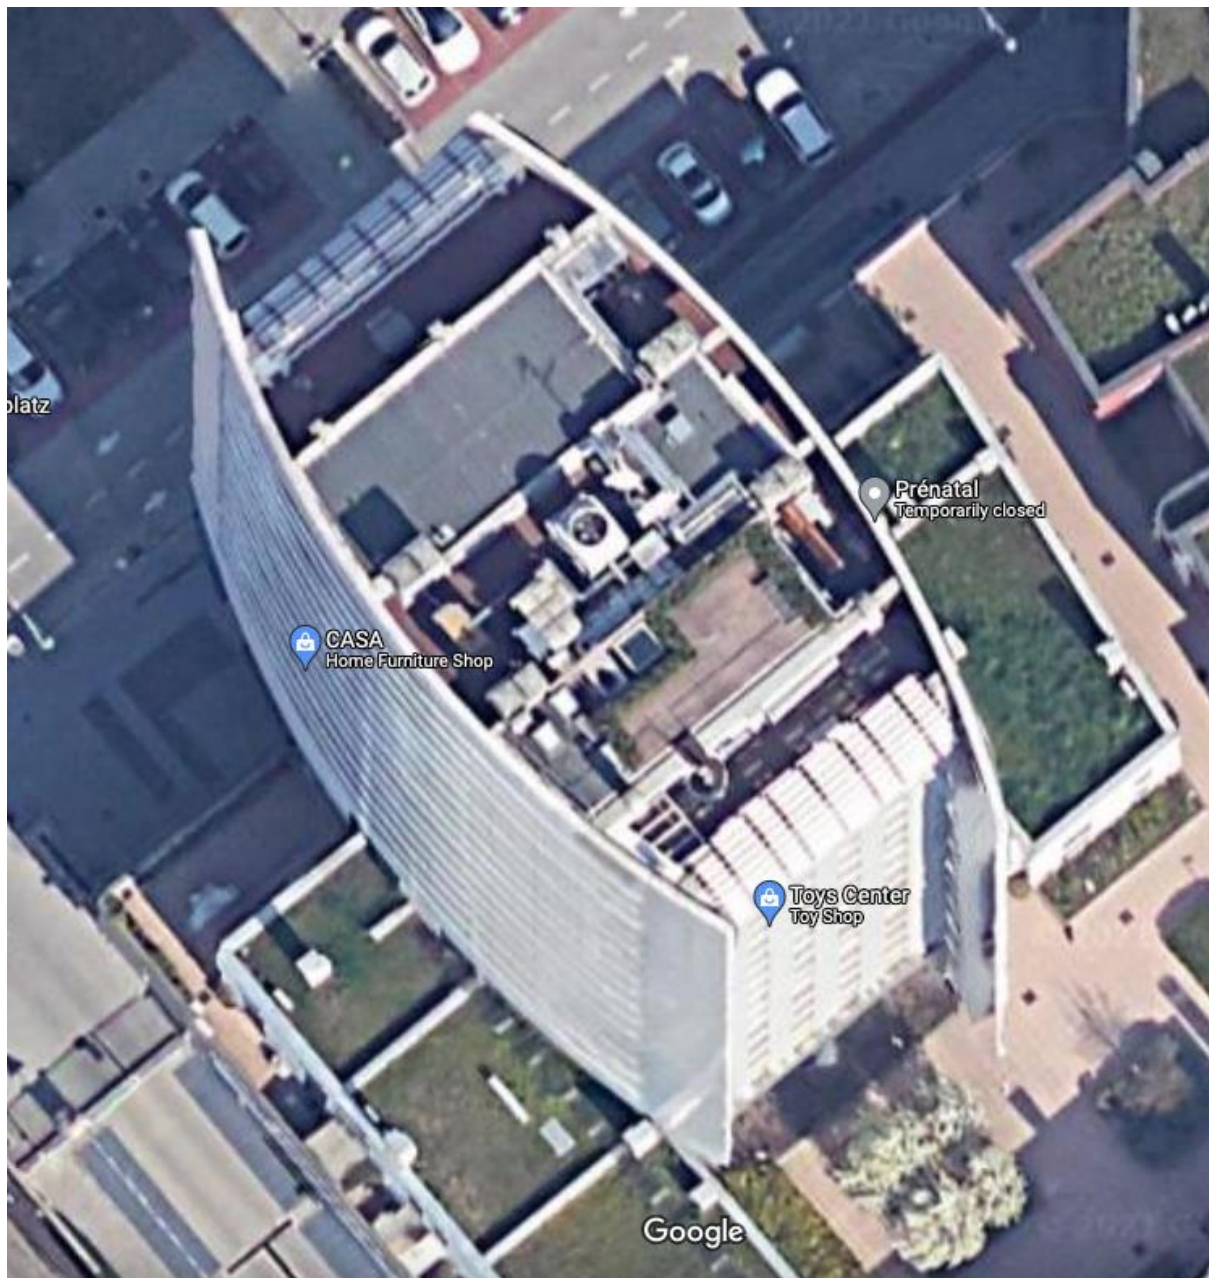
Figure 3: An aerial view of the building from which the relationship of the sails with the core can be appreciated. The core is rectangular with a curved sail attached to the long sides of the rectangle. These project beyond the short sides of the rectangle (ends) to create vertexes where flames can manifest themselves. At each of the ends, one sail projects further than the other.

3.2 The sails protrude beyond the ends of the building, extending more on one side than the other on opposite sides at each of the ends (*Fig.3*). The projections create introverted corners at the interface between the core and the sails, therefore providing areas where the flames could become concentrated and intensify the fire spread (*Fig.4*). This is what is known as “Corner Influenced Fire Spread,” the definition of which is “*The extension of flame height*

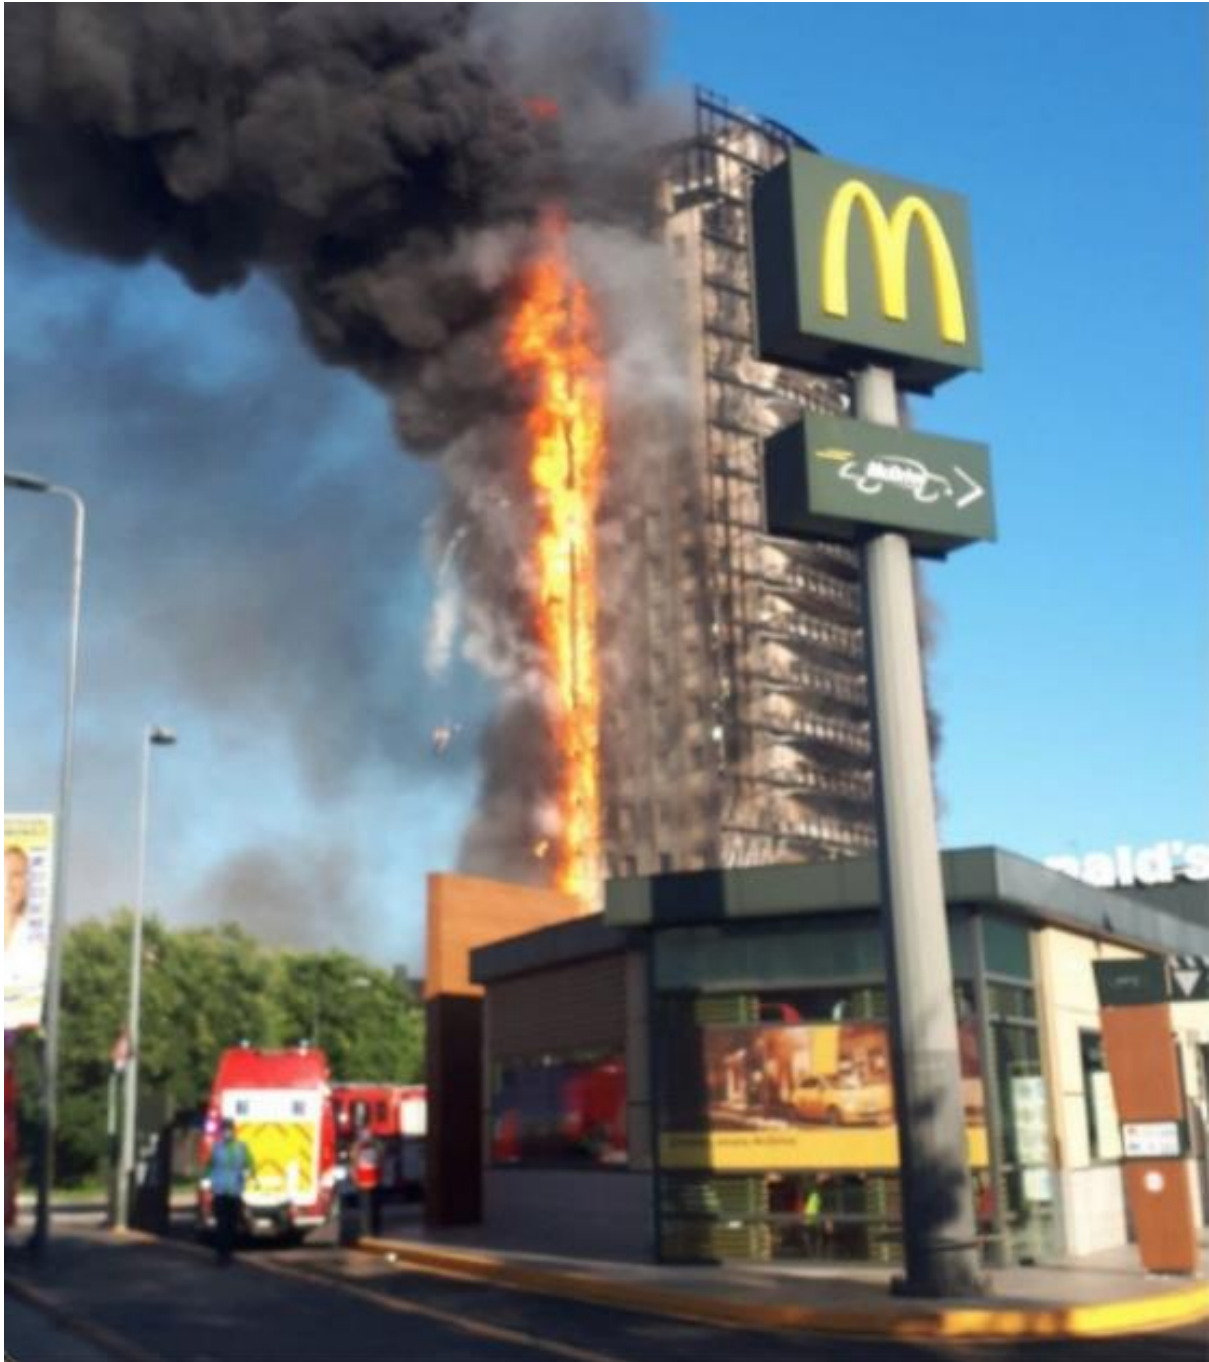
Figure 4: In this photograph the flames are concentrated within the vertex created at the interface where the sail projects beyond the edge of the core. The fire, having rapidly consumed the cladding on the sail, entered the corner where it became concentrated on a band of cladding.

which occurs when the fire becomes confined to an introverted corner (vertex) on a building face.” The fire, as it spread through the sails, was able to enter these corners and then spread rapidly upwards, having ignited the ACM cladding on the vertical columns, the edges of which protruded into this area.

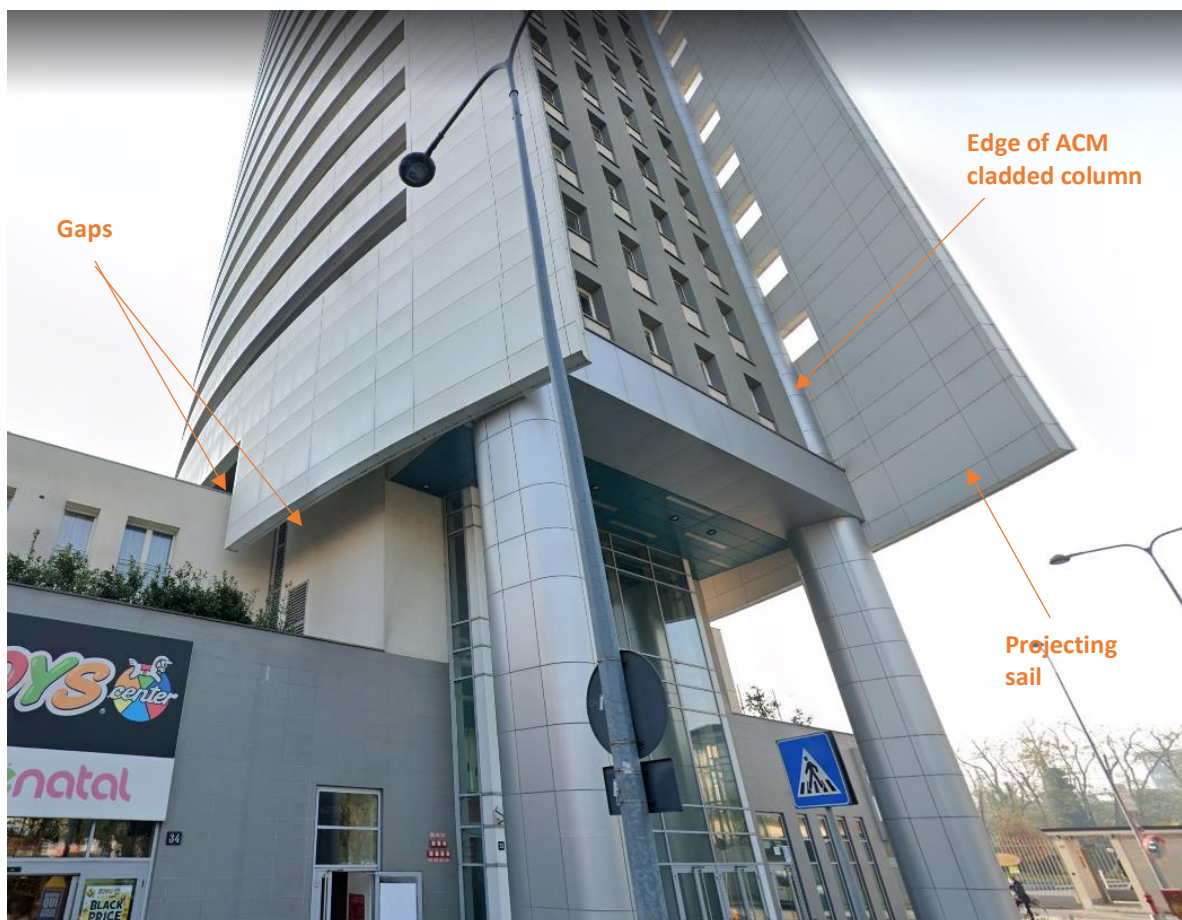
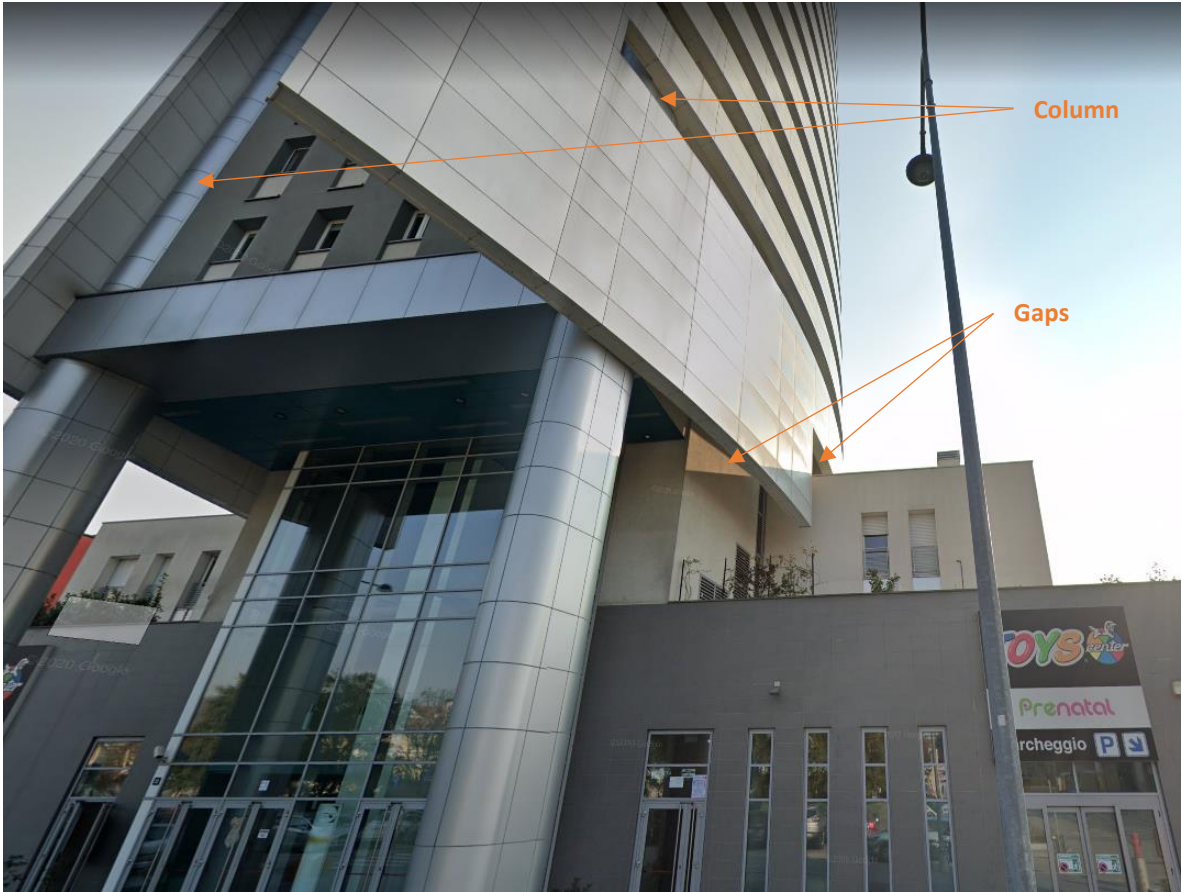
Figures 5 (above) & 6 (p.9 below): The structural columns are exposed at ground level and extend the full height of the building up to the roof. It can clearly be seen that they extend behind the sails, to which they are attached. One sail extends further outwards than the other, and it is here that the column is exposed at intervals, as it extends past the openings for the balconies. The edges of these columns are visible in the corners, and were a means of fire spread on this elevation of the building.

3.11 At each end of the building, there are gaps at first floor level where the sails are constructed around the podium at the bottom of the building (*Figs. 5, 6 & 7*). The gap represents a pathway for fire which can affect the inside face of the sail and the outer face of the core at the same time. It will also act as a chimney where heat can build and intensify the fire.

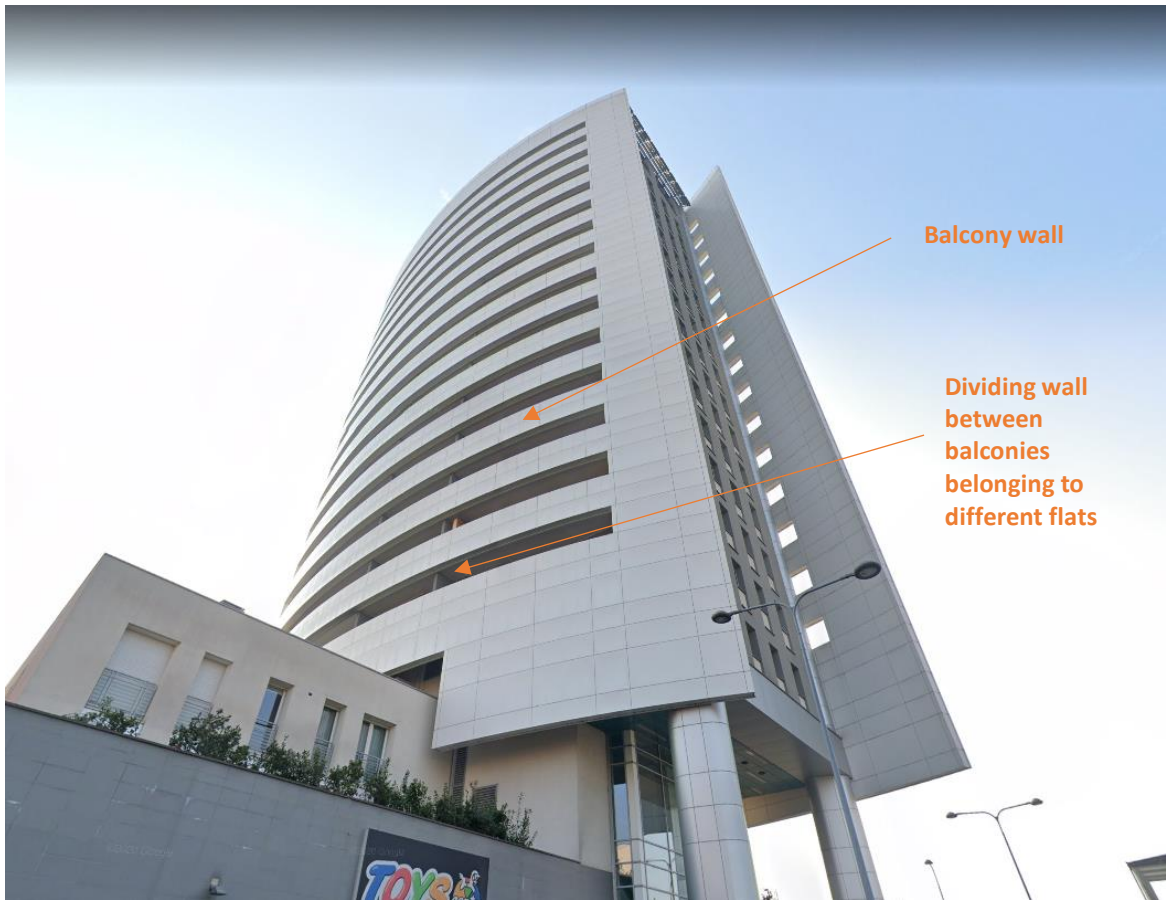
Figures 7 (p.9 below): This photo shows the balconies, the decks for which are between the sails and the core. The edge of each balcony is protected by a wall, which is covered in ACM cladding with an opening above. In order to provide each flat with its own private space, the balconies are divided at intervals by walls, which provide separation from neighbours. It can be realised that the sails are clad with ACM on both their inner and outer faces.

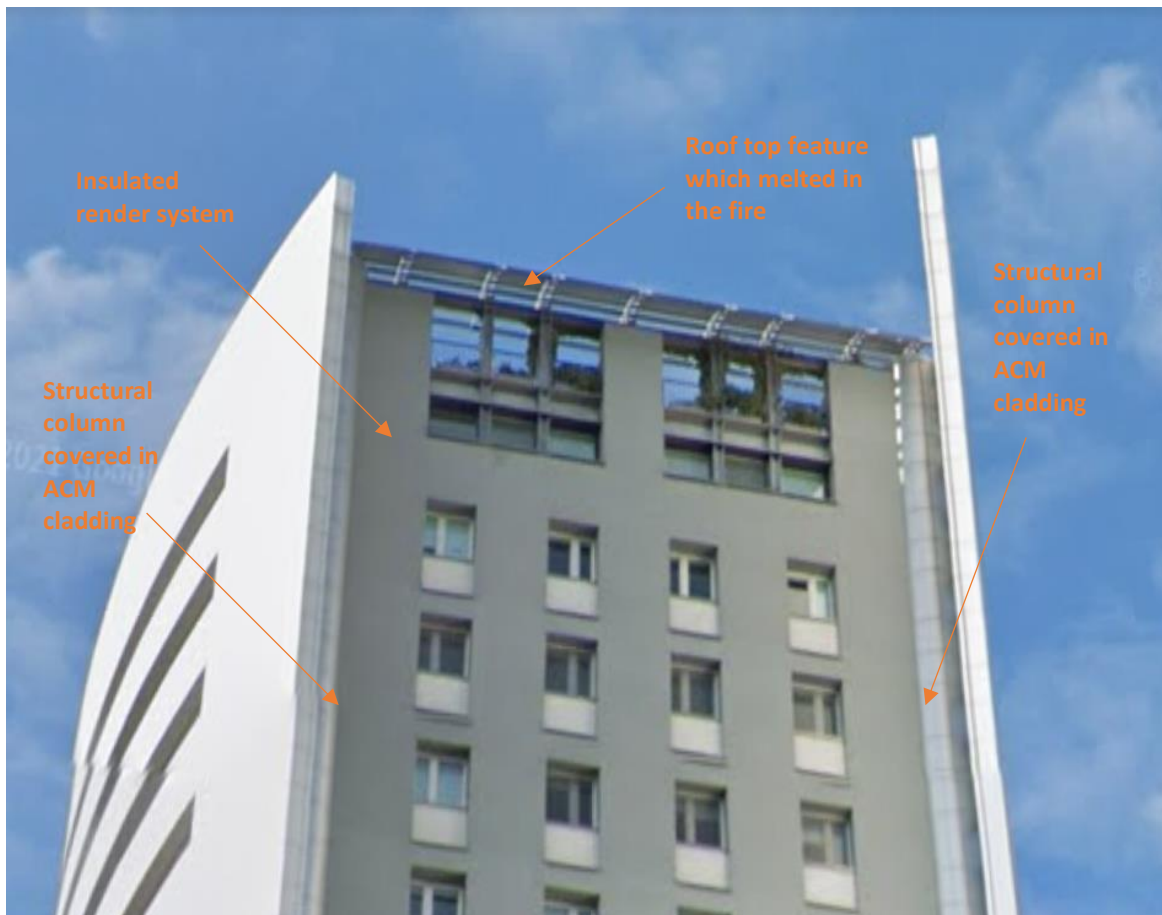
Figure 8: The façade at each end of the building consists of insulated render, but the combustible ACM is in close proximity with the structural columns in direct contact at the interface with the wall. It can also be seen in this photo that there is a feature at roof level which appears to be made of metal, although confirmation would be necessary. This sustained damage during the fire.

4.7 The walls at the ends of the building (*Fig.8*) are covered with a type of insulated render system, in this case an External Thermal Insulation Composite System (ETICS) containing mineral wool insulation. This has a Euro Class A2 rating which means it is of limited combustibility. In contrast the ACM cladding which covered the sails and columns was highly combustible (Class E), which explains why it burnt so rapidly compared to the insulated render system made little contribution to the fire.

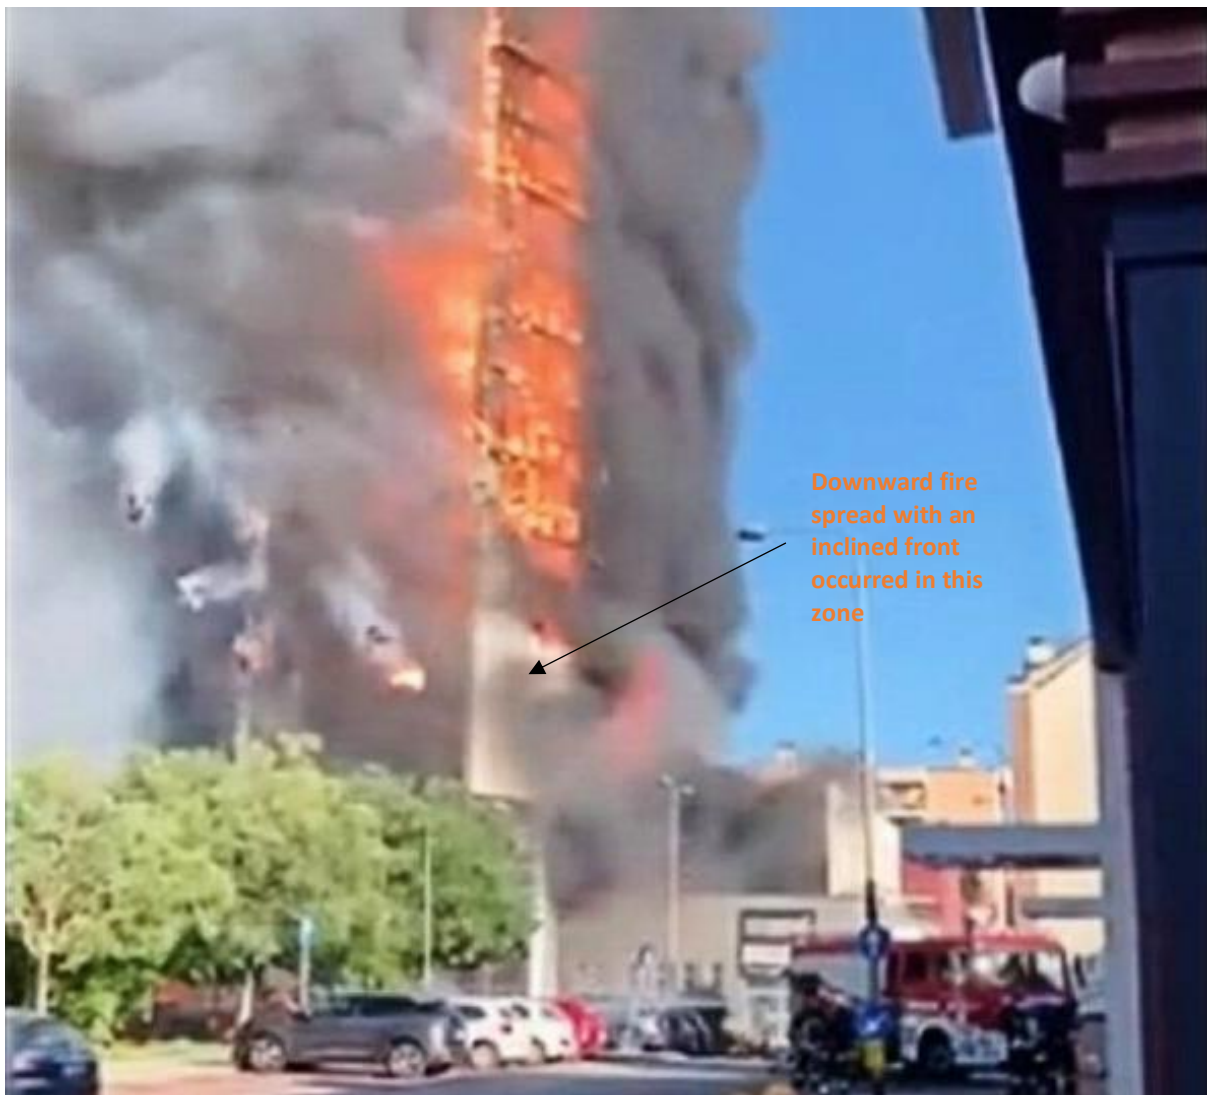
Figure 9: The fire started on the 15th floor and spread across the building and downwards, as the cores of the panels melted and burned. In the lower corner of the building, just below the main band of fire and the tree tops, a diagonal pattern can be seen. This is a still image taken from a video where it is easier to observe the effect in motion, although in both cases the large amount of smoke makes it difficult to see.

3.14 It is the sub-type which was observed on the Torre del Moro, where it occurred in association with “Downward Vertical Fire Spread.” This is defined as *the downward spread of fire, affecting continuous bands of cladding due to the flowing and dripping of molten burning material. This does not involve projecting features. See Figure 9.*

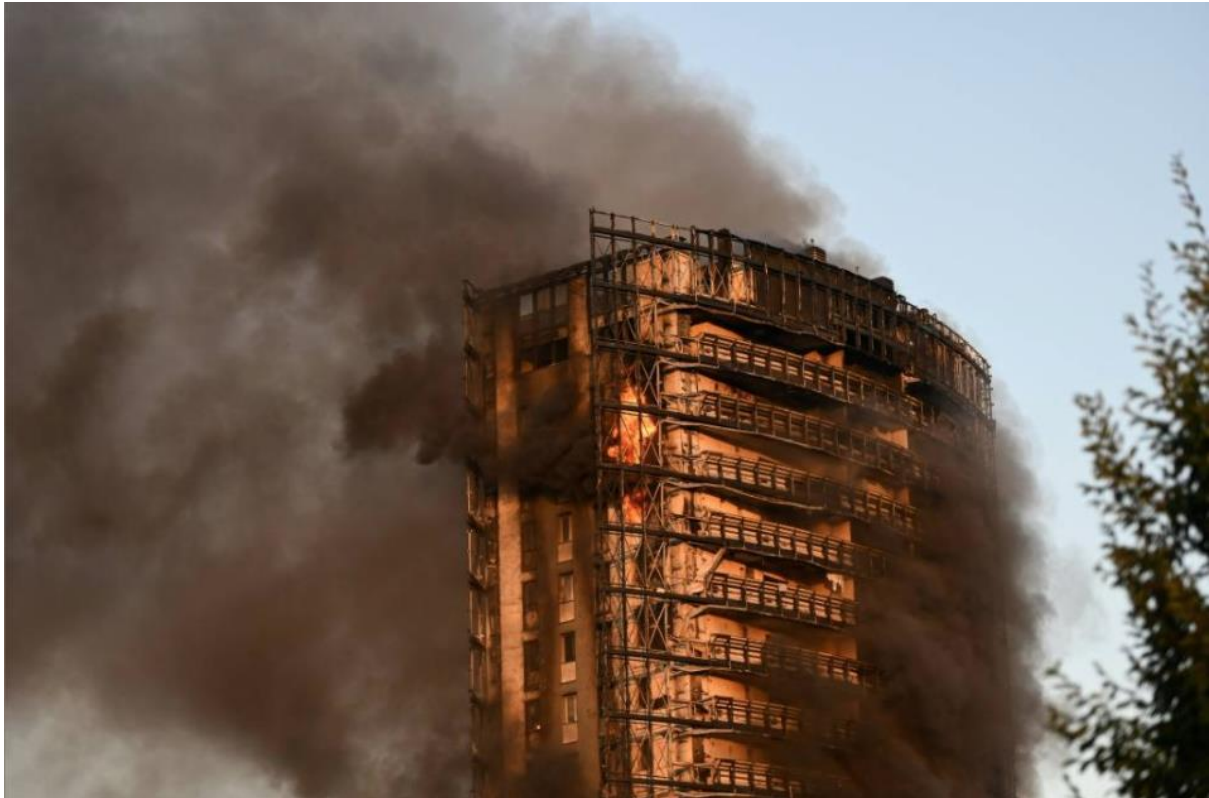
Figure 13: The fire has consumed all of the sail on the south-western side, leaving behind a skeletal framework. It seems that the fire spread along combustible material at roof level to reach the sail on the opposite side of the building.

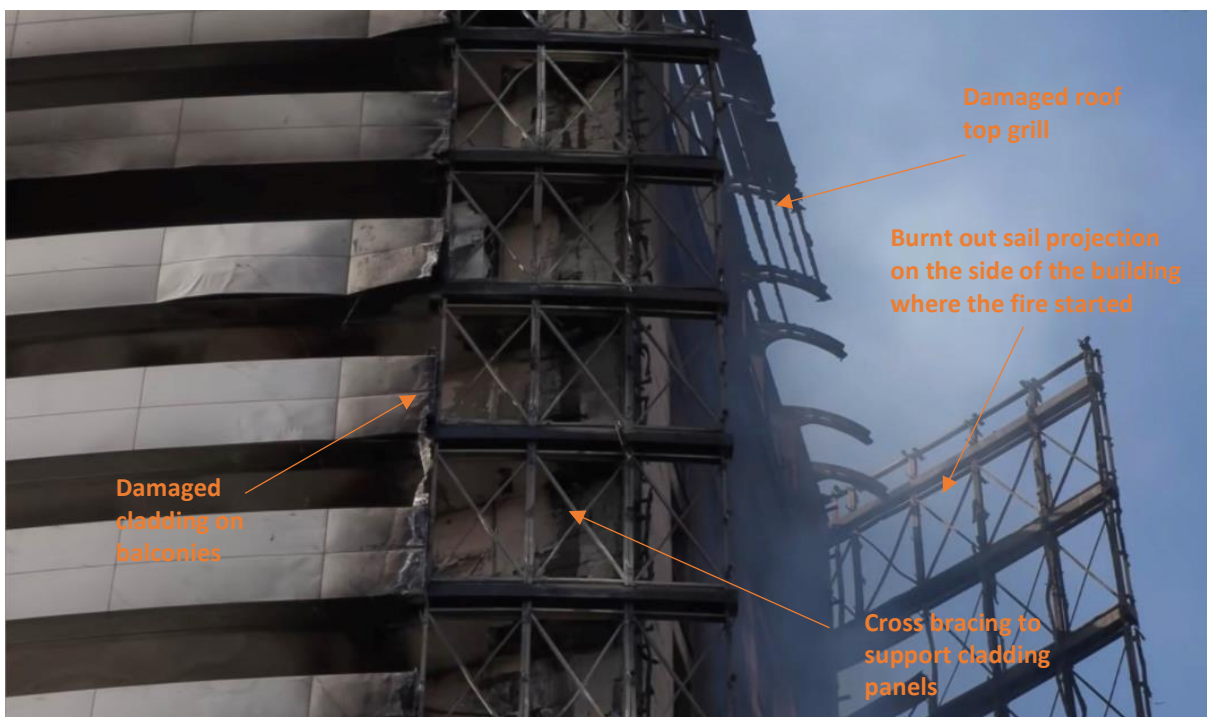
Figure 14: A close up view of the building from the opposite side to that where the fire started; the end of the sail has borne the brunt of the fire with only the framework surviving. It can be seen that the fire stopped abruptly before the balconies, where the cladding has started to delaminate and deform. This suggests that there may have been fire barriers between the balconies and the ends of the sails.

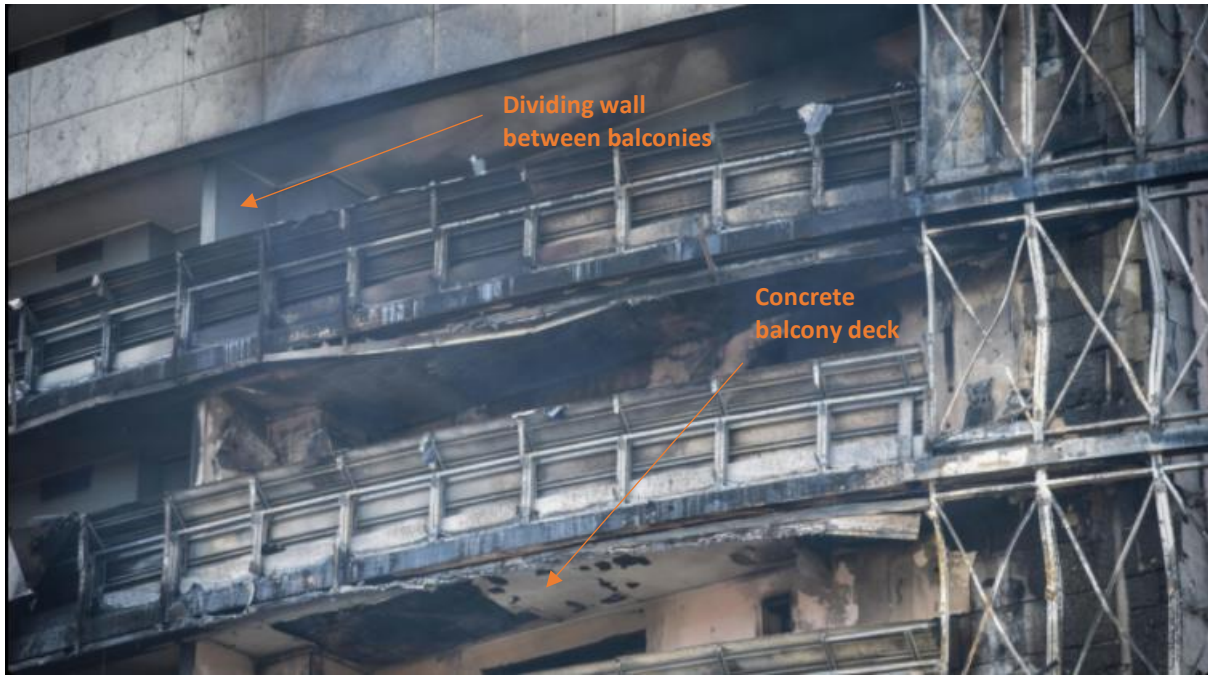
Figure 15: A close-up view of the balconies which shows the difference in the design of the framework with that on the ends of the sails. It is difficult to tell what lies behind the framework on the balconies, but whatever the material is, it has remained intact. The ends of the sails have burned through completely and the wall behind, at the interface with the core and the balconies, is exposed.

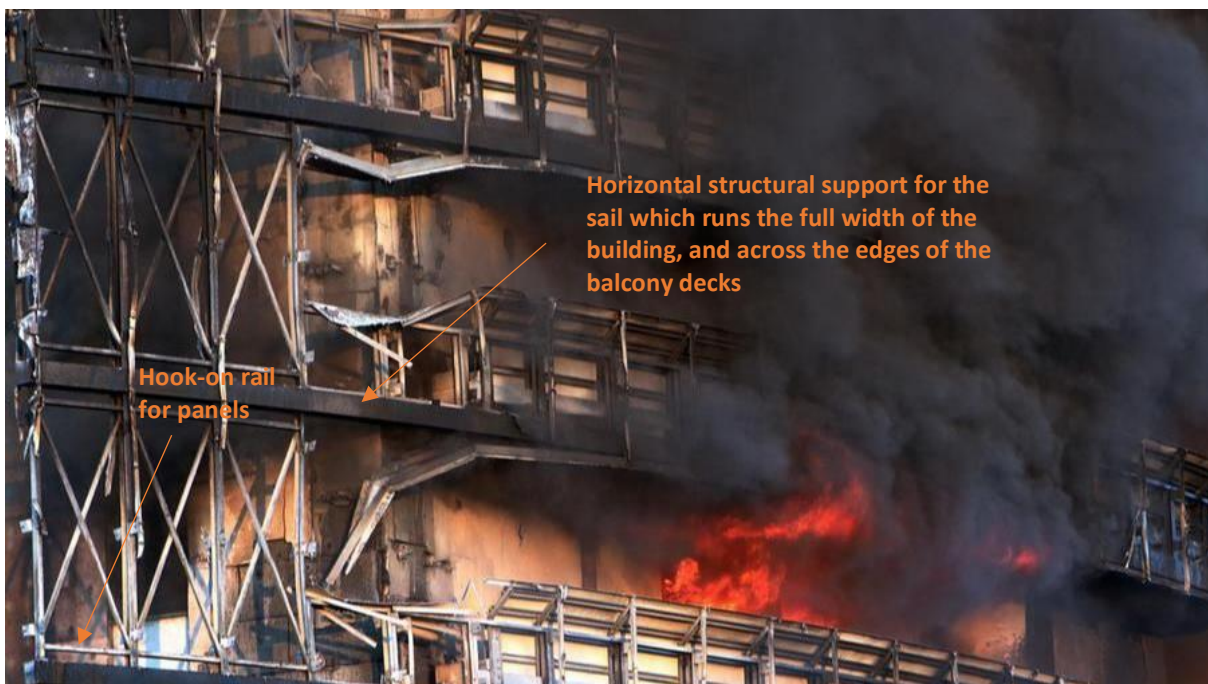
Figure 16: The same areas of the structure in Figure 15 above, but during the fire, where flames can be seen venting through the doors and windows of one of the flats.

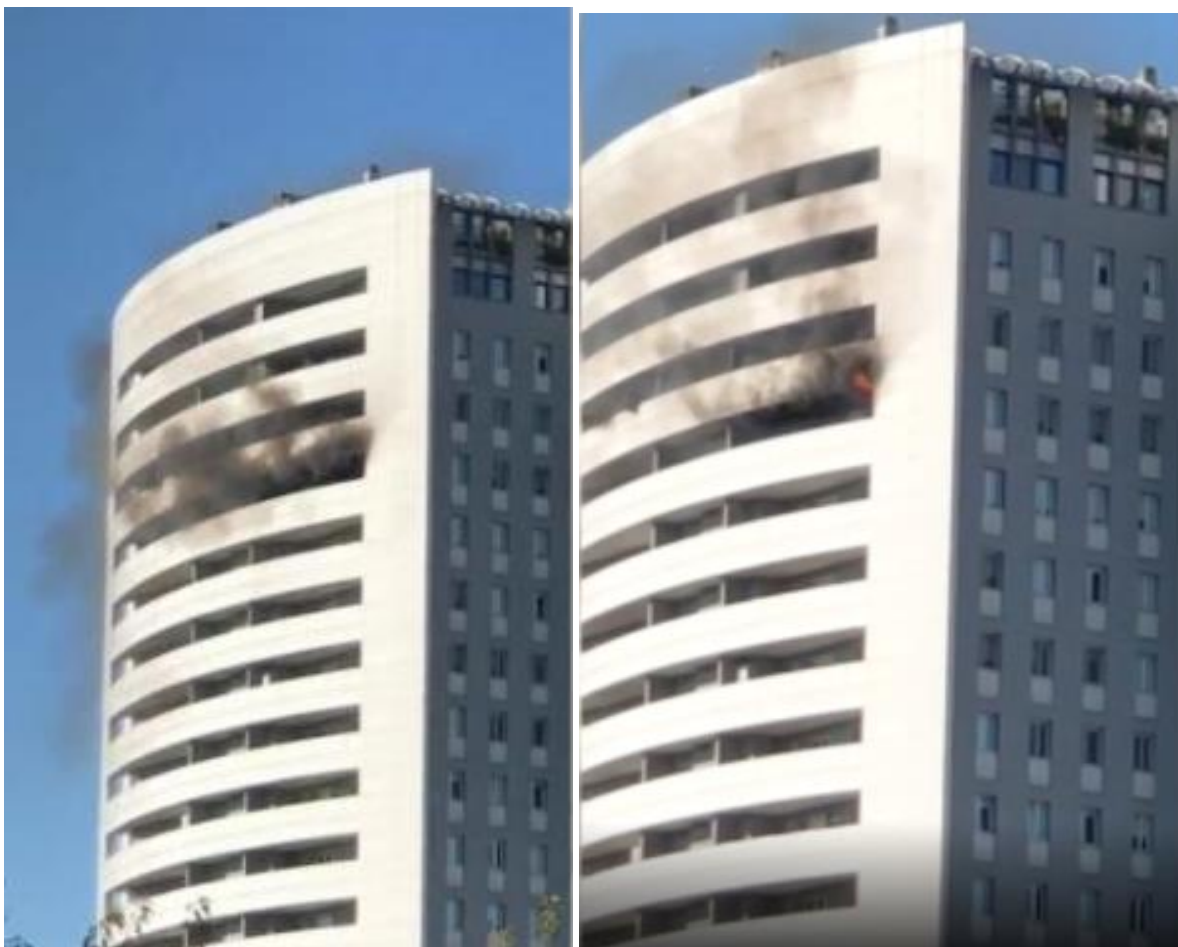
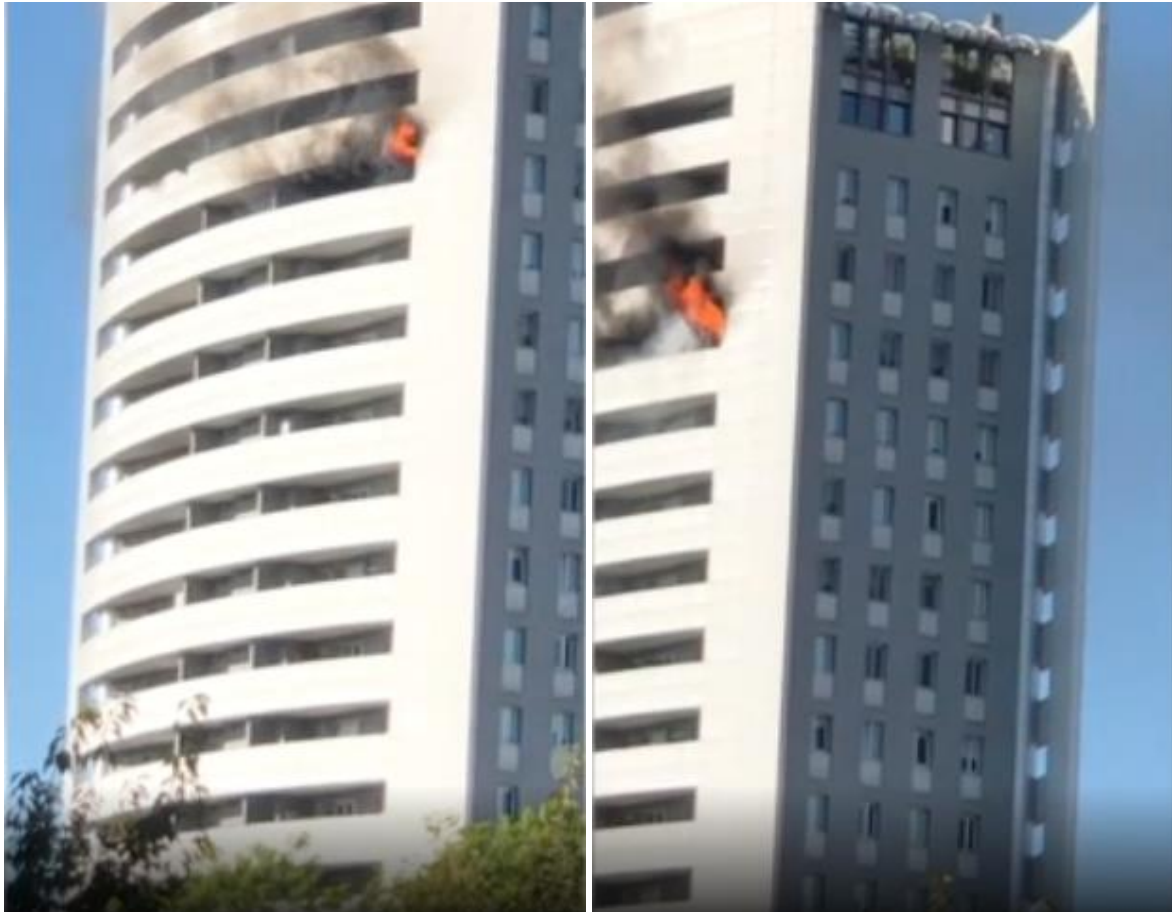
Figure 17: These four photos show the initial stages of the fire’s development, from wisps of black smoke in Photo 1, to a small flame in the top corner in Photo 2, to a larger flame in Photo 3 and finally an established fire in Photo 4, which is venting through the balcony opening and impinging on the cladding above.

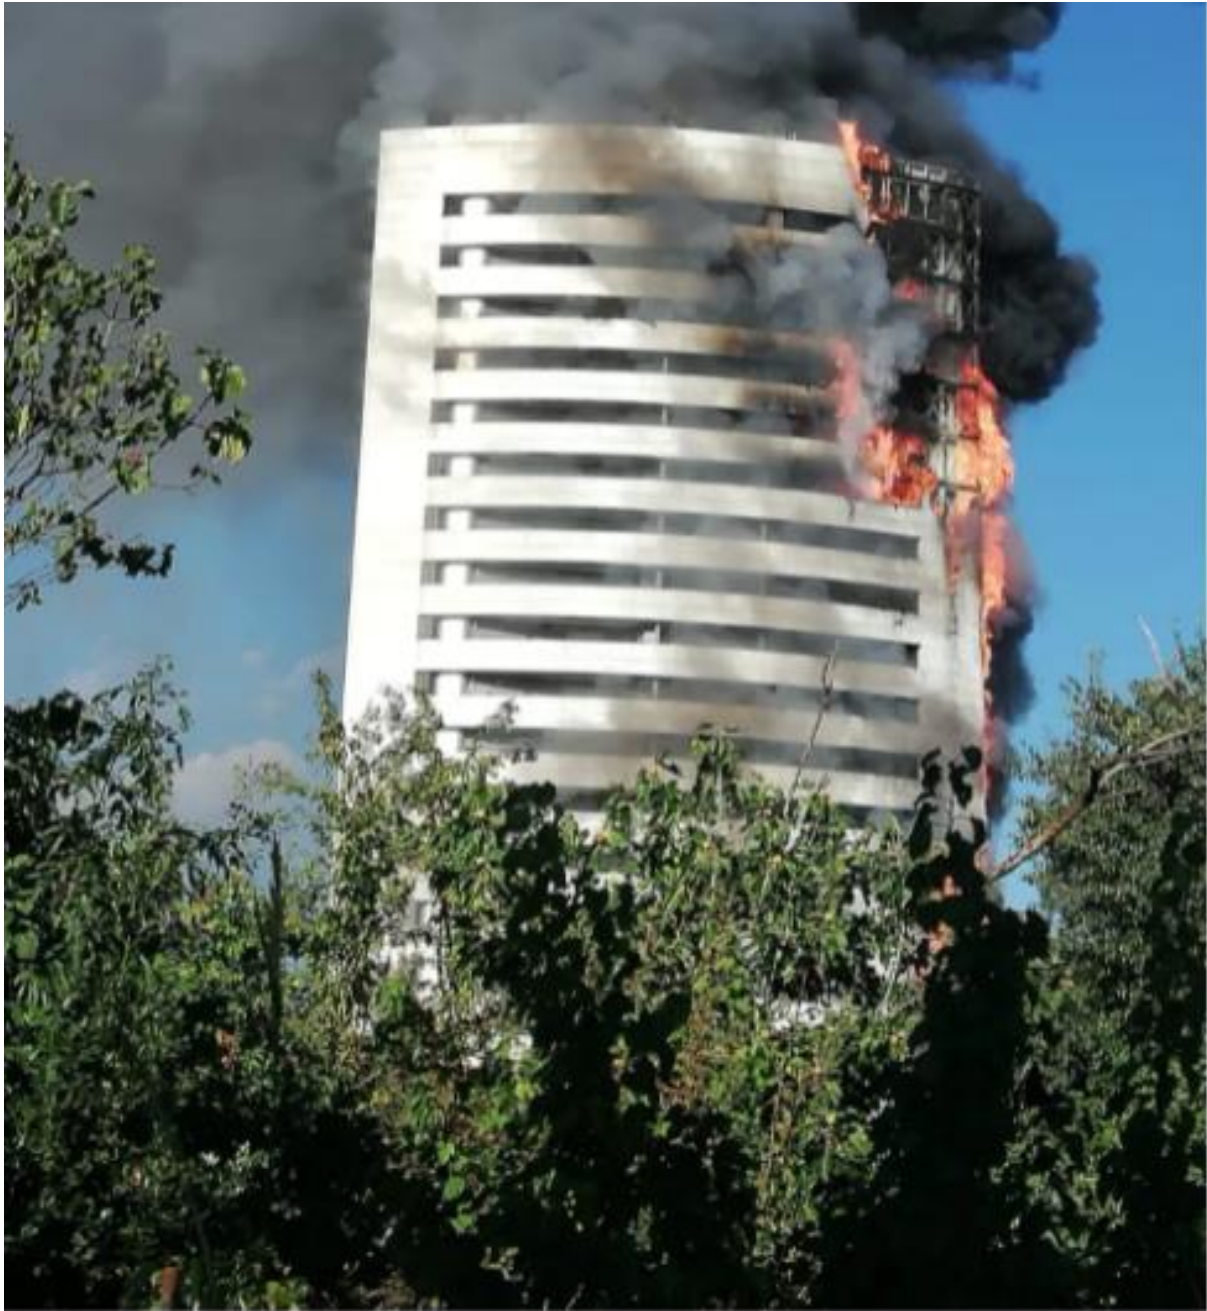
Figure 18: The fire is now well developed and has destroyed the cladding on the top right corner of the sail. It has spread upwards, downwards and horizontally from the flat where it started. It is now affecting the combustible material at the top of the sail, around the edge of the roof.

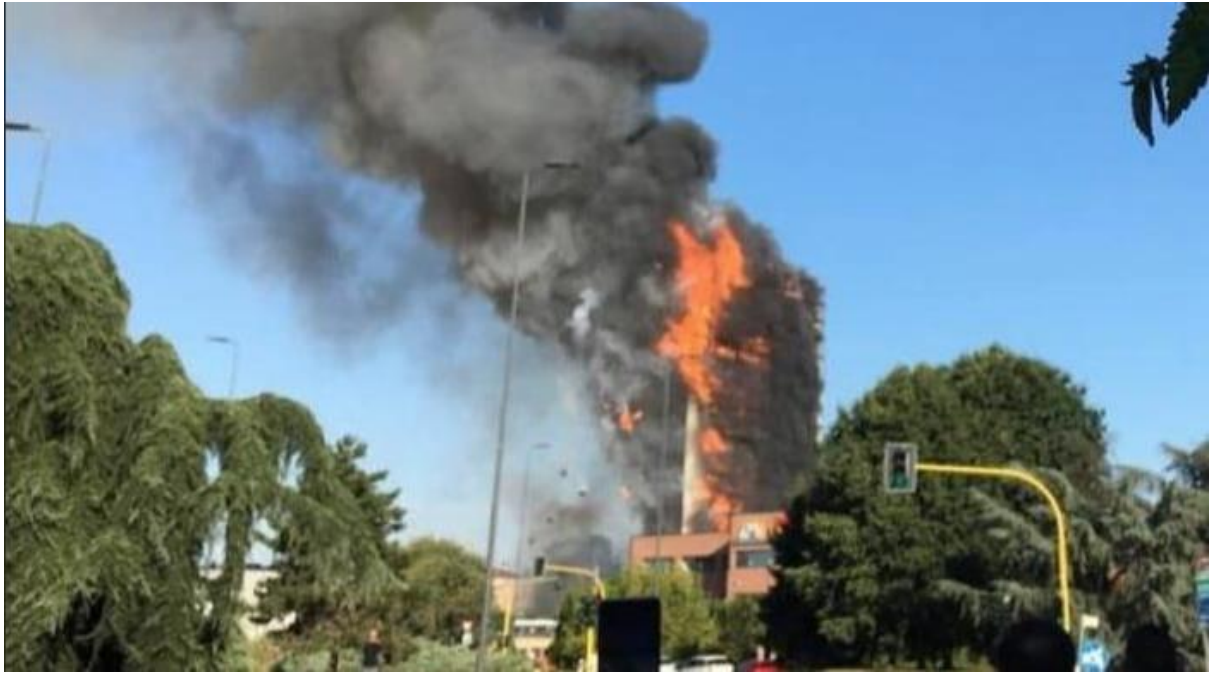
Figure 19 (top photo, p.22): The fire has now swept its way across the tower with fierce flaming at the opposite end of the sail to that where it started. There appears to be a strong wind which is blowing in the same direction as that in which the fire is spreading. However, although in this case the wind may be helping the fire to spread faster, examination of previous fires has shown that geometry is of greater importance, and a fire will even spread into an oncoming wind (ie. A wind blowing in the opposite direction to that in which it is travelling) if the profile and features are such that they promote fire spread.

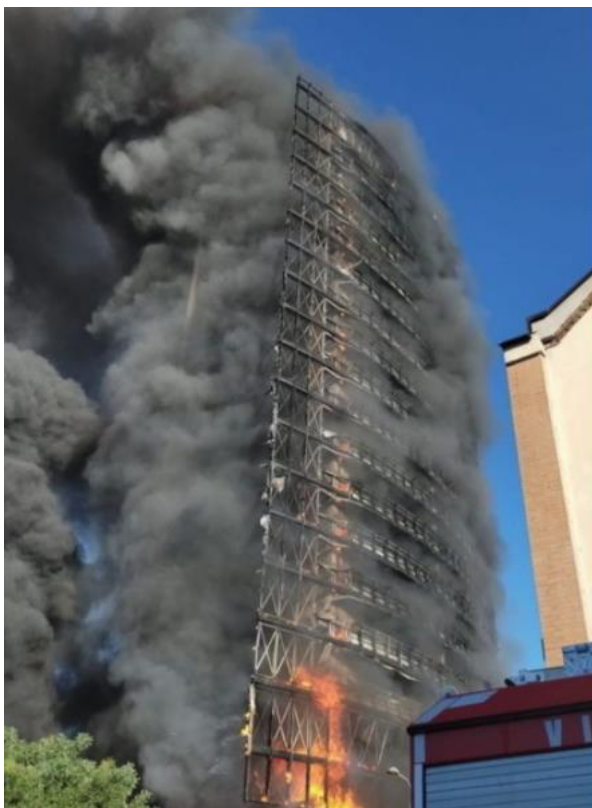
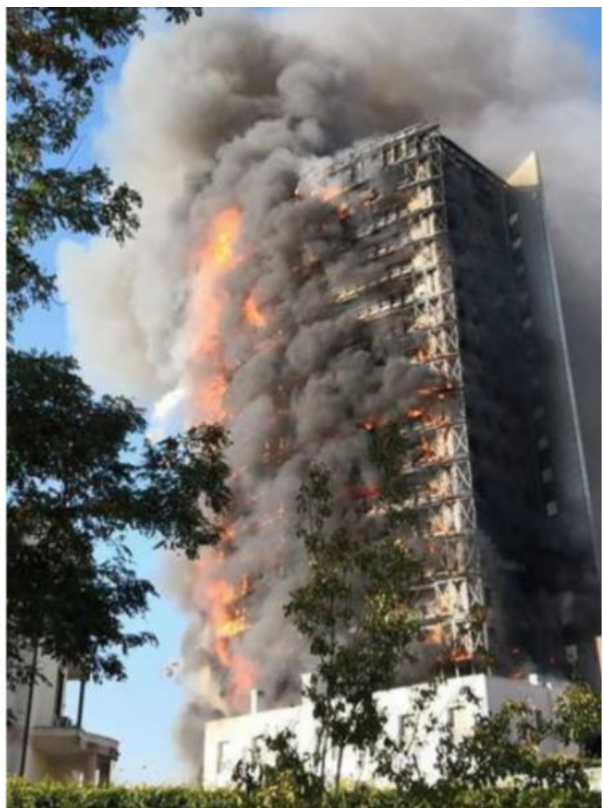
Figure 20: Most of the cladding has now been destroyed and the fire on the sail has burned itself out. However, the structural column (which extends behind the sail) continues to burn (left photo) and the interior of the flats (which the fire entered from the outside) are still alight.

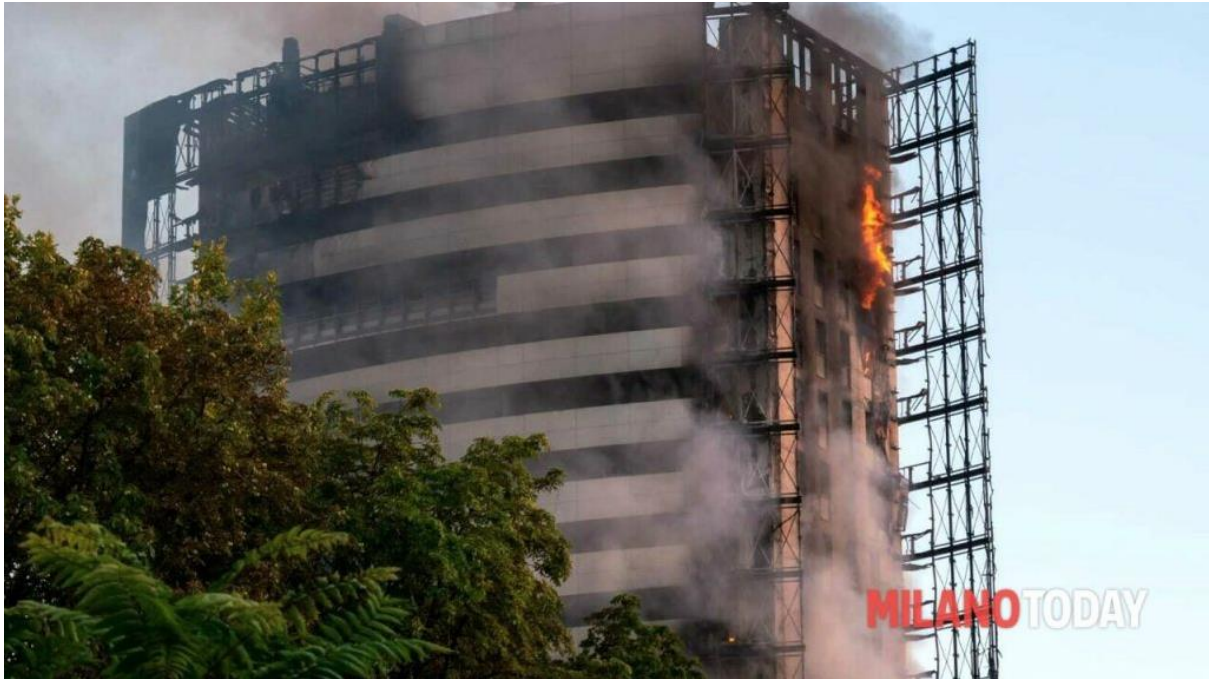
Figure 21: The tower viewed from the other side; the opposite one to where the fire started. The fire has spread around both ends of the building to affect both ends of the sail. On the left side there is evidence of horizontal fire spread along the balcony walls. There is also evidence of extensive fire spread via the perimeter of the roof.

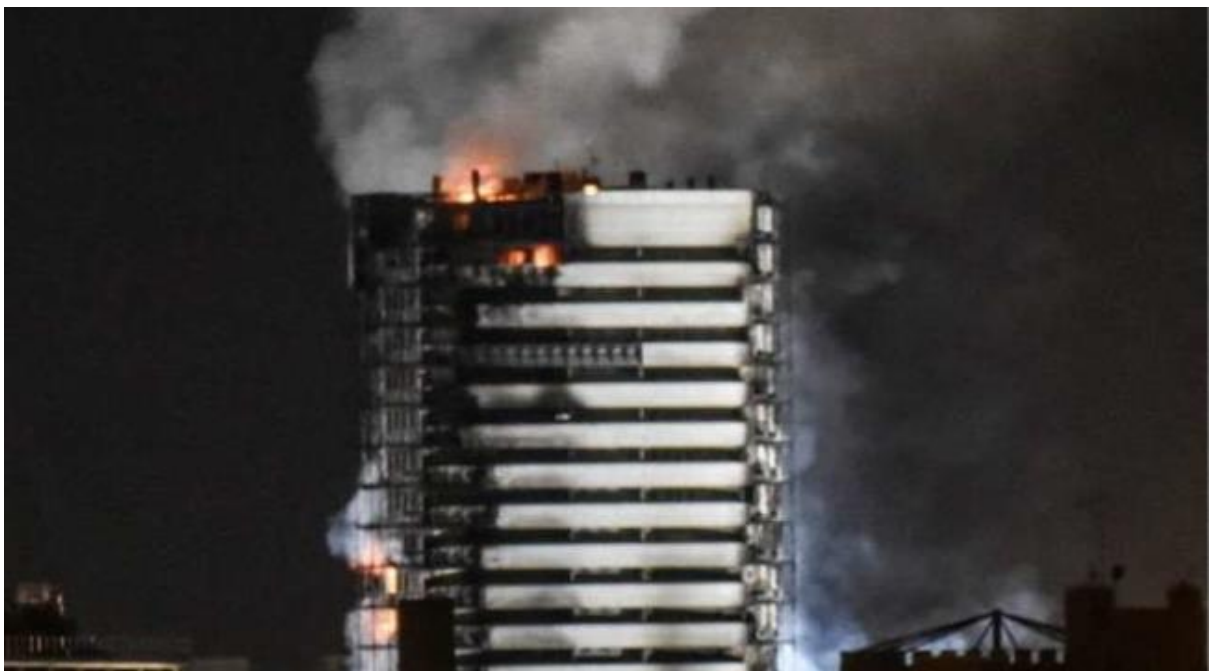
Figure 22: The same side is viewed again from a different angle, where flaming can be seen at roof level against the darkened sky.

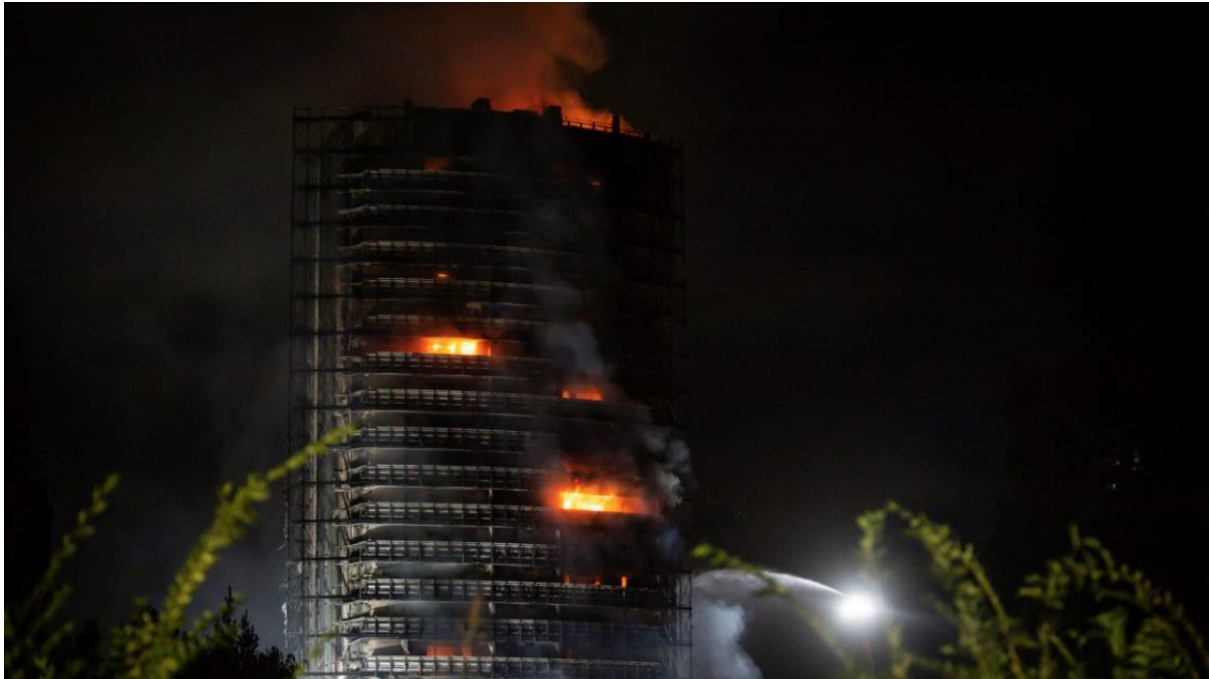
Figure 23: A night-time view of the side where the fire started showing that the interior of flats remain alight and there is still substantial flaming at roof level.
