# Intelliclad Responds to Apartment Block Fire

## Case Study

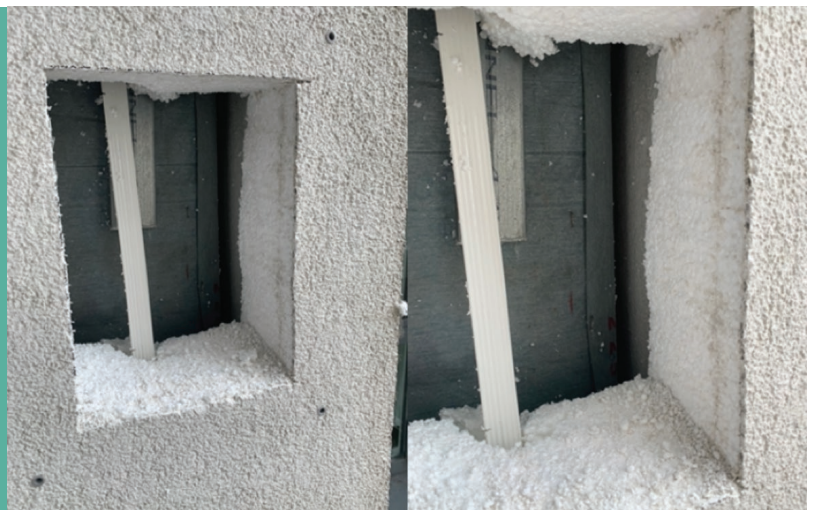
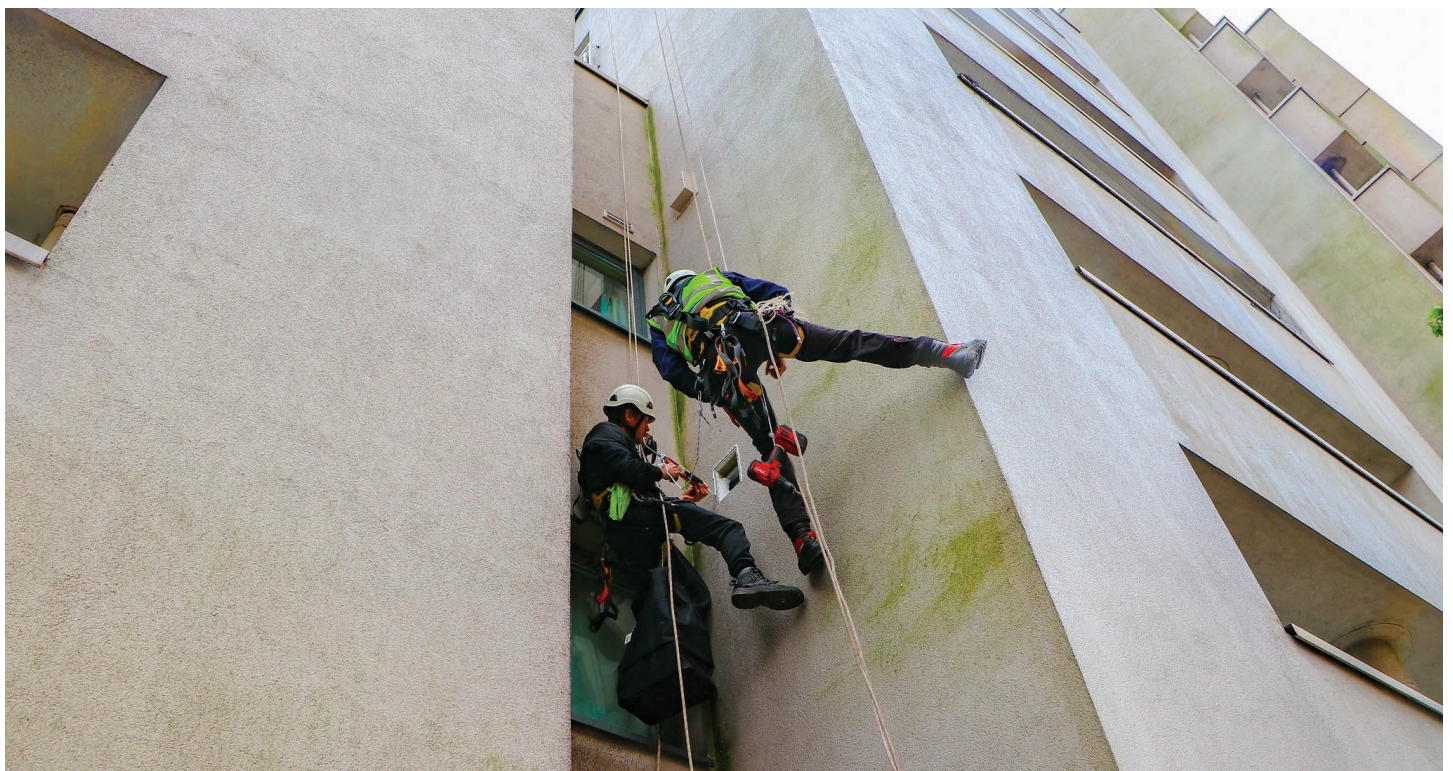
## Photo 1

The building concerned possesses several factors which increase the risk to residents if the façade should catch fire. Firstly, the entire eight-storey building is completely covered in an insulated render system which contains expanded polystyrene or EPS, shown in **Photo 1**. EPS has a Euroclass rating of “E” which has a high contribution to fire.

A hole was cut in the insulated render to allow the Intelliclad sensor to be inserted. This revealed a thick layer of EPS with a gap behind through which air can be drawn and fire can spread. EPS is highly combustible and emits toxic fumes as it burns.

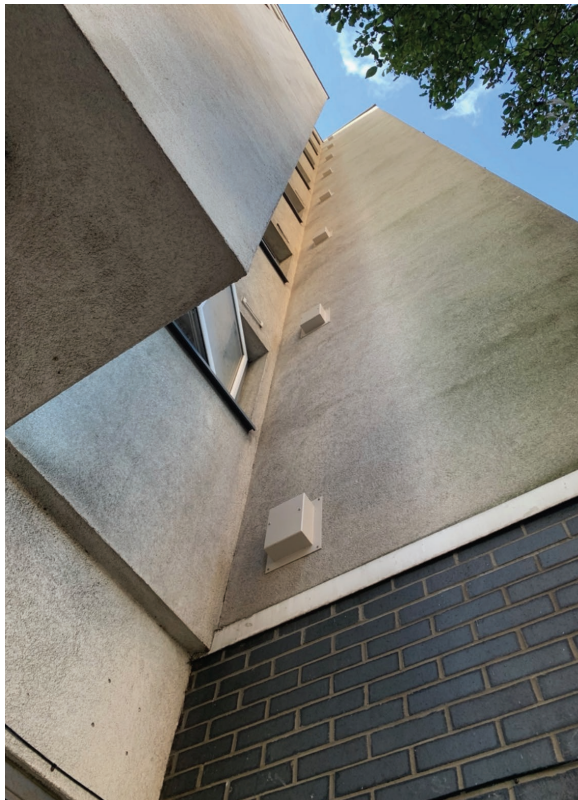
### Photo 2

Secondly, the bin store is located within a deep recess (see **Photo 2**), inside which there are windows. These windows are not in communal areas, but the flats themselves. Therefore, any fire which occurs, will spread rapidly up the recess, causing the glazing to fail and allowing the flames and toxic smoke to enter the flats.

The deep recess contains windows from flats on that side of the building. Due to the depth of the recess, conditions are ideal for the Trench Effect to occur; the flames and hot gases would be fully contained within the recess, allowing the heat to build and the intensity of the fire to increase.

The glazing in the windows would readily fail during a fire due to the intense heat, allowing flames and toxic smoke from the EPS to enter the flats, greatly endangering the lives of the occupants. If internal detection only was installed, it would not be until the fire was at this advanced stage that its presence would be detected and residents warned.

Once the fire reaches the top of the trench, the flames are forcefully ejected (at roof-level on a building, and at the top of the escalator at Kings Cross, where flames shot across the ticket hall with intensity). It is for this reason that Intelliclad sensors are strategically placed, having used the principles derived from the research to identify the parts of the building which present the greatest risk. On this particular building, sensors were positioned in the recess as shown in the images, as well as the adjacent balconies.
