# REPORT ON THE FIRE WHICH OCCURRED AT CHINA TELECOM TOWER, CHANGSHA, CHINA ON 16 SEPTEMBER 2022

**By Frances Maria Peacock**

*September 2022*

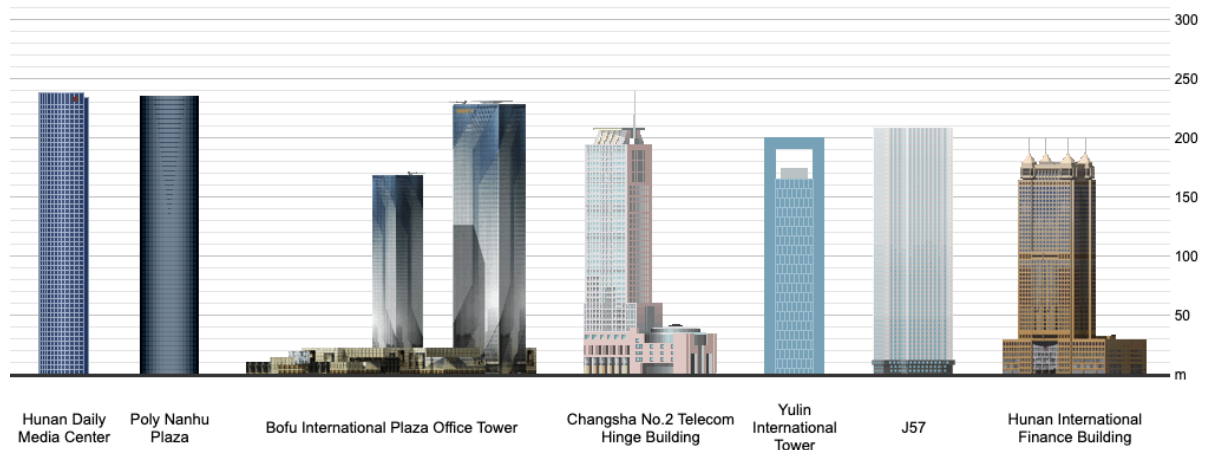
**Figure 1:** The Changsha No.2 Telecom Hinge Building set in the context of other high-rises in the city. The lowest is the Hunan International Finance Building on the left. *Drawing: The Skyscraper Page*

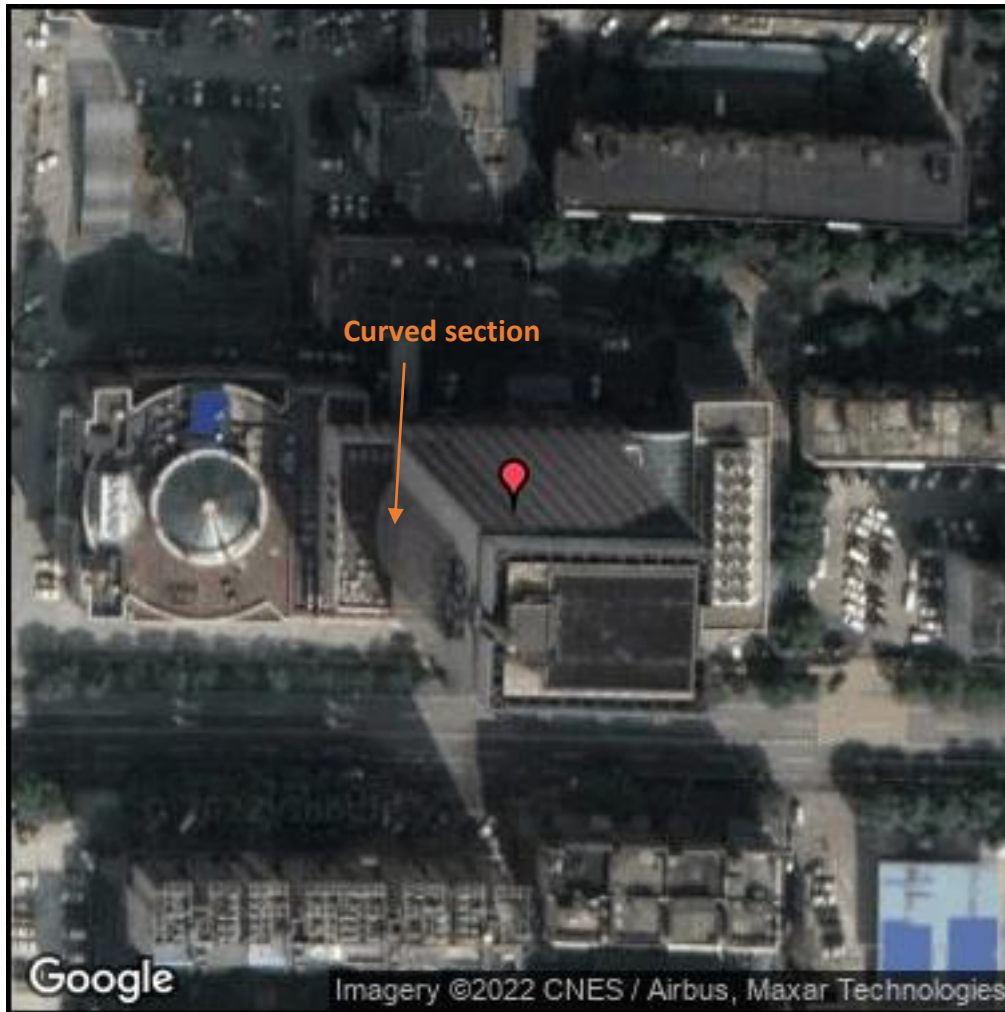
**Figure 2:** A Google image showing the tower from above and giving a good view of its geometric profile which had a profound influence on the way in which the fire spread and behaved. Of particular note is the curved section on the front elevation of the building which forms a vertex at the points where it joins with the main building face.
