An Analysis of the Design, Installation & Materials of the Rainscreen Cladding System at Grenfell Tower

An Insight into what went wrong

Frances Maria Peacock

September 2020

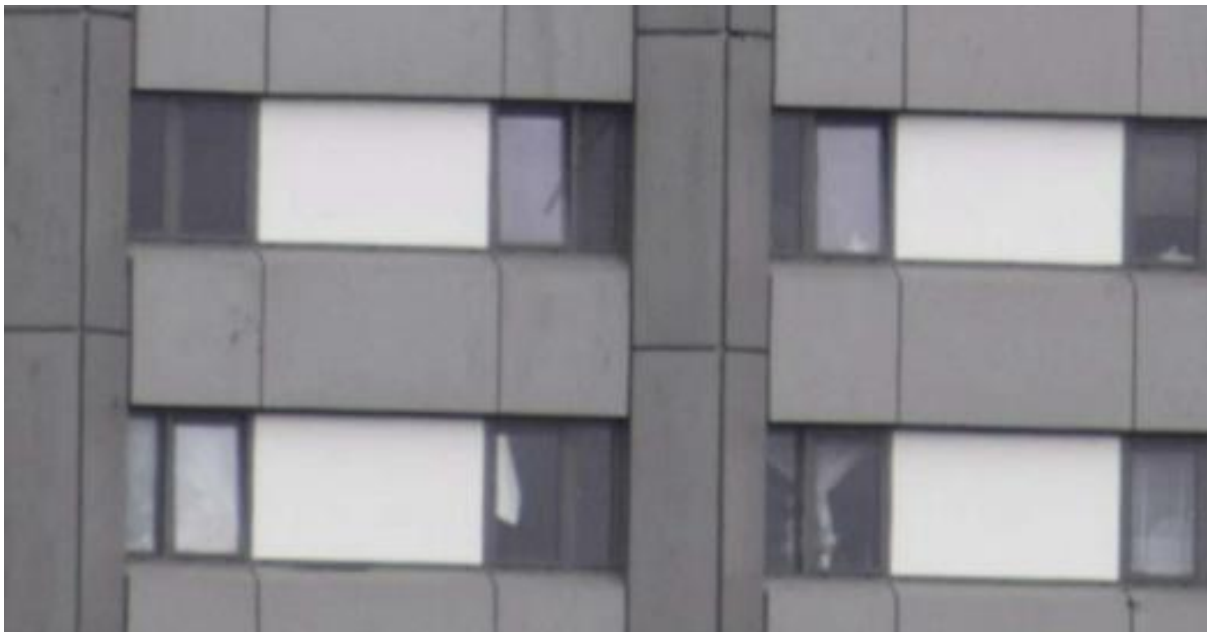
when they were opened inwards. The design of the windows meant that they could be tilted inwards along their bottom edge (*Photo 5*), or the entire casement could be opened inwards along its side by releasing a catch (*Photo 6*) – hence the term “turn.” Interestingly, he seems to make no mention of thermal benefits in changing the position of the windows.

Photo 5: A close-up view of Grenfell Tower showing windows which have been opened using the “tilt” option. They are tilted inwards along their bottom edge.

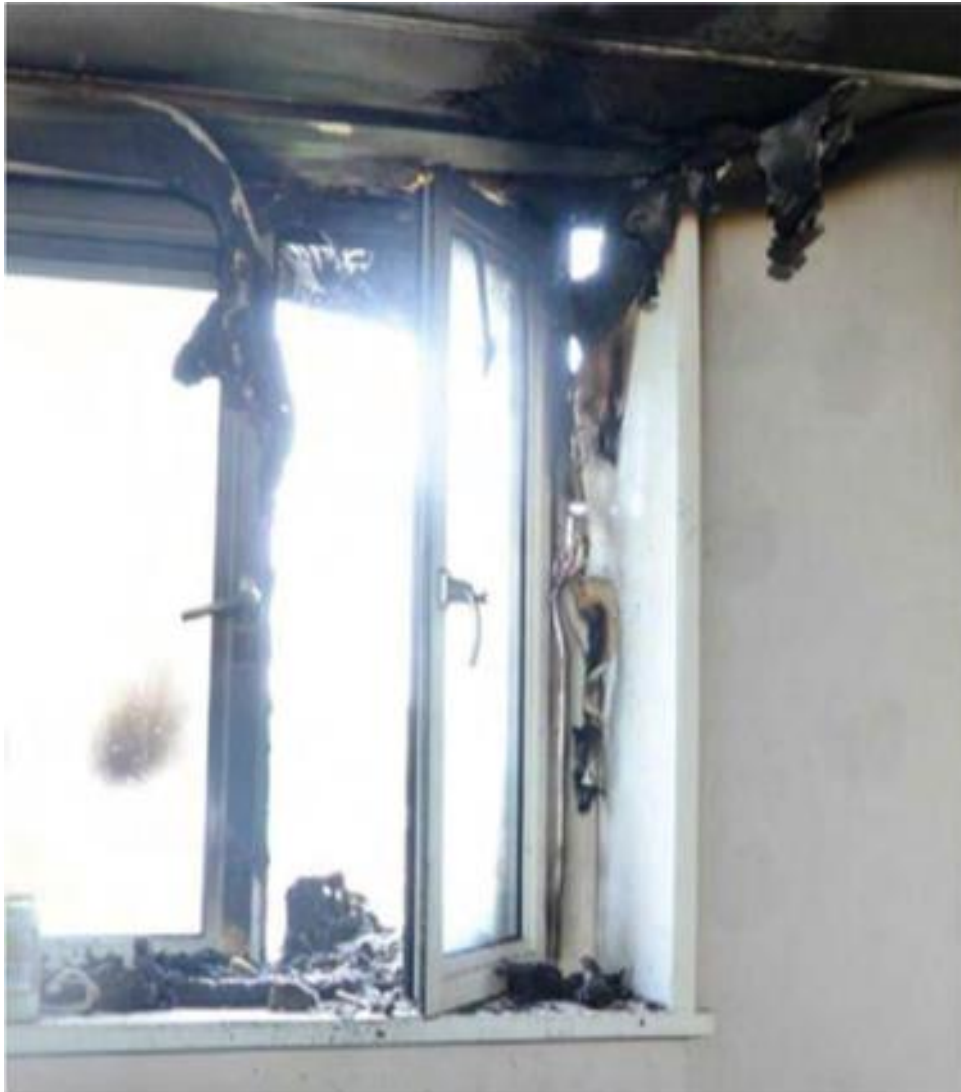
Photo 6: A fire damaged window viewed from the inside which has been opened using the “turn” option to disengage the tilt mechanism and allow it to be fully opened as a side-hinged casement.

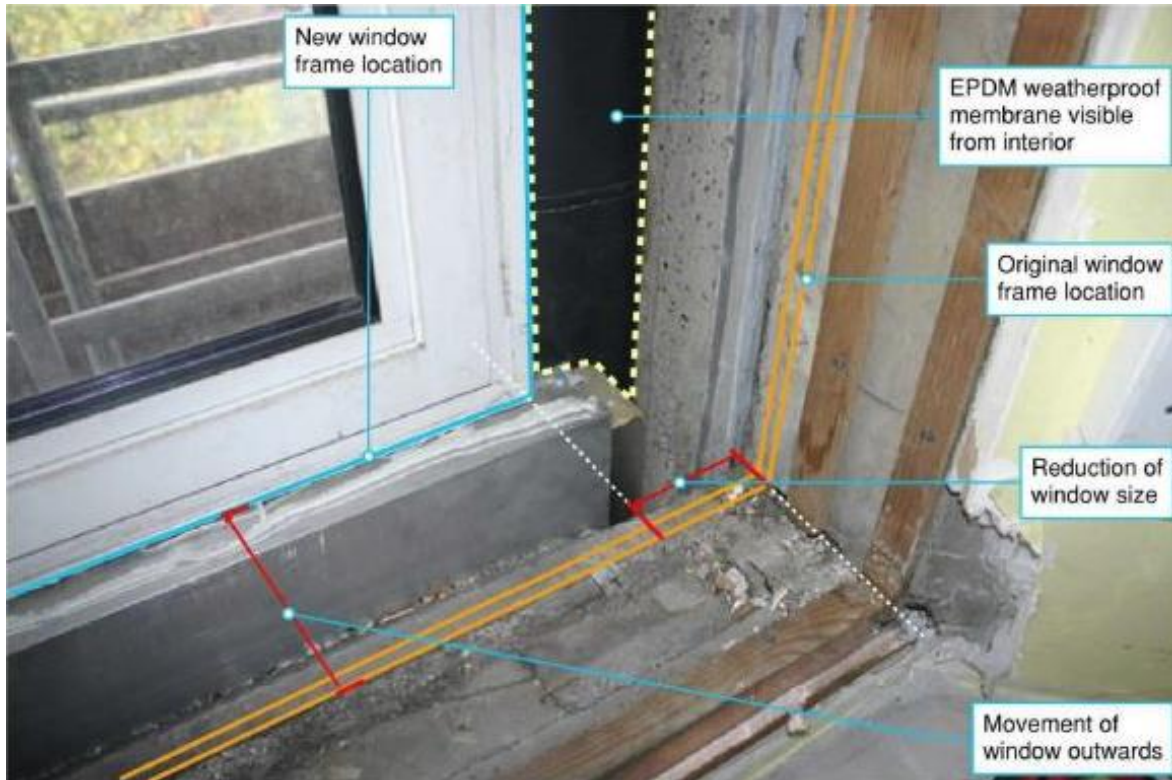
Photo 8: An image from Dr Barbara Lane’s Supplementary Report showing the new position of the window in relation to the original.

4.2 The drawings support the assertion in *Paragraph 3.11* above, that the intention of Studio E as part of their design for the refurbishment, was for the windows to be moved out into the thermal envelope of the building (*Diagrams 6 & 7*). The position here of the window centre line is estimated as being approximately 75mm forward of the existing openings (to give a window reveal of 250mm) which is much less than the 185mm (window reveal 360mm) it later became after the design was changed (*Diagram 5 and Photo 8*). The original window reveal – from when the Tower was built – was 195mm in depth.

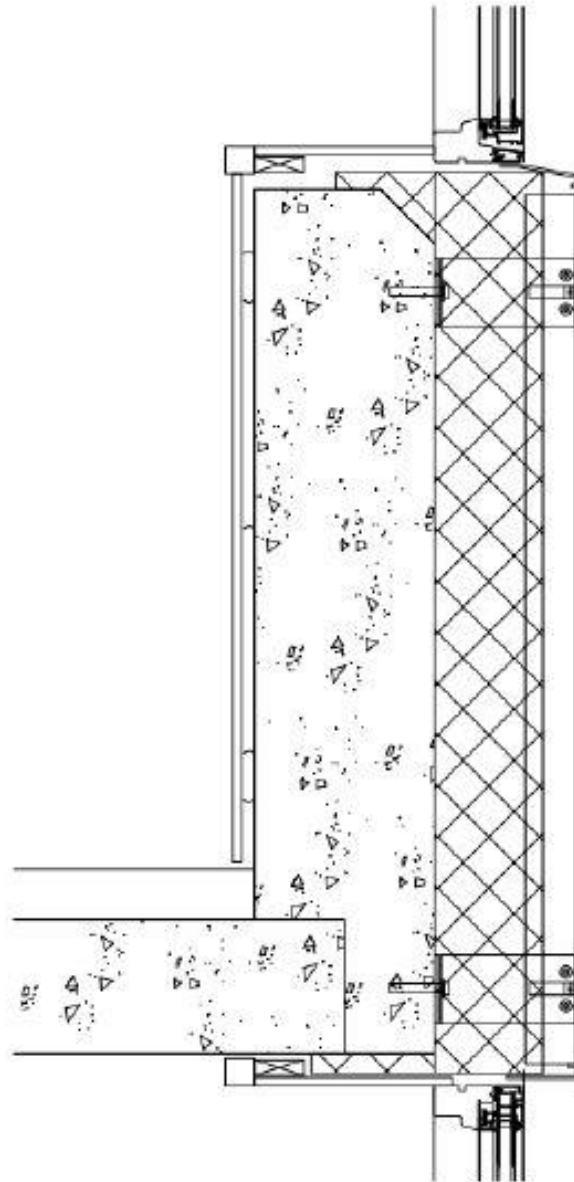
Diagram 7 (p.25): This drawing is a vertical section through a spandrel panel which shows the construction of the cladding system, as well as details at the head of the window and the cill. No fire protection is shown in either of these locations, where there are small gaps to allow the system to ventilate. Without adequate fire protection, the flames can gain easy access to the interior of the cladding system.

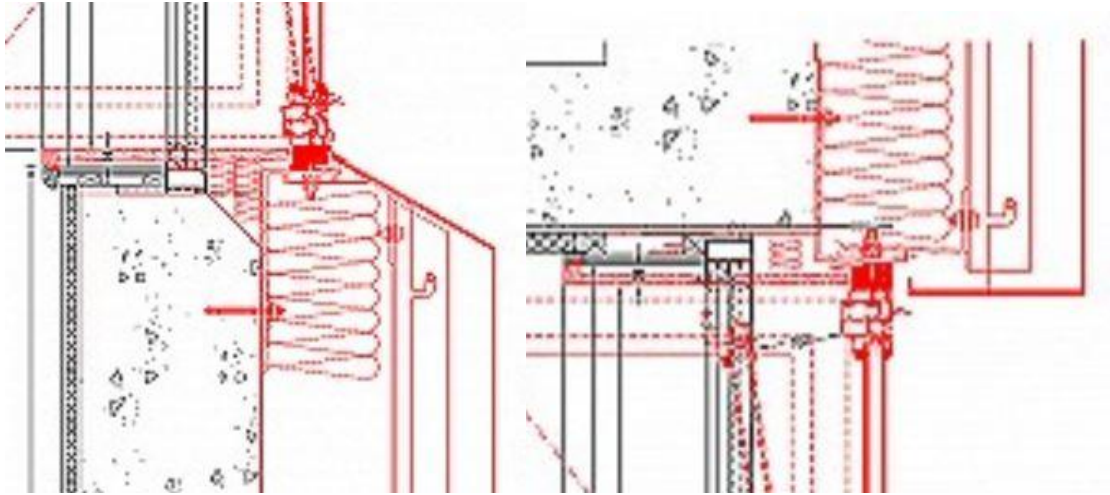
4.3 Around the same time that the specification of the materials was changed, the type of façade system was also changed to a hook-on system (*Diagrams 8 & 9*). This too lacked adequate fire protection, and as with the earlier drawings, no fire protection is shown. Cavity barriers were not designed into the system at the outset and were added retrospectively to the scheme. The reasons for the change of system type appear to be mainly aesthetic. As the panels are fixed internally, a smooth look could be created by avoiding the use of fixings such as screws and rivets which would be visible from the outside. The hooked attachments would also secure the panels much better than other invisible fixing methods such as adhesive. Panels fixed with adhesive will detach and drop off under certain conditions, including during a fire.

Diagram 8: Two extracts from a draft drawing by Studio E Architects dated 2014 showing details of the cladding system; the one on the left shows the details at cill level, whereas that on the right shows the details above the window head. It is much bulkier than the previous design and the carrier rails are shown with hook attachments for the panels.

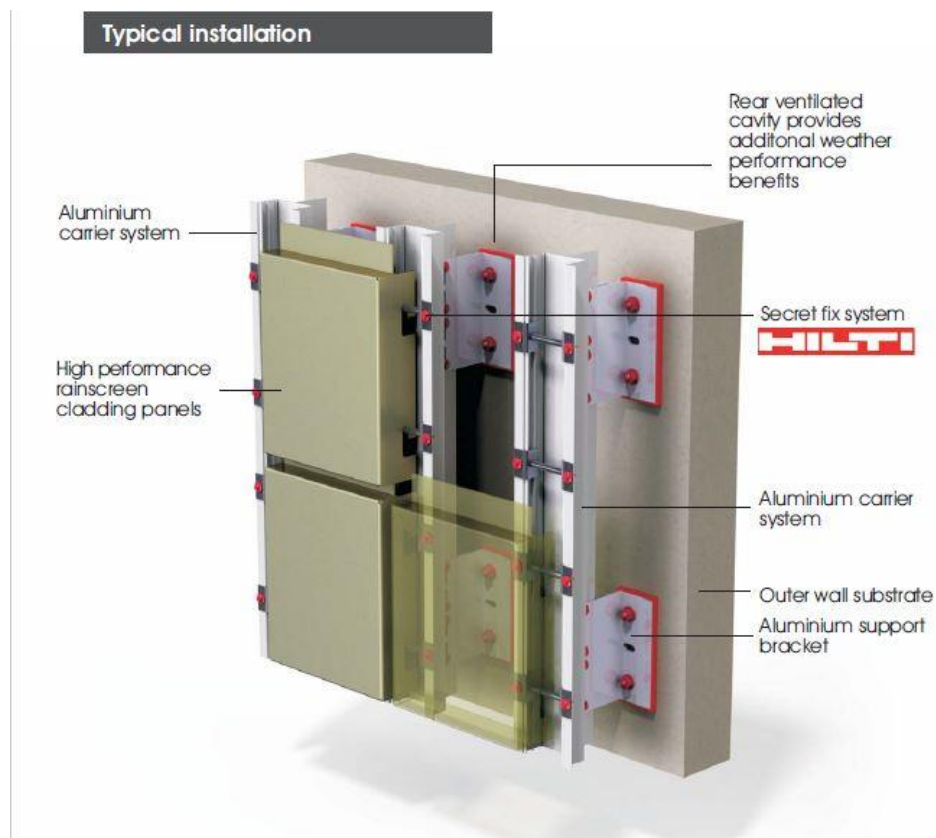
Diagram 9: 3D image showing the typical arrangement inside a hook-on façade system; the carrier rails are attached to brackets fixed to the wall, and the rainscreen panels are hooked directly onto bolts between the two arms of the U-shaped rails. No insulation is shown in this image, but this is for clarity because insulation - if shown - it would obscure the bracket details.

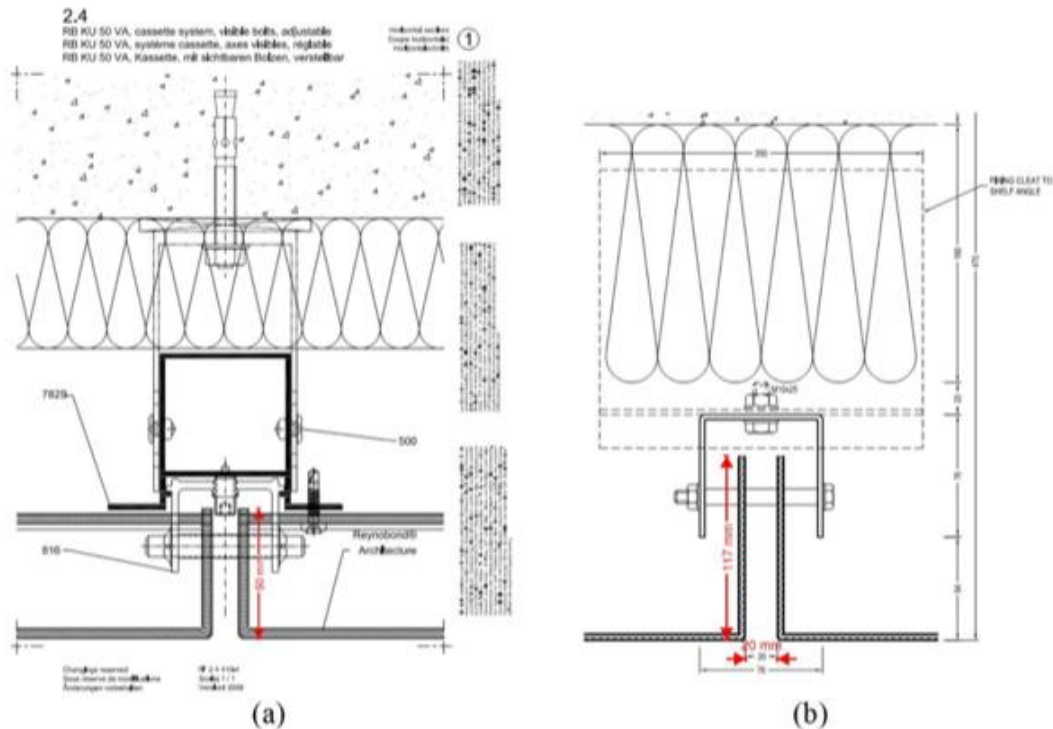
Figure 8.62 (a) Arconic Standard detail for KU50 (50mm return of ACP panel) (b) Depth of return of Grenfell Cladding panel (measured from C1059-305 Rev D [HAR00008903])

Diagram 10: A horizontal section through two different hook-on façade systems. The one on the left is a standard Arconic system of this type with the ACM panels configured in such way that they can be secured internally with screw fixings. The one on the right is what was installed at Grenfell Tower, with the panels configured in such a way that they cannot be secured with internal fixings, and rely on the hook-on method only. *Source: Dr Barbara Lane’s Supplementary Report.*

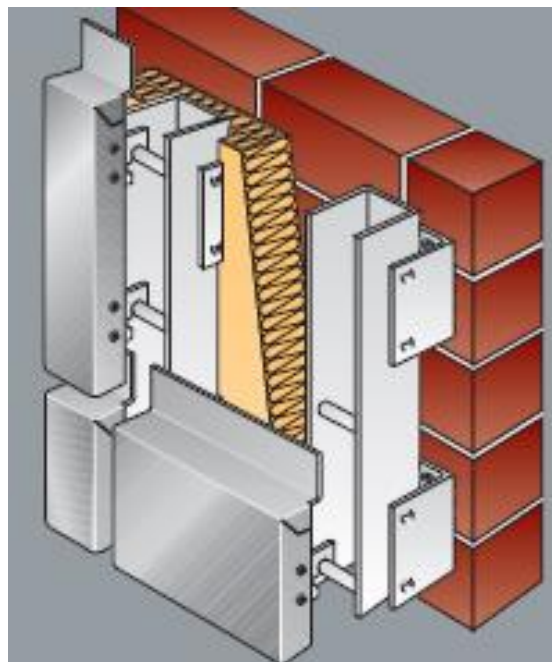
Diagram 11: The arrangement of rails, fixings, panels and insulation which make up the hook-in rainscreen façade system as seen here; the U-shaped carrier rails are set back into the insulation, and at the front of the system they touch the rear of the lips on cladding panels (which they should sit against tightly with no gaps), thus creating an independent zone between the rails. The space between the lip at the top of one panel and the lip of the one above, enables segmental ventilation.

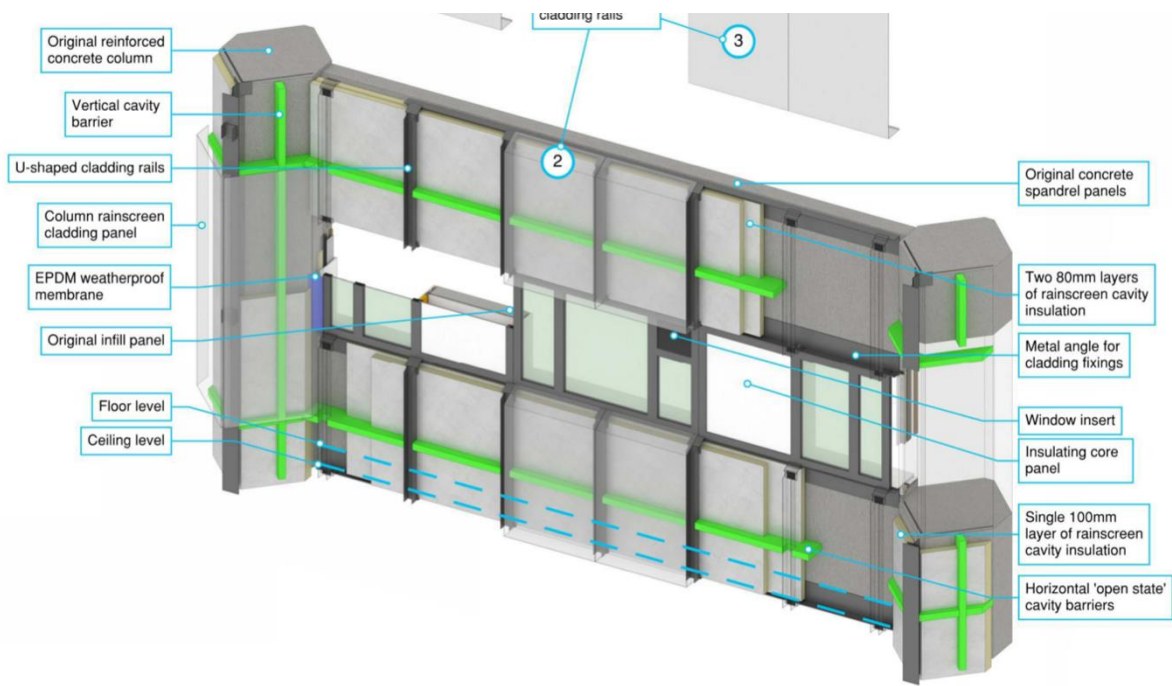
Figure 8.8: Render of external wall construction after completion of the refurbishment works

Diagram 12: Graphic of a spandrel bay at Grenfell Tower with two columns. The ACM panels have been removed to show the interior of the cladding system where cavity barriers are shown in green. The space is interrupted at intervals by the carrier rails to form “boxes” within which a fire could potentially be contained. On the columns some vertical cavity barriers are present, but these seem only to be in places where separation and division of the space cannot be achieved with carrier rails. There are no cavity barriers at the tips of columns because it was probably believed that a fire would never be able to pass the non-combustible metal rail located there. *Diagram: Dr Barbara Lane’s Supplementary Report, Part 8*

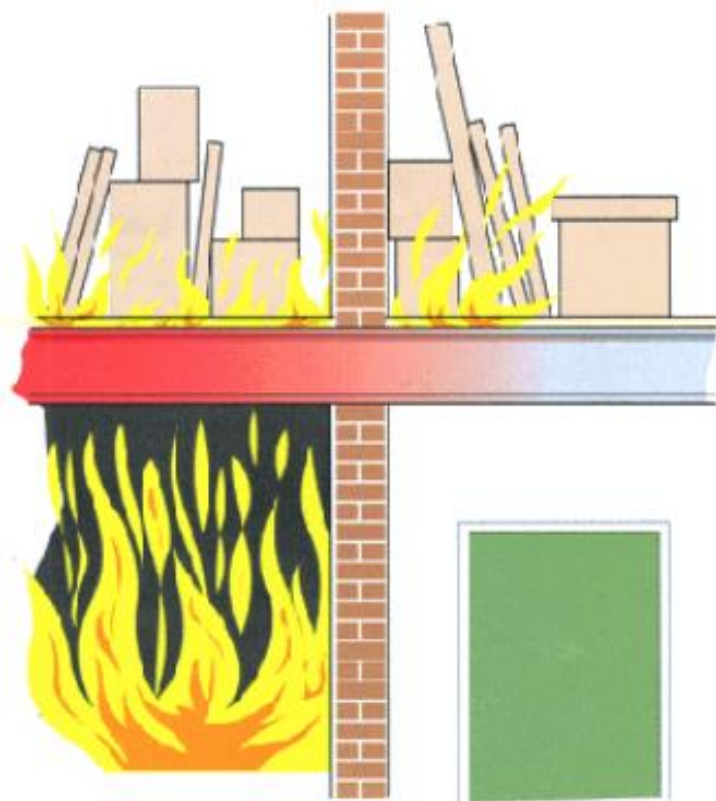
5.3 It is possible that the metal rails within the cladding system helped the fire to spread by conducting heat to other parts of the system not yet affected by the fire. Metal is a good conductor of heat and a metal girder passing through a wall into a neighbouring compartment may conduct sufficient heat to enable the contents of that compartment to ignite, without the fire actually needing to enter the room itself (*Diagram 14*). This is recognised as a particular problem with steel framed industrial buildings. If this scenario is applied to a rainscreen cladding system, heat will be conducted along the rails and this may be sufficient to ignite combustible material ahead of the fire front.

Diagram 14: An image taken from a Firefighters' training manual showing how the conduction of heat along a metal girder can cause the contents in adjacent compartments to ignite without the fire needing to enter these areas.
