REPORT ON THE FIRE WHICH OCCURRED AT MARINA DIAMOND 2, DUBAI, UAE ON 23 OCTOBER 2021

By Frances Maria Peacock

November 2021

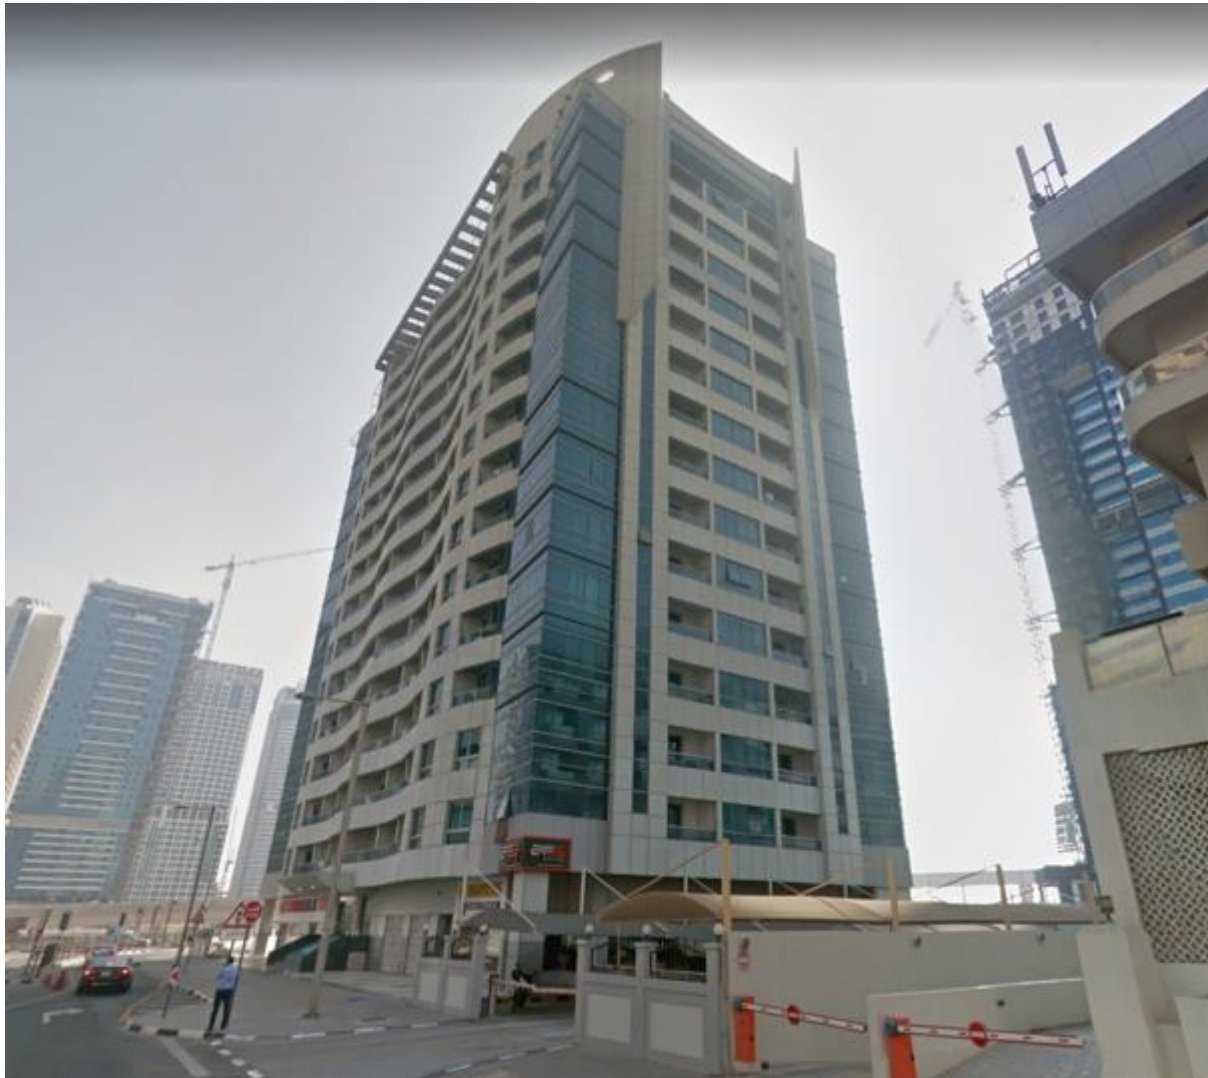
2.3 The building is orientated north-west to south-east. The fire affected a two-bedroomed flat at the north-east end, the floor plan for which is shown in *Figure 5*. The elevation in its undamaged form can be seen on the cover of this report. The two-bedroomed flats – of

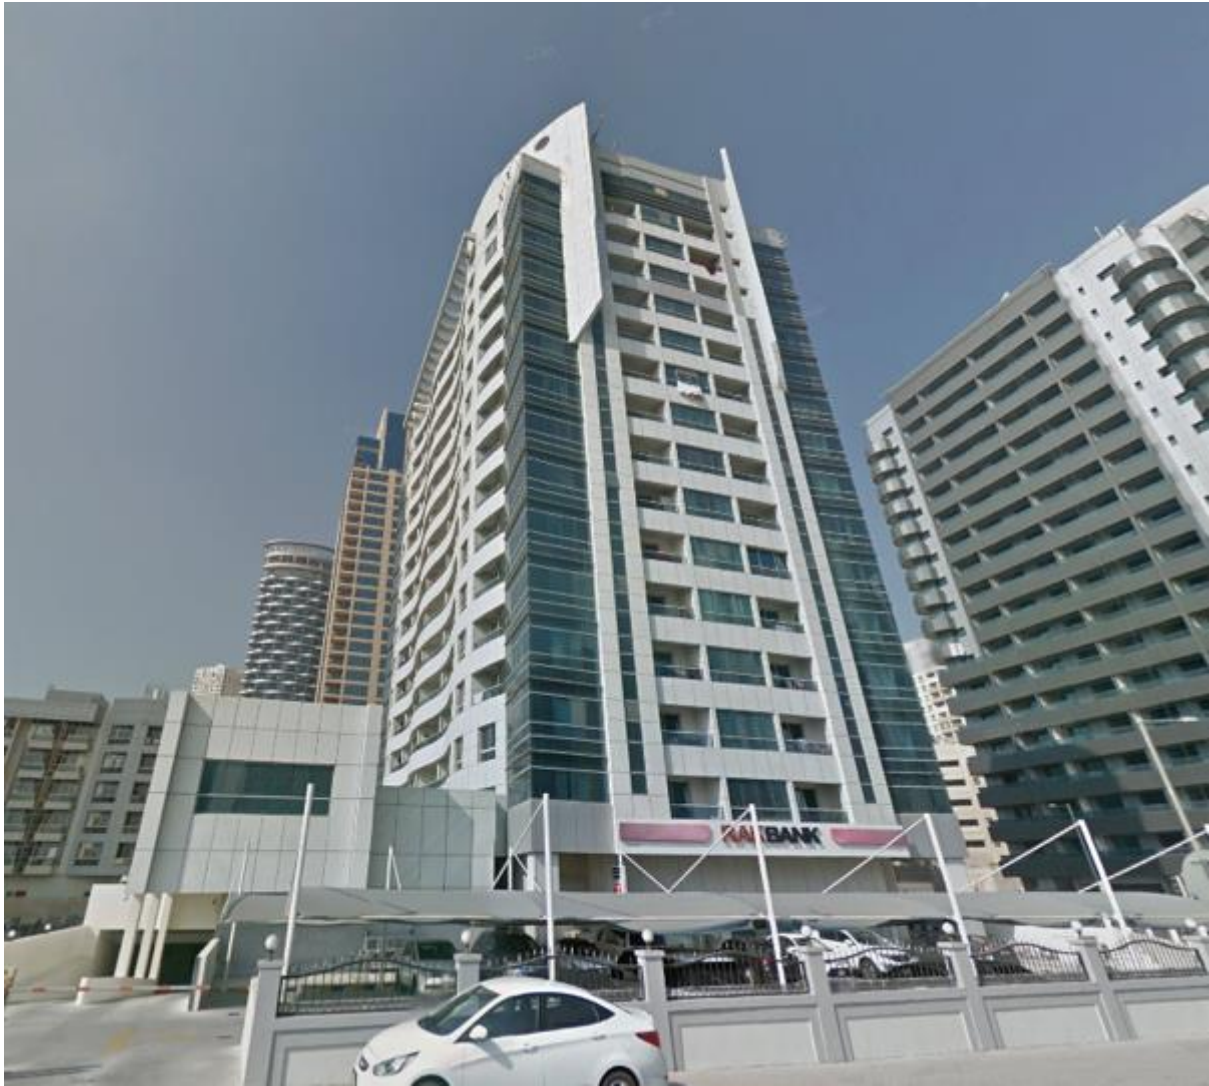
Figure 4: The south-east end of the building showing the fins which project beyond the curved corners from the tenth floor upwards. The fire occurred affected the opposite end of the building which is a mirror image of this one (see cover photo). *Photo: The Author*

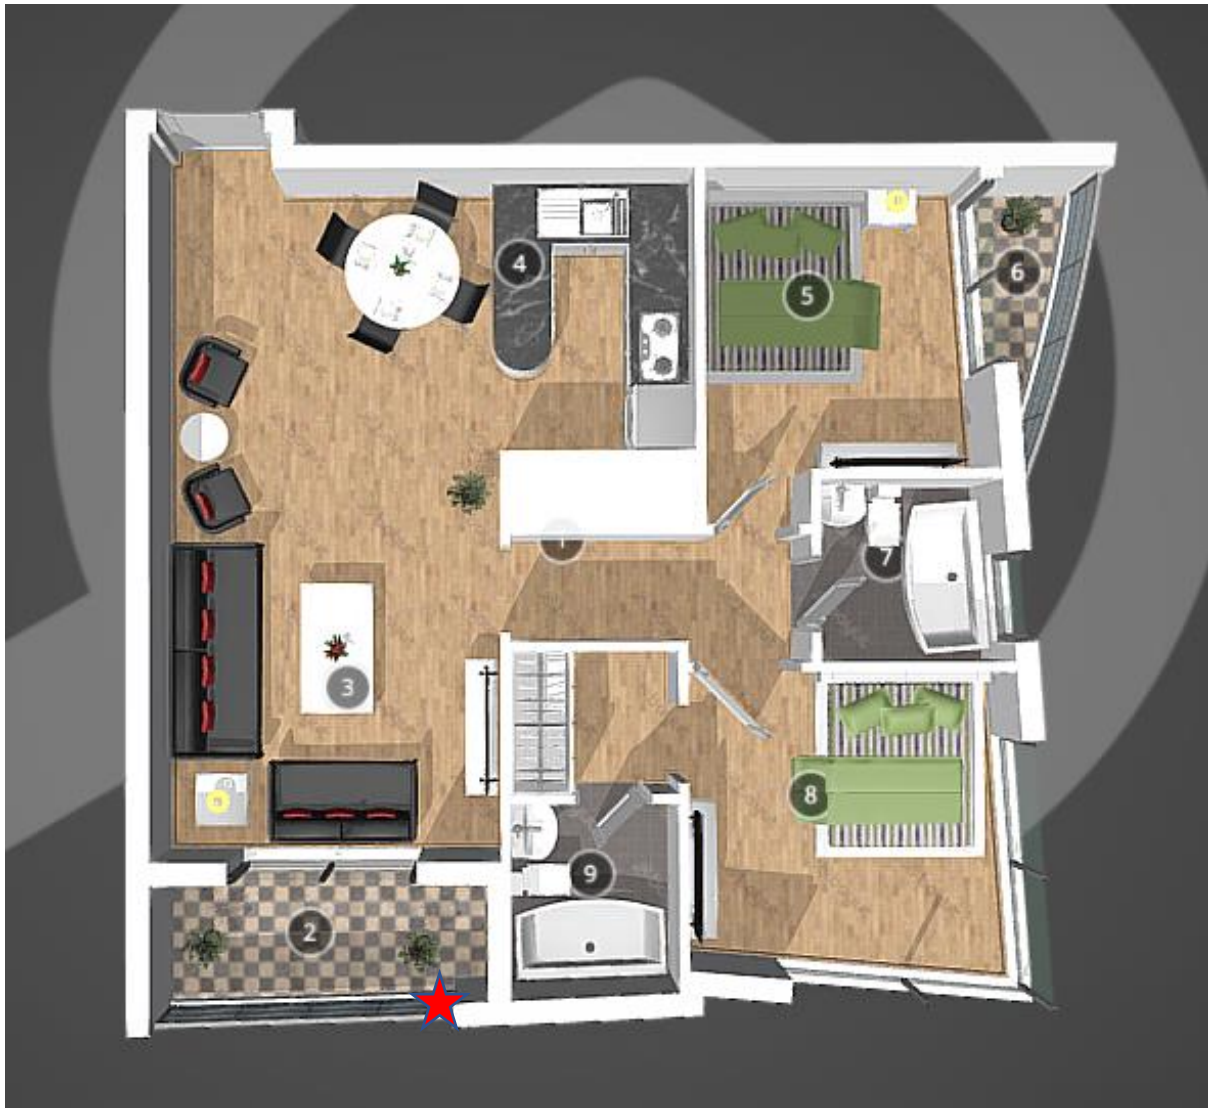
Figure 5: A two-bedroomed corner flat of a type which can be found on floors 3-13. The fire started on the balcony numbered “2” on the plan. The probable point of origin is marked with a red star. *Image: Bayut*

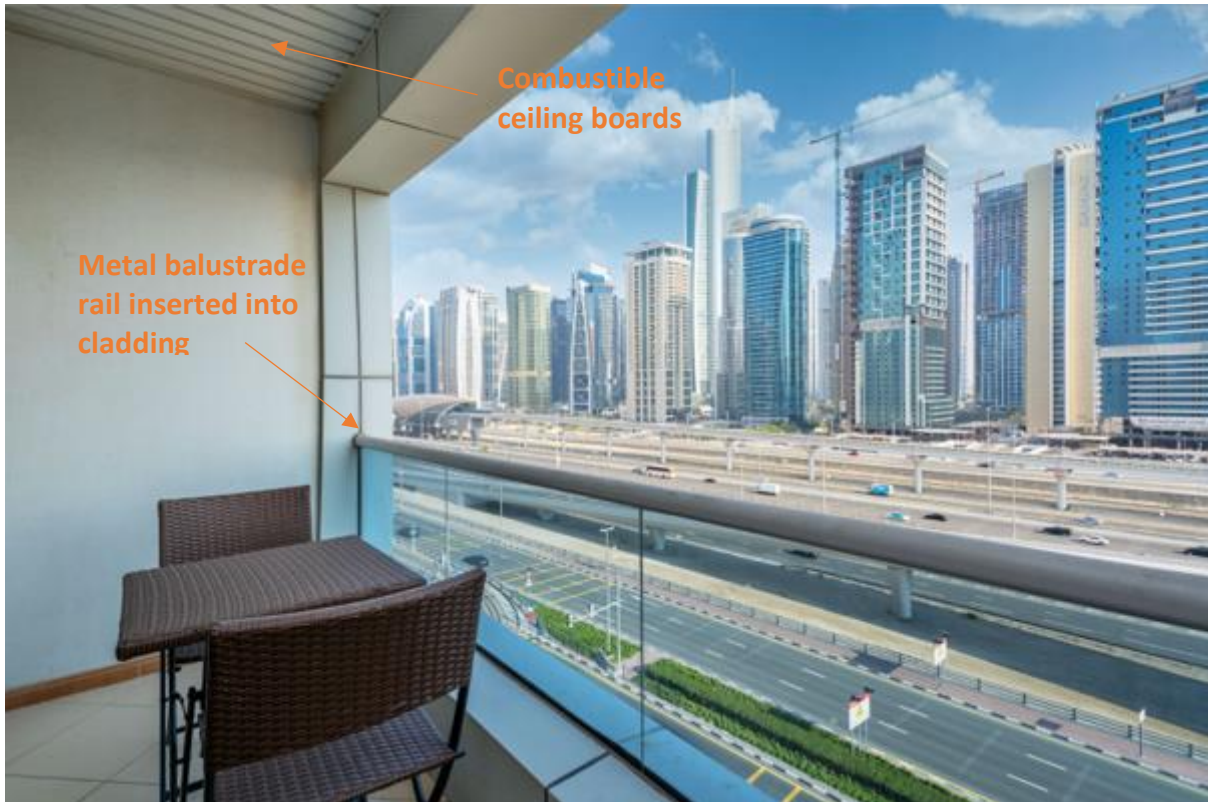
5.9 The balconies have ceramic tiled floors which are not combustible and the side walls appear to be plastered (*Figs.13 & 14*). However, the balcony wall consists of combustible cladding with glass balustrading above. The framework for the glazing is metal, and therefore is not combustible (*Fig.14*). At ceiling level, there is an abundance of combustible material, mainly in the form of synthetic boarding, but also on the short section of wall which extends down into the opening. Like the wall below the balustrading, this too is covered in combustible cladding.

Figure 14: The impressive view from a balcony of a two-bedroomed apartment at the south-east end of the building. This elevation is identical to the one where the fire occurred at the north-west end of the building.

5.10 The fire started in the location shown in Figure 15, where there are multiple locations for it enter the interior of the cladding system. These include panel joints, as well as the point at which the balustrade rail penetrates the cladding system (Fig.14). The location as seen from outside the balcony, is shown in *Figure 16*.

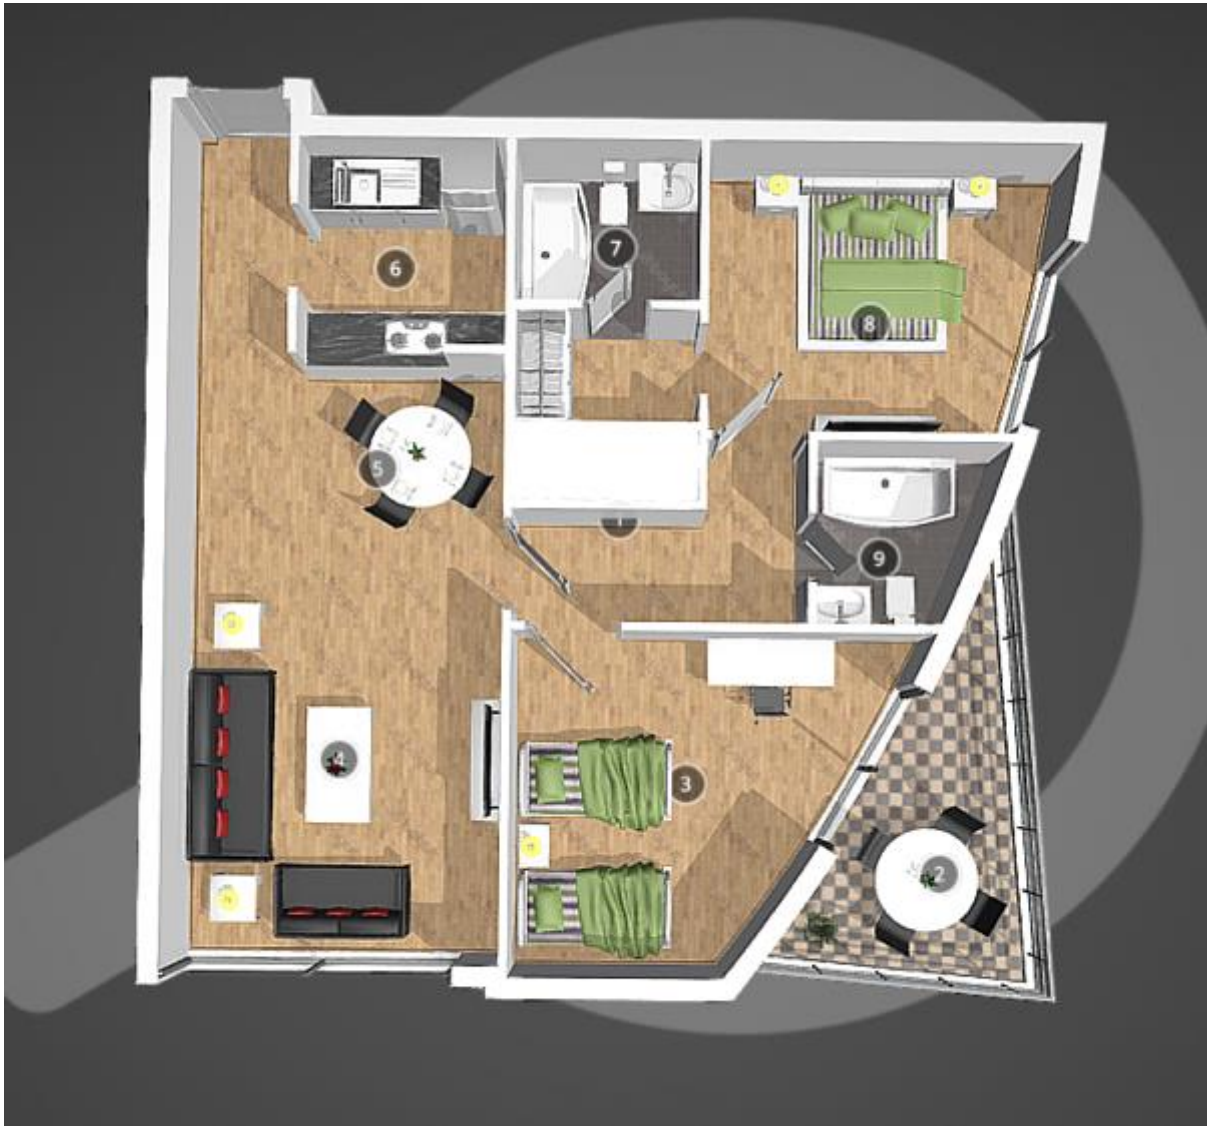
5.16 Although the fire reached the 15th floor, the damage was less because the apartments at this level have no balconies on the elevation affected by the fire. Instead, each has a fully exposed triangular balcony which is located on top the glazed sections at the corners of the building (*Fig..22*).

Figure 22: The plan showing the layout of the flats on the 15th floor, where the outer wall on one side follows the curved profile of the fins. The fully-exposed triangular balcony is at the top of the glazed corner section.
Image: www.bayut.com

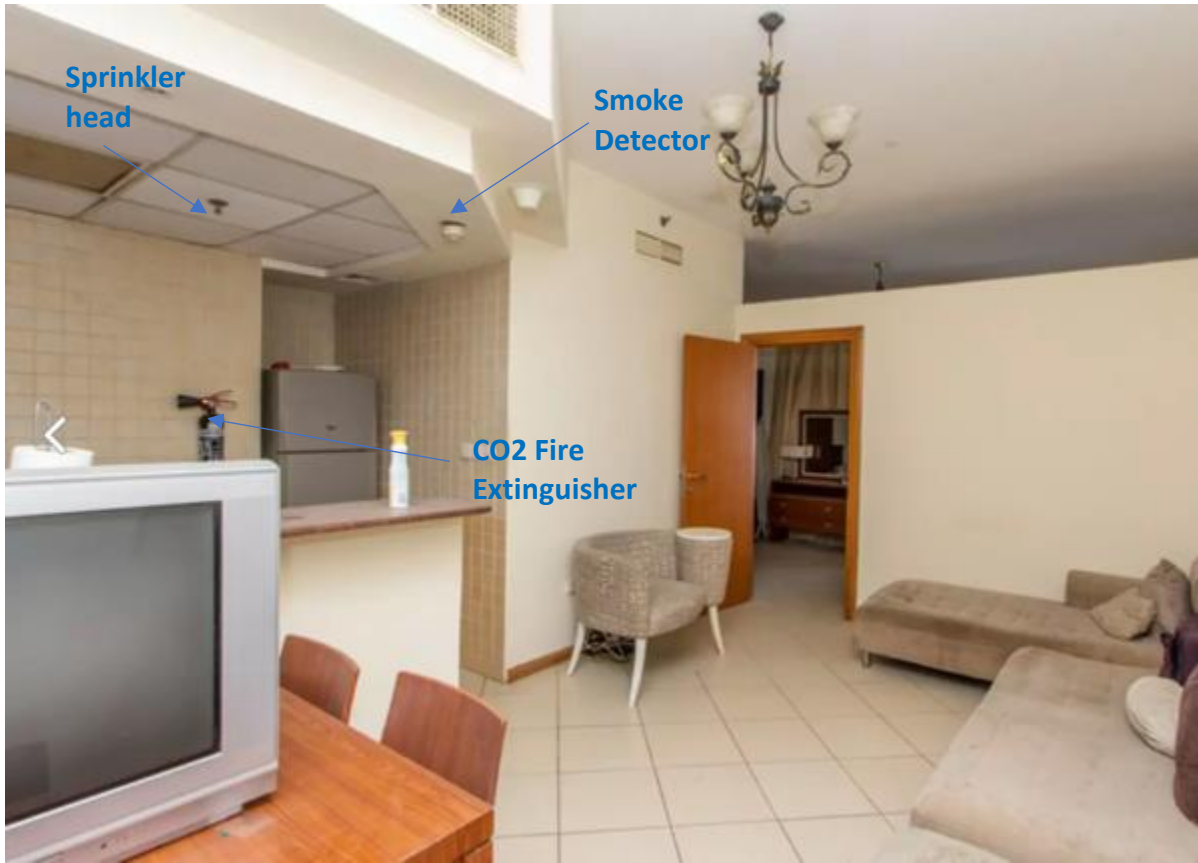
6.3 The building appears to have been fitted with a sprinkler system (*Figs.22 & 23*). This would activate upon detection of fire and raise the alarm, allowing residents to leave the building whilst limiting the spread of fire within the interior of the flats. The building manager, Mr. Siddiqi, stated that *"The fire sprinklers were activated, so there is some water damage as a result. Everything in those areas is wet, with only five or six apartments seriously affected by the fire itself."*

Figure 23: The interior of a one-bedroomed flat in the Marina Diamond 2 building, which has an open plan kitchen/diner/living area. A fire extinguisher, sprinkler head and smoke detector are visible. Such provisions do not appear to be anywhere else within the flat other than the kitchen. *Photo:* www.bayut.com

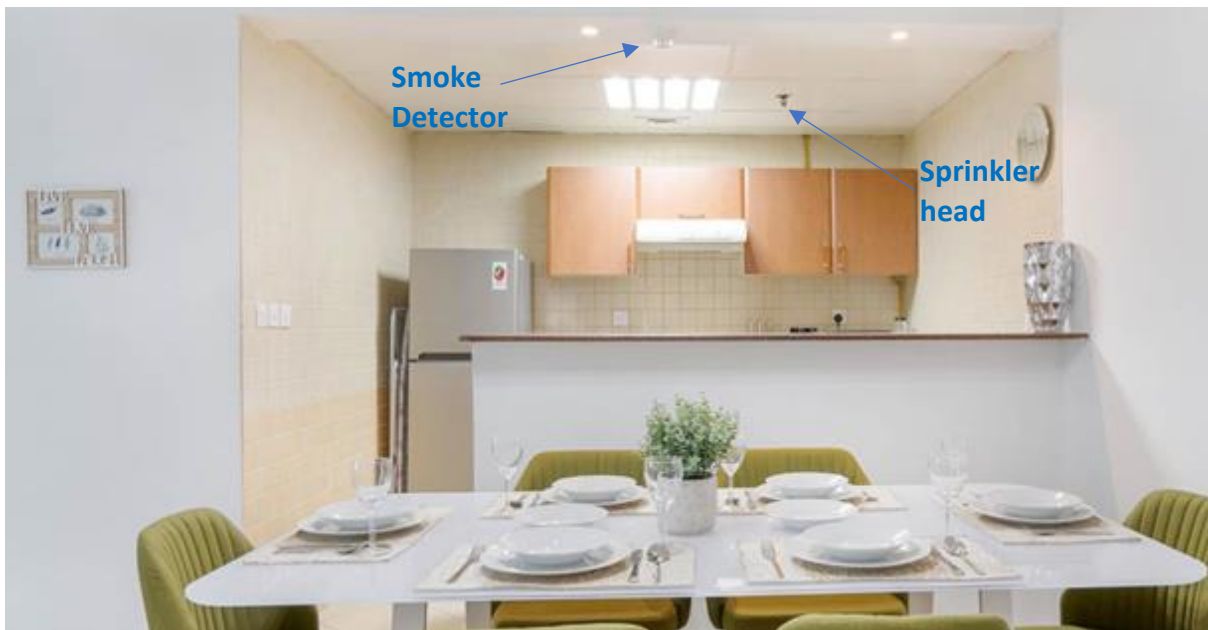
Figure 24: The kitchen and dining area in a two-bedroomed flat of the same plan (but in reverse) as the one where the fire started. There is a smoke detector and a sprinkler head. These provisions are only found in the kitchen and not elsewhere in the flat. *Photo:* Kennedy Towers www.kennedytowers.com
