**REPORT ON THE FIRE WHICH OCCURRED AT TORRE DEL MORO,
MILAN, ITALY ON 29 AUGUST 2021**

By Frances Maria Peacock

Updated Version - October 2021

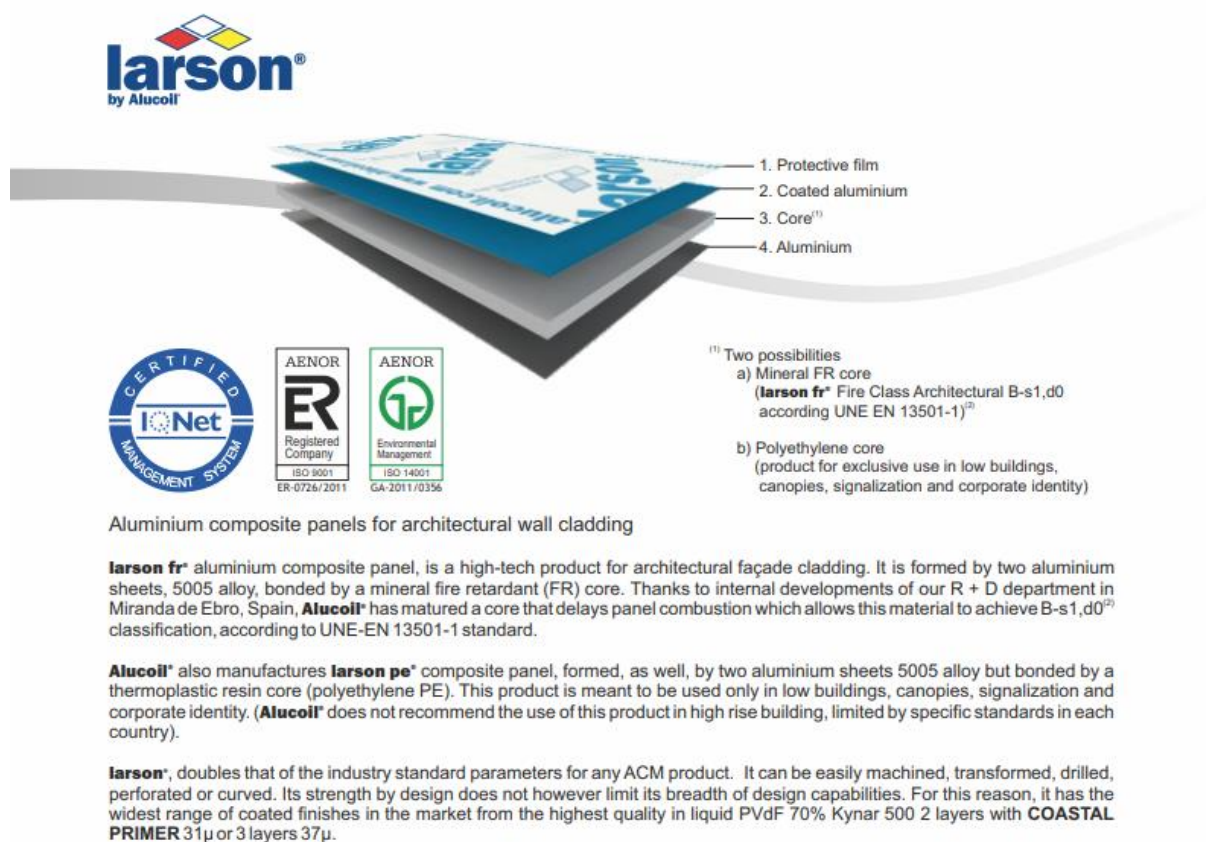
Figure 11: The first half of the product data sheet for Alucoil/Larson cladding panels

4.1 The sails and the columns are covered in a rainscreen cladding system comprising aluminium composite material (ACM) panels, which have aluminium skins and a polyethylene (PE) core. They are therefore of the same type as those used at Grenfell Tower, although they are the product of a different manufacturer. At Grenfell, the panels were manufactured by *Arconic®*, based in France, but in the case of Torre del Moro, they were manufactured by *Alucoil®*, trading using the name *Larson®*, which is based in Spain. The *Alucoil* panels have a Class E* rating and may therefore quickly lead to a flashover situation and are described as *products capable of resisting for a short period, a small flame attack without substantial flame spread.* This means, in a building situation, a fire may be avoided if the exposure to flame was a matter of seconds, but once the panels are ignited, the fire spreads rapidly with little anyone can do to stop it. This is why Grenfell Tower, the Torre del Moro and other high rise buildings with the same type of cladding have become engulfed in flames very quickly. Therefore, this product is highly combustible and make a significant contribution to fire. Ratings for smoke and droplet production are usually given, but the manufacturer’s data sheet, reproduced in *Figures 11 & 12*, does not give any smoke or droplet classifications for its PE panels.

4.2 From the data sheet it can be realised that there are two types of “Larson by Alucoil” panel. One of these has a PE core and the other a Fire Resistant (FR) core. The latter is rated Class B s1 d0. Unfortunately, as at Grenfell, the FR version was not used at the Torre del Moro, and therefore the building was given a façade which was a fire risk and a disaster waiting to happen. Euro Class B products will not lead to a flashover situation, but will contribute to a fully developed fire, and are described as being *capable of resisting, for a longer period, a small flame attack without substantial flame spread. In addition, they are also capable of undergoing thermal attack by a single burning item with sufficiently delayed and limited heat release*. This means that although the product is combustible, there will be a longer delay between exposure to fire and ignition. Although safer than a product with a Class E rating, the FR panel is still not suitable for use on high rise residential buildings.
